marine casualty

Petro Giant Drilling Ship (Platform)

Injury to the left hand of an able-bodied seaman (able seaman, hereinafter also A/B) while working at the hook block on 30 April 2023.

December 2023

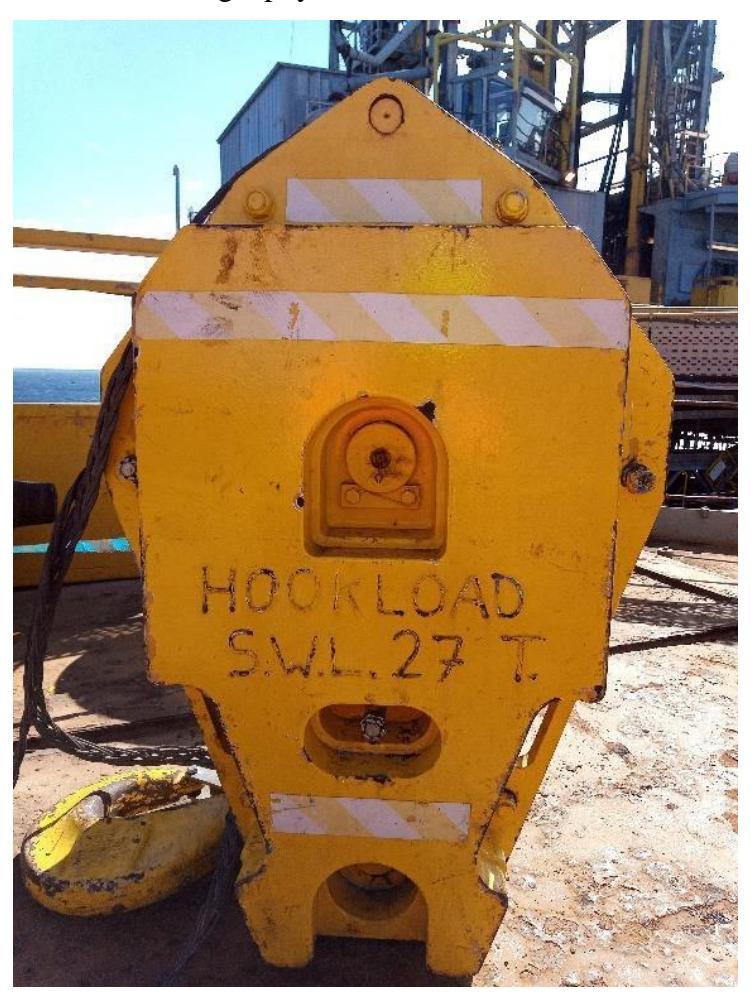
Photo 1. Hook block (SWL 27 T) on the platform's geophysical deck

While working on the hook block, he suffered crushed fingers of his left hand as a result of the hook block tilting and the fingers of his left hand becoming jammed between the hoisting wire (also called a rener)³ and the sheave of the hook block with the casing. After the accident, the injured person was given first aid in the ambulatory by the platform doctor.

As a result of the investigation, the Commission found that the immediate cause of the A/B's work-related accident while replacing the hook block was the uncontrolled tilting of an unsecured on the rig's deck hook block while it was being replaced. When the able-bodied seaman pulled back the rener wire with his left hand, the hook block (weighing 1,200 kg) became unstable and tilted, causing A/B's hand to become trapped between the rener wire and the hook block housing. This led to the crushing of the fingers of the A/B's left hand.

In the Commission's view, the mechanical factor that directly contributed to the accident was the uncontrolled tilting of the unsecured heavy hook block when the A/B's left hand was between the rener wire and the sheave of the hook block. This resulted in his hand being pulled in, jammed and the fingers of his left hand being crushed. In addition, the size and shape of the block and the small area of its base were factors contributing to the loss of the block's stability and its tilting. This made the hook block unstable on the uneven platform deck.

In addition, the Commission recommends following the crane manufacturer's recommendation to place the hook block in a basket when working on it, to properly prevent it from losing stability and tilting.
