PAŃSTWOWA KOMISJA BADANIA
WYPADKÓW MORSKICH

FINAL REPORT

**M/V
SITULA**

Missing crew member on the Baltic Sea on 10 January 2019

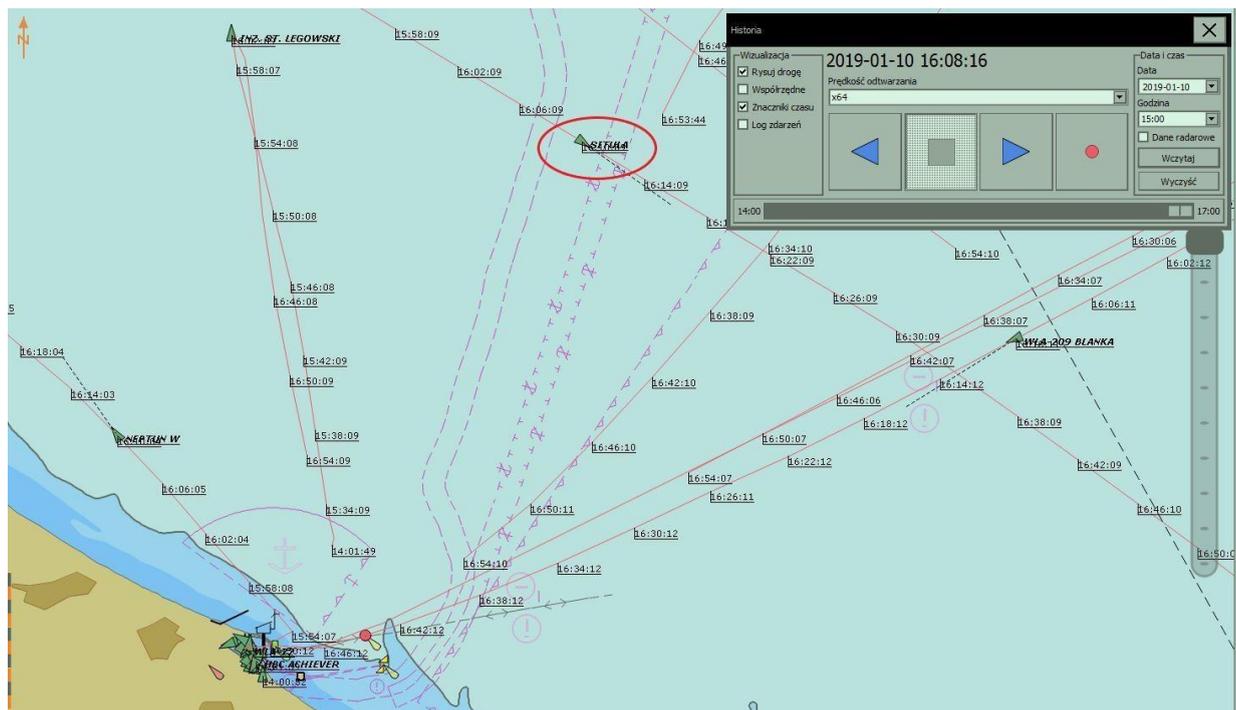
On 10 January 2019, around 9:45 p.m., after arriving at the port of Gdynia the captain of Situla vessel reported to the agent and VTS services the absence of one of the crew members. The missing person was last seen around 4:00-5:00 p.m. during preparations for mooring the ship, when the vessel was sailing along the coast at a longitude of port of Władysławowo [Figure 1].

Figure 1. Position of the Situla vessel on 10 January 2019 at 4:08 p.m.

On 10 January 2019, the Situla vessel was on its way from Qatar's port of Doha to the port of Gdynia. At around 4:00 p.m., 4-5 NM north of Władysławowo [Figure 1], the captain instructed the crew to prepare the ship for mooring – laying ropes and attaching fenders. At that time, according to the crew's testimony, the weather was nice, the sea was still, it was almost windless.

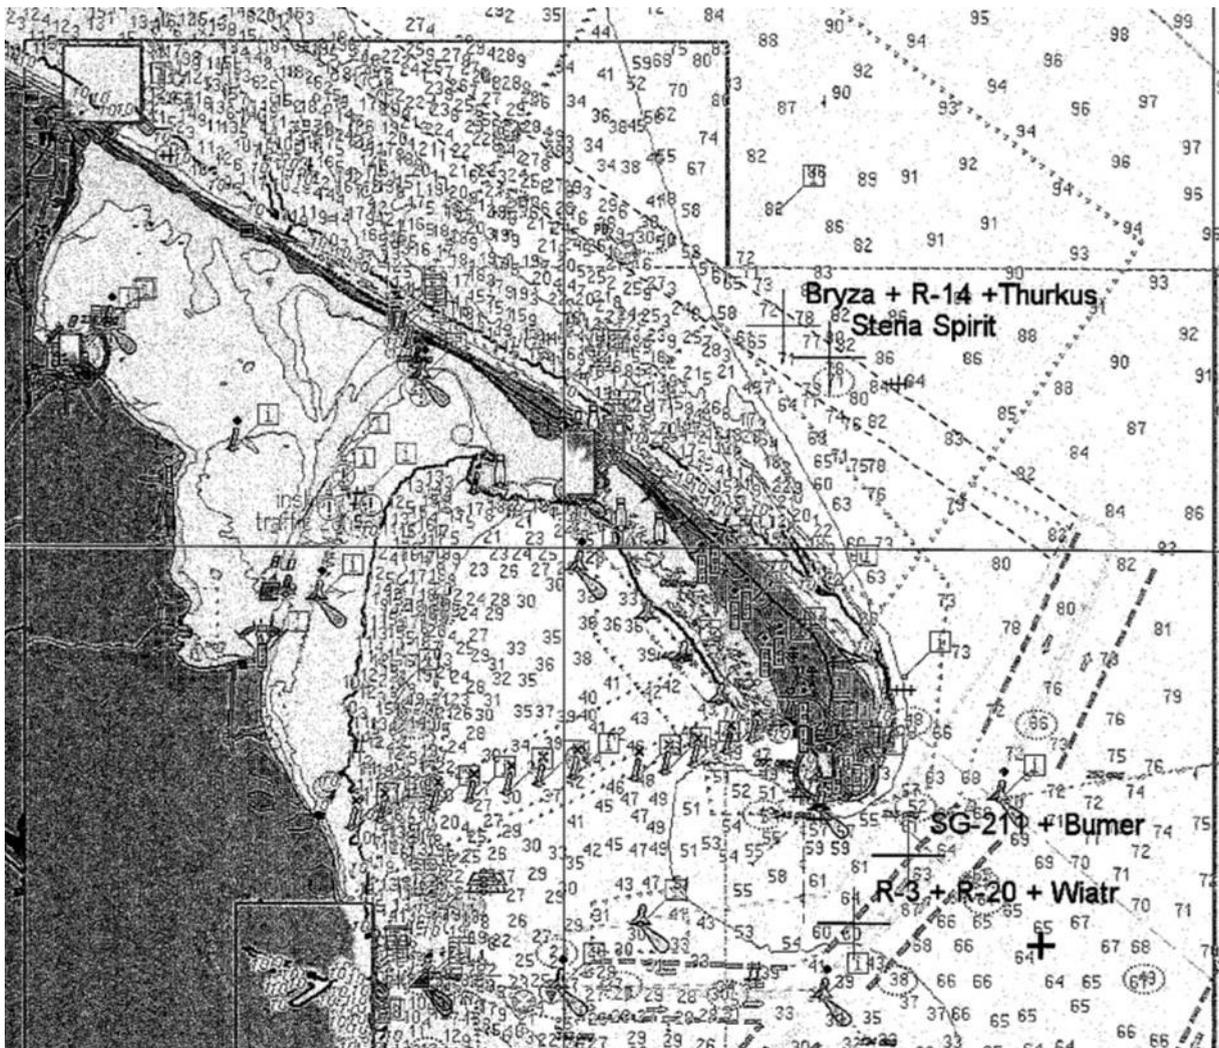
On 10 January 2019 at around 9:46 p.m., an agent of the Situla vessel notified the Port Authority in Gdynia that a crew member was missing, and subsequently the Authority notified the Marine Rescue Coordination Centre. At 9:54 p.m. the Coordinator of the operation at sea rescue vessel Kapitan Poinc ordered to prepare rescue vessels R3 and R20 for putting to sea. At 10:10 p.m. an order was issued to include the Bryza and BSR WŁA vessels in the search and rescue operation. The search began at a distance of 4 NM north of Rozewie, then on the course of 120° along the Hel Peninsula. At 10:36 p.m. the vessels taking part in the operation were given new instructions to search the fairway near the HEL buoy, then the fairway area towards Gdynia, together with SG-211 vessel [Figure 2]. Bryza and R14 vessels conducted joint search on parallel courses from position 54° 51.2' N 018° 30.0' E. At 10:58 p.m. helicopter 0813 was included in the operation, but it had to stop action due to deteriorating weather conditions in the search area. The helicopter resumed operations at 00:14 a.m. making visual observation using a reflector. Stena Spirit ferry also took part in the search and left the search area at 11:47 p.m. with negative results. At 00:18 a.m. m/v Thurkus was included in the operation. At 00:44 a.m. another SAR vessel – Wiatr – joined the operation. After re-crewing and refuelling, the rescue vessels were reorganised, successively R-20 joined the Wiatr vessel and SG-211 near the GD buoy and together they continued to search in the area of the fairway to the HEL buoy. The R-3 vessel was searching the port road area from the breakwater to the GD buoy. On 11 January 2019 at 01:24 a.m. near the GD buoy, Bumer boat of WOPR of Gdynia joined the search.

Figure 2. Area of search for the missing crew member of *Situla*.

On the same day at 9:46 p.m. the search and rescue operation began on the Gdynia-Władysławowo route [Figure 2].

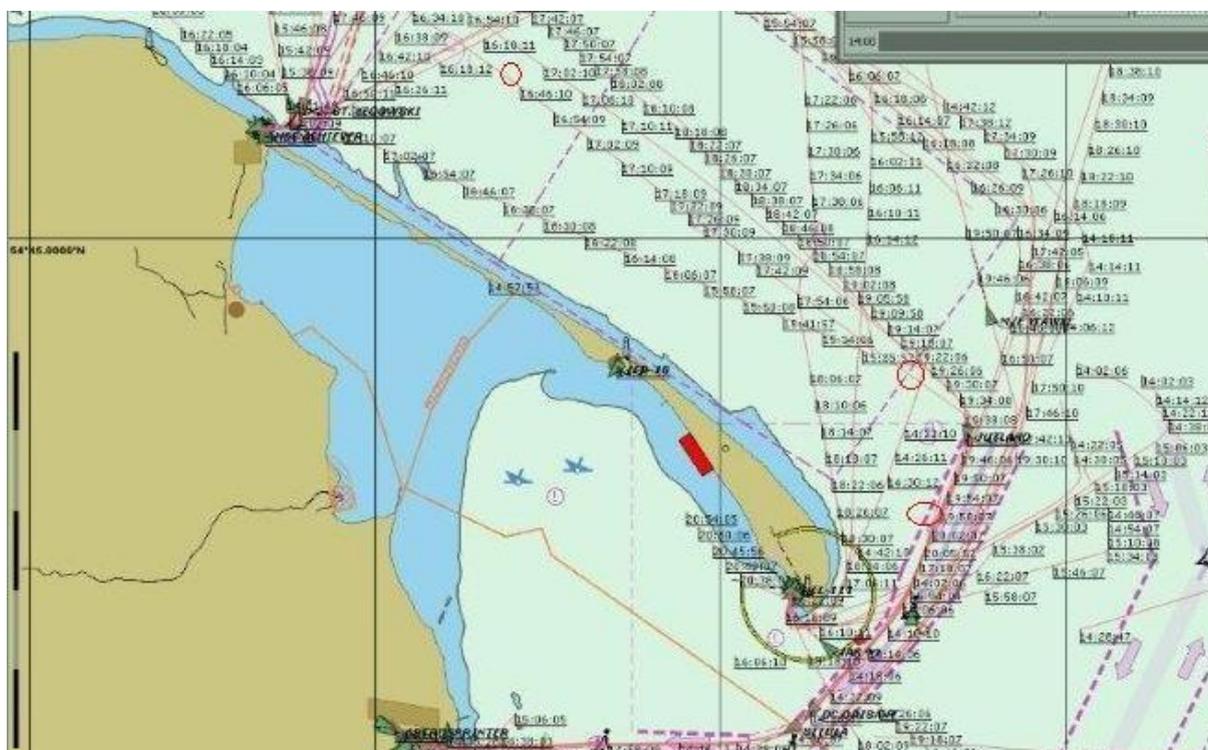
Figure 3. Władysławowo-Gdynia route

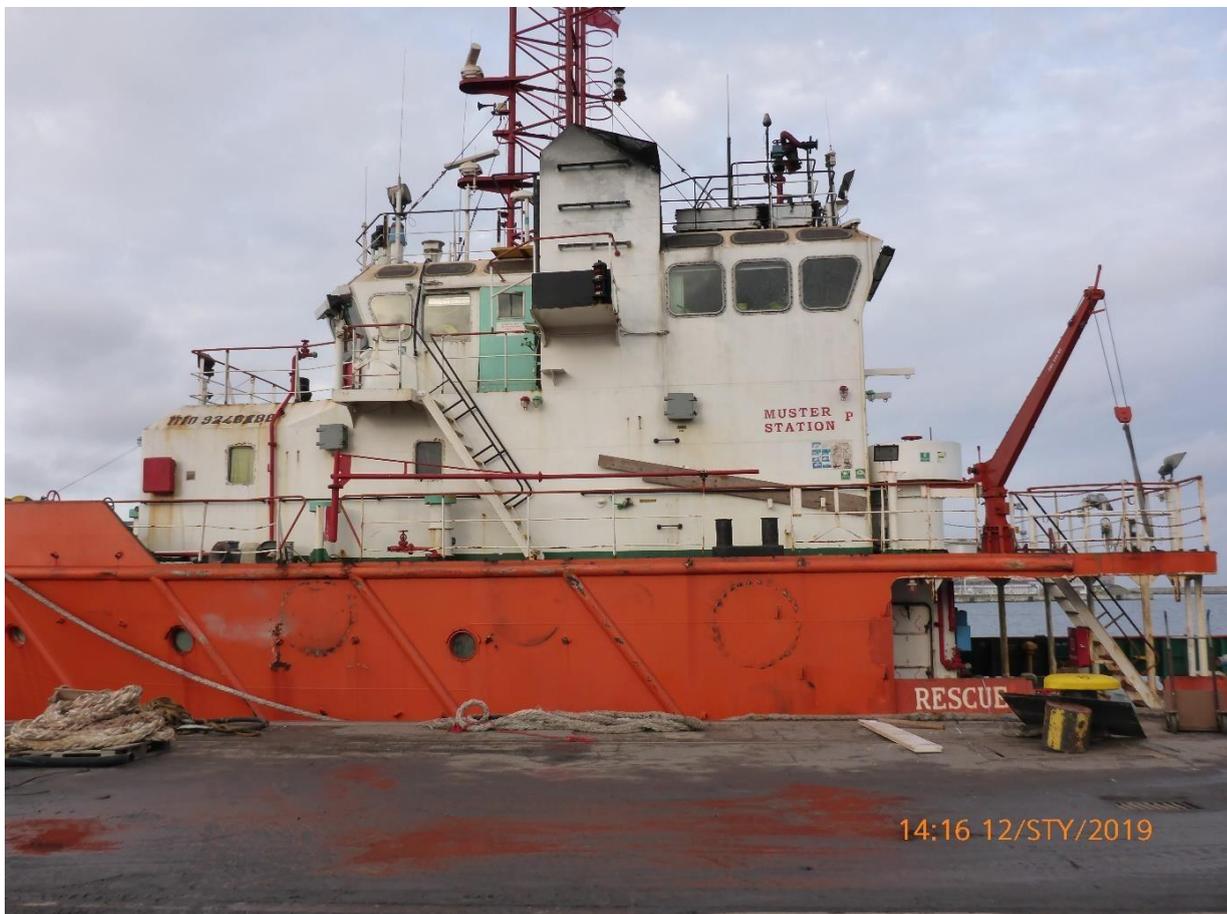
Analysing the construction of the Situla vessel, and in particular the elements of the deck part (height of railings and the manner of their construction), it can be stated that the design of these elements could prevent a sailor from accidentally falling overboard [Photograph 2].

Photograph 2. Situla vessel at Nabrzeże Angielskie in the port of Gdynia on 12 January 2019.
