STATE MARITIME ACCIDENT INVESTIGATION COMMISSION

INTERIM REPORT 48/14

M/V ACHILLES

Grounding of the ship

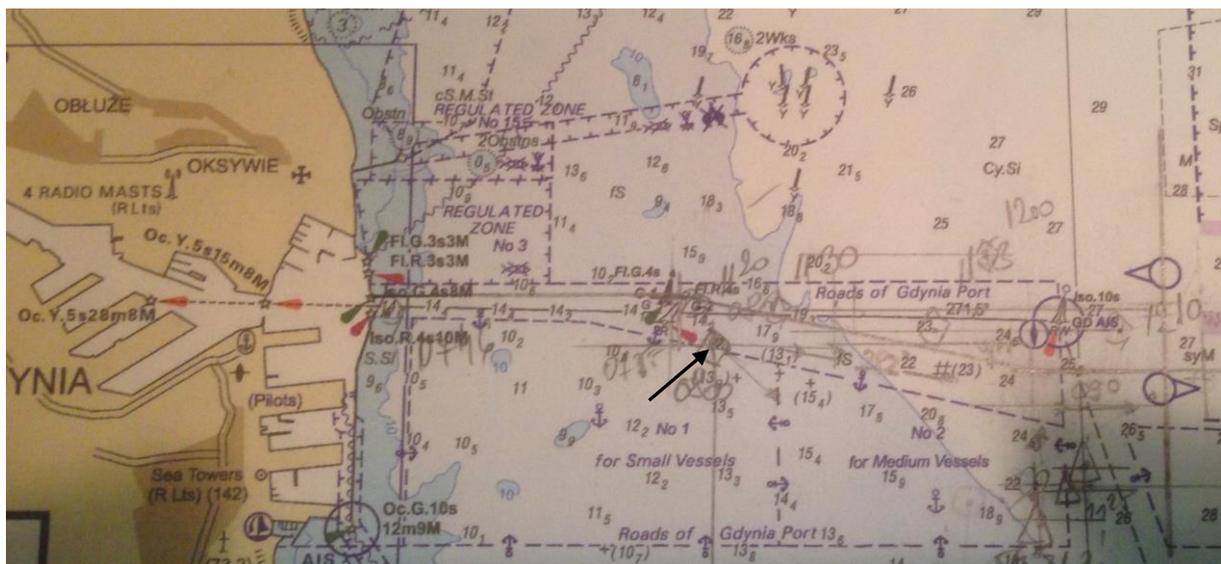
Photograph 2. BA chart 2680 (approach to Gdynia) with the place where Achilles ran aground marked

About 7:38 am, after Achilles passed the entrance heads, Centaur II was released. Heros was released at the stern at 7:40 AM. At 7:45 AM Achilles passed G1-G2 buoys gate. Due to waves, the pilot agreed with the master that the ship would turn starboard and then port to give a lee on the leeward for the pilot to get to the pilot boat. The pilot left the bridge at 7:55 am. At 8:00 am the pilot returned to the bridge because Achilles did not finish the manoeuvre and lost speed due to running aground at $\varphi = 54^{\circ}31,95'N$; $\lambda = 018^{\circ}36,77' E$ on course $092,5^{\circ}$. The ship was slightly heeled to port.

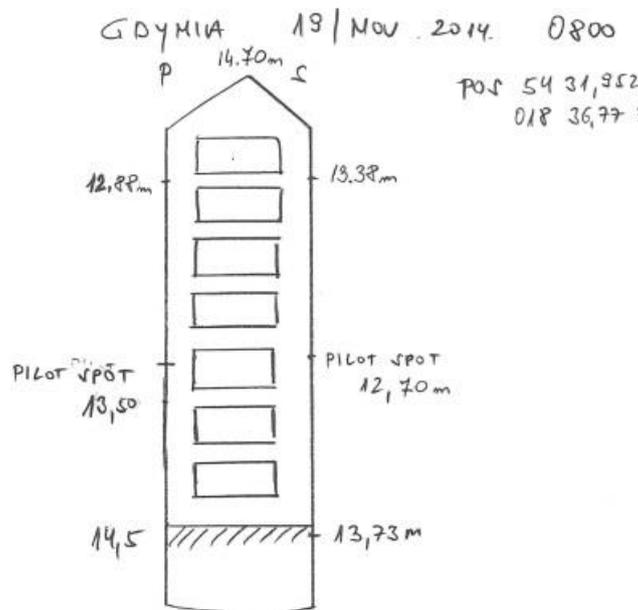
Figure 1. Plan of soundings around Achilles on a shoal.

The accident was notified to the Port of Gdynia harbour master's office and to "VTS Zatoka". Initially, the crew tried to leave the shoal using ship machines alone, but didn't succeed. At 8:30 am the crew measured draught around the ship and checked the bottom tank fill level. Measurements revealed that the ship ran aground by the starboard, and the hull remained tight.
