SMAIC
STATE MARINE ACCIDENT
INVESTIGATION COMMISSION

FINAL REPORT

**m/y Mietus II
and m/v Begonia S**

**Collision of vessels at the Baltic Sea
on 4 November 2018**

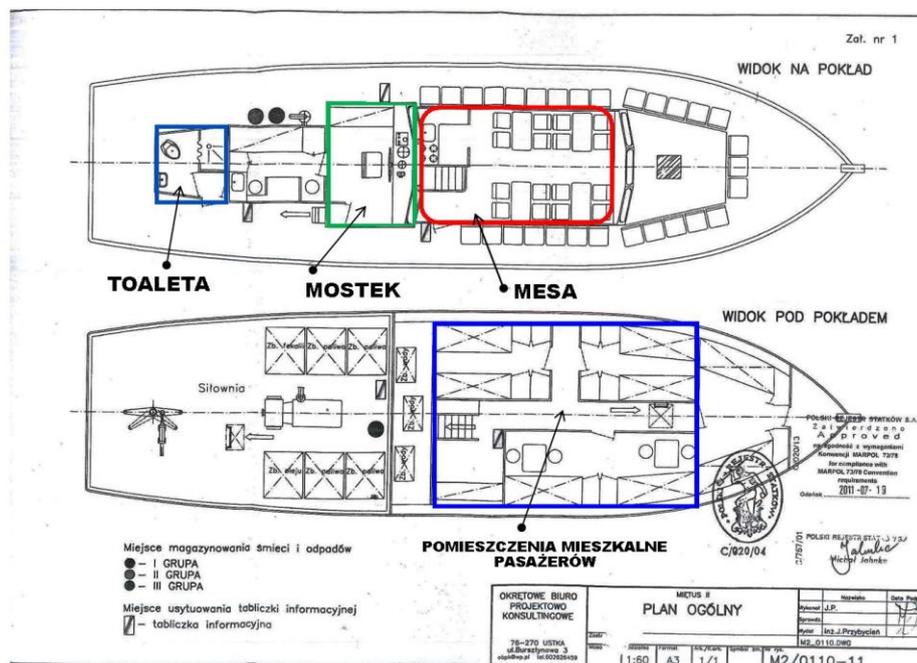
Figure 4: Plan of accommodation aboard „Mietus II”

On *Mietus II*, since 02:30 the observation and control over the yacht had been conducted by the helmsman. From the control place, an unlimited observation towards the bow and to both sides, as well as the ability to observe the radar screen and other devices were ensured. At night the decks were darkened and only at the stern, at the back of the superstructure there was a light illuminating the entrance to the toilet. The explanations of the crew submitted to the Commission confirm that the visual and radar observation were correct and allowed for an early detection of the approaching *Begonia S*.

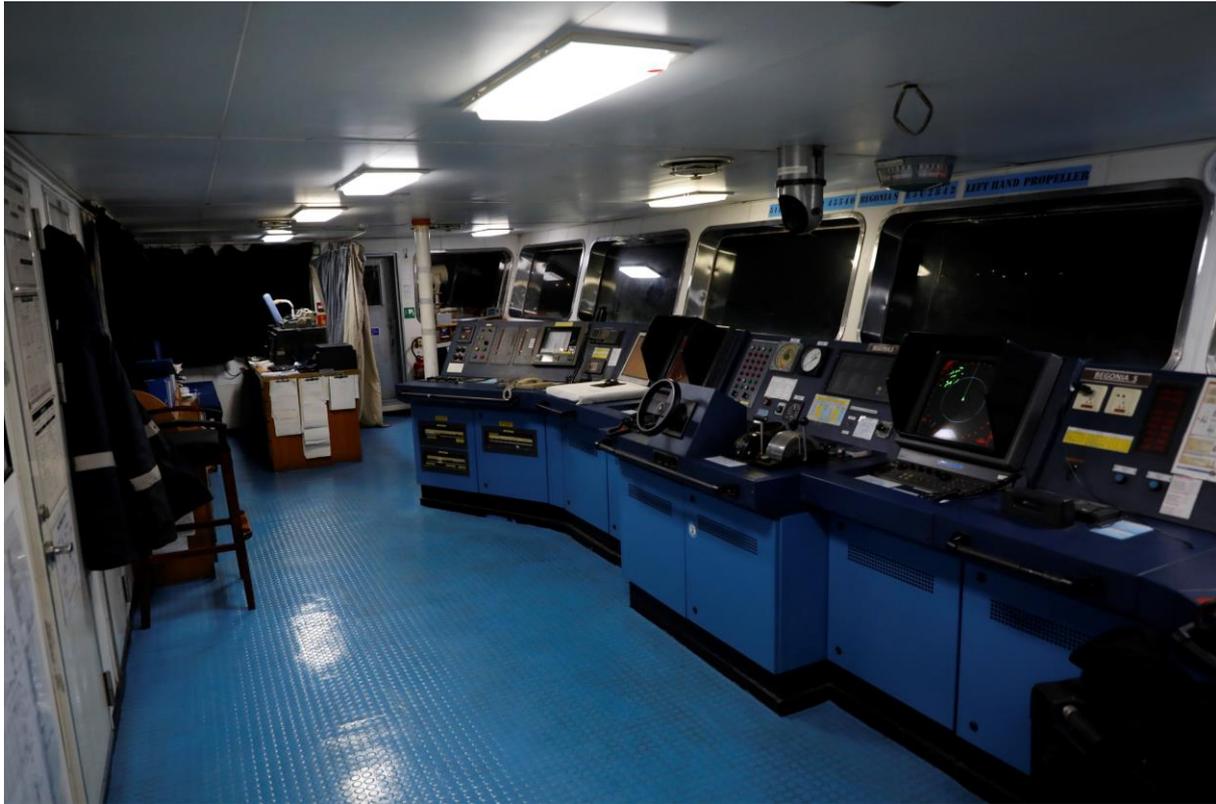
Photograph 4: The bridge on „Begonia S”

Aboard *Begonia S*, the watchman was conducting visual and radar observation while staying in front of the right radar screen on the bridge before the collision.

superstructure. The evidence of the influence of the above-mentioned factors on the quality of observation was the fact that *Mietus II* was noticed only at a distance of about 40 m from *Begonia S*, and the yacht was observed by the officer of the watch and not the O/S whom the lookout duties were entrusted to. By analyzing the information obtained, the Commission was not able to assess why the yacht's echo had not been detected on the radar screen despite the technical possibility of both radars to do so. The reason could be wrong settings of radar operating parameters removing weaker echoes, conducting occasional radar observation or assuming that all vessels have AIS installed. When conducting other accident investigations, the Commission noted that since vessels had been furnished with AIS devices, the quality of radar observations carried out by watchkeeping officers had decreased.

Due to a late detection of the yacht, at a distance of about 40 m from the bow, the watchkeeping officer of *Begonia S* had no chance to analyze the risk and could only take actions to minimize the effects of the collision. There was also no time for any communication or attention signal. On *Mietus II*, the vessel, *Begonia S* was being observed for at least 20 minutes until the collision. The observation officer assumed that, in accordance with the provisions of the COLREG Convention, the ship would change course, giving way. No radar plot was carried out, but only visual observation confirming the invariability of bearings on *Begonia S*. Despite having the radar and the ability to precisely determine the distance of the vessel from the yacht, no action was taken to avoid the collision at the moment it became clear that the sole operation of *Begonia S* may not be sufficient to avoid the collision. Actions taken by the helmsman - waking up the skipper and turning to starboard were done too late. Despite doubts as to the correct behavior of *Begonia S*, the helmsman of *Mietus II* did not try to give light or sound signals to draw attention or to radio communicate with the vessel, and above all to wake the skipper in good time.
