FINAL REPORT

STATE MARINE ACCIDENT
INVESTIGATION COMMISSION

**Very serious marine casualty
of a fishing cutter
*JAS - 57 Magdalena***

Death of a crew member due to electric shock

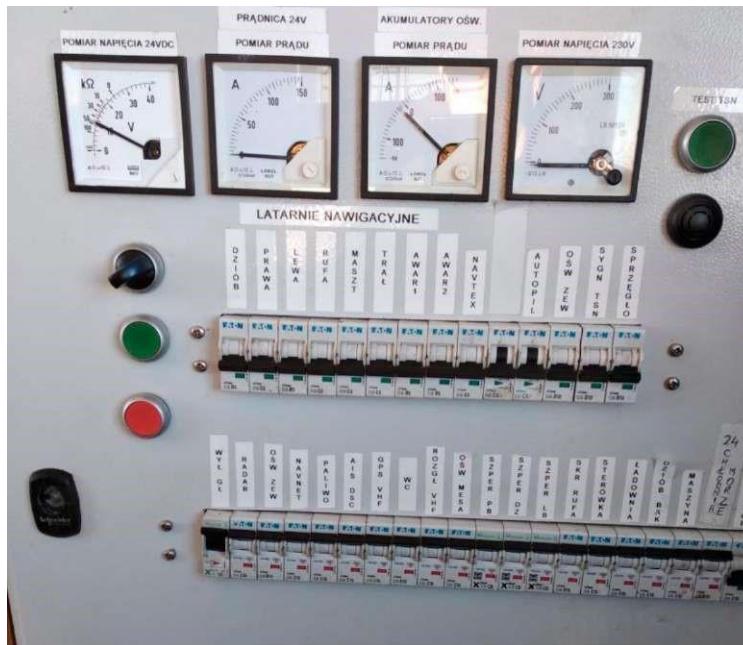
Photograph 7: 24 VDC power supply distribution panel

Main electrical installation of the JAS 57 cutter is based on a 24VDC installation. The basic source of electricity on the vessel is an accumulator battery working with a shaft generator. During the operation of the main engine of the cutter, the shaft generator with an output voltage of 24VDC is used. This generator is one of the basic sources of electric power. It supplies the low-voltage loads necessary for navigation, fishing, safety systems and cutter communication. It works with the accumulator battery. The distribution of 24VDC electricity is carried out through the switchboard located in the wheelhouse of the vessel.

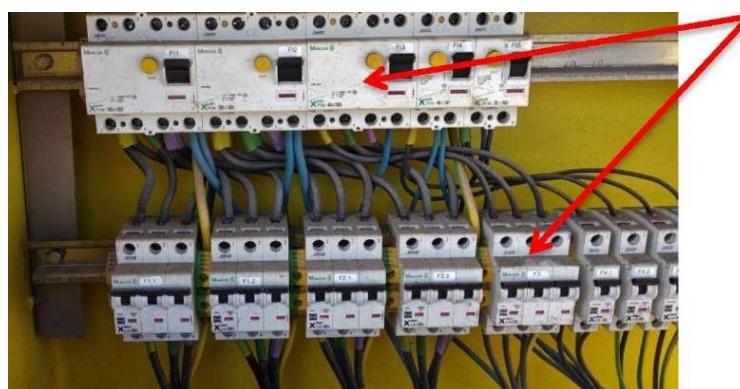
Figure 7: Protection of the 32A socket circuit supplying power to the cutter on the day of the accident

- F13 residual current circuit breaker: Xpole PFIM 40/4/003, Moeller, which switches on at the current of 30mA,
- F3 circuit breaker: Xclear CL S6 - C32 / 3.

The 3x400V, 50Hz power socket protection circuits are shown in Figure 7.

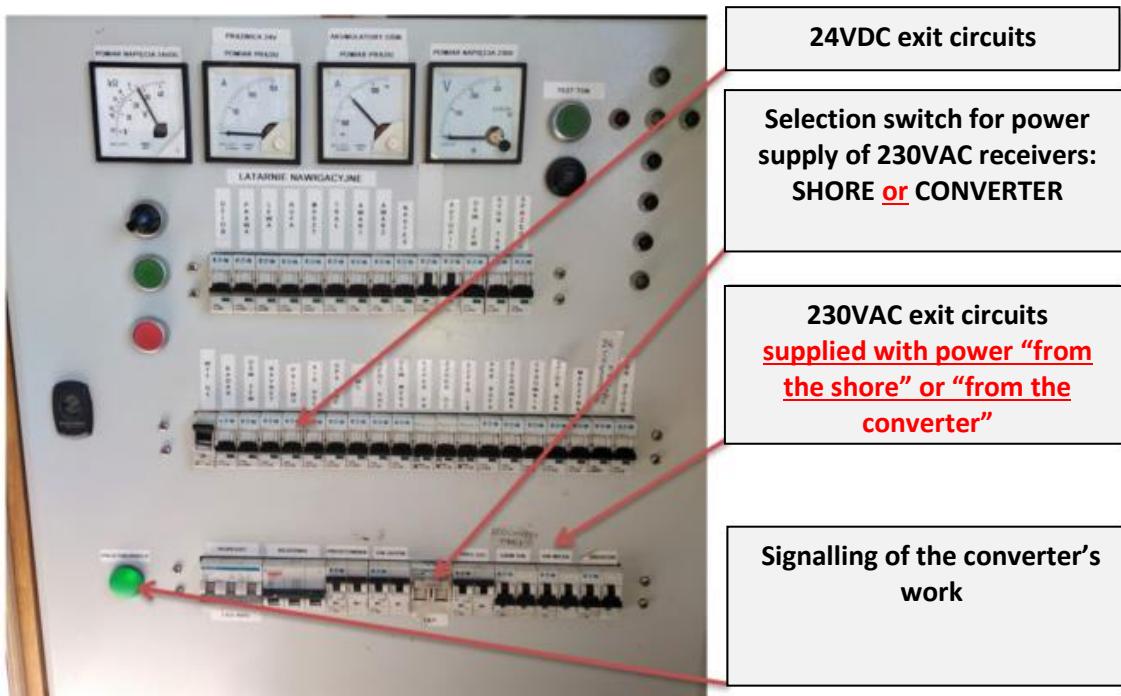
Figure 9: Switchboard at the bridge

- 3x400VAC shore power was connected to the socket mounted on the front side of the superstructure. Then, electricity from the three-phase socket was supplied through overcurrent protection, located in the wheelhouse panel, to the 230VAC sockets located in the engine room of the cutter. The converter was connected to such a 230VAC socket.

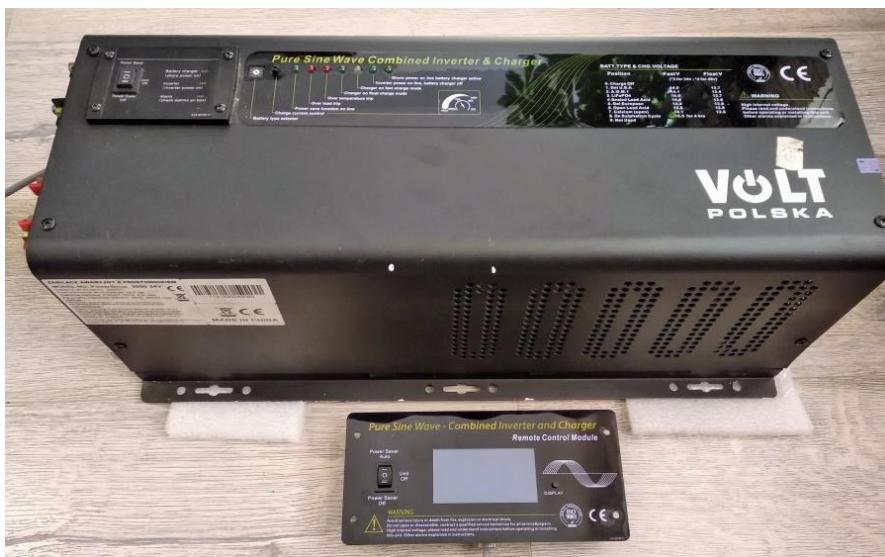
Photograph 11: Power Sinus 3000 24V converter

After removing the Power Sinus 3000 24V converter from the vessel, it was examined in conditions similar to those prevailing on the cutter, with regard to their ability to generate dangerous voltage on the housing or clamps giving an electric shock to a crew member. The results of the examination clearly showed that it was not possible. At the same time, the Commission found that the converter was not properly grounded and it was installed in a room that did not meet the requirements specified in the User's Manual of the device, and the device itself did not meet the requirements of the classifier and as such should not have been installed on the side of the vessel.

High Power Emergency Power Supply Power Sinus, distributed by Volt Polska Sp. z o. o. and hereinafter referred to as the **Power Sinus 3000 24V converter** or the **converter** is shown in Photograph 10.

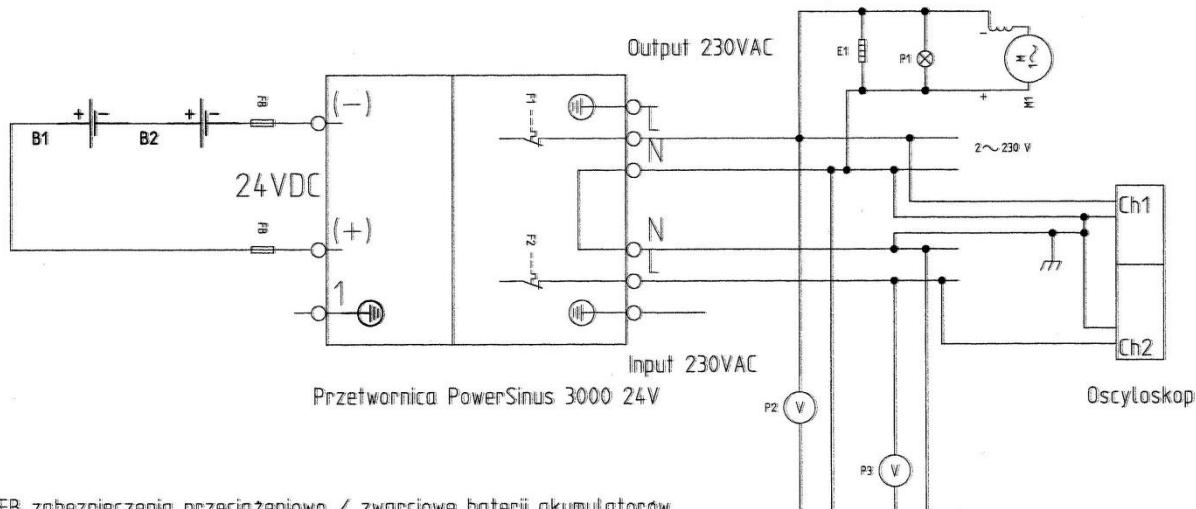
Figure 11: Schematic diagram for the analysis of the converter's work

After switching on (intentionally or accidentally) the converter to work in the Power Saver Off mode, by switching the switch on the converter's housing or switching the switch on the LCD panel located on the cutter's bridge, the converter started working in the inverted mode. It has properly generated voltage at its 230V, 50Hz output terminals (Output 230V). The 230V power supply selection switch on the bridge that was turned on to the converter position (Figure 9) caused the supply of power to the damaged 230V circuits. Damaged insulation of electrical circuits caused the appearance of phase voltage marked "L" on the steel-aluminum structure of the cutter.

At the same time, the crew member was carrying a cable connected to the converter's input terminals. After leaving the engine room, he touched with his hand one of the poles of the plug, the unshielded pin of the plug connected to the converter's "N" terminal. During this time he was standing on a wet mat lying on board in front of the exit from the engine room. Damaged insulation of the electric system of the cutter caused that the crew member suffered an electric shock.
