STATE MARINE ACCIDENT  
INVESTIGATION COMMISSION

# FINAL REPORT

# 89/19

**Pushed train: Atlant 1  
pusher tug and Ułan 72  
barge**

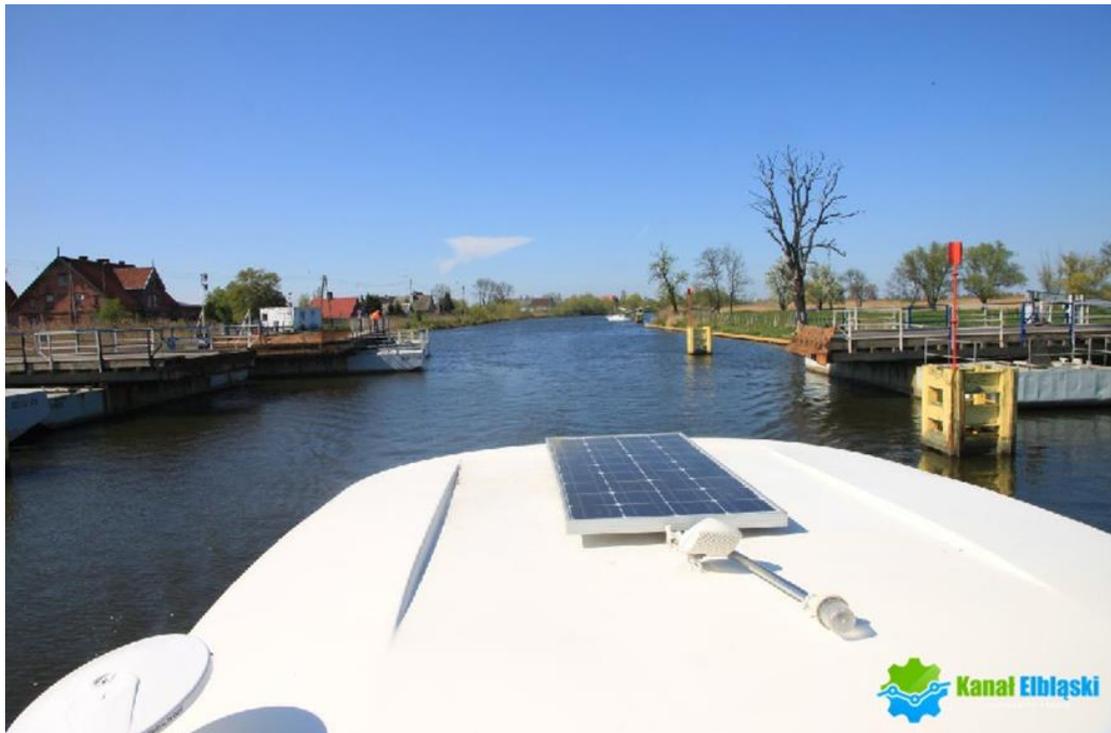
*Pic. 2 - Exemplary vessel approaching the bridge in Nowakowo (from the Elbląg side).  
(Source: <https://kanal-elblaski.pl>)*

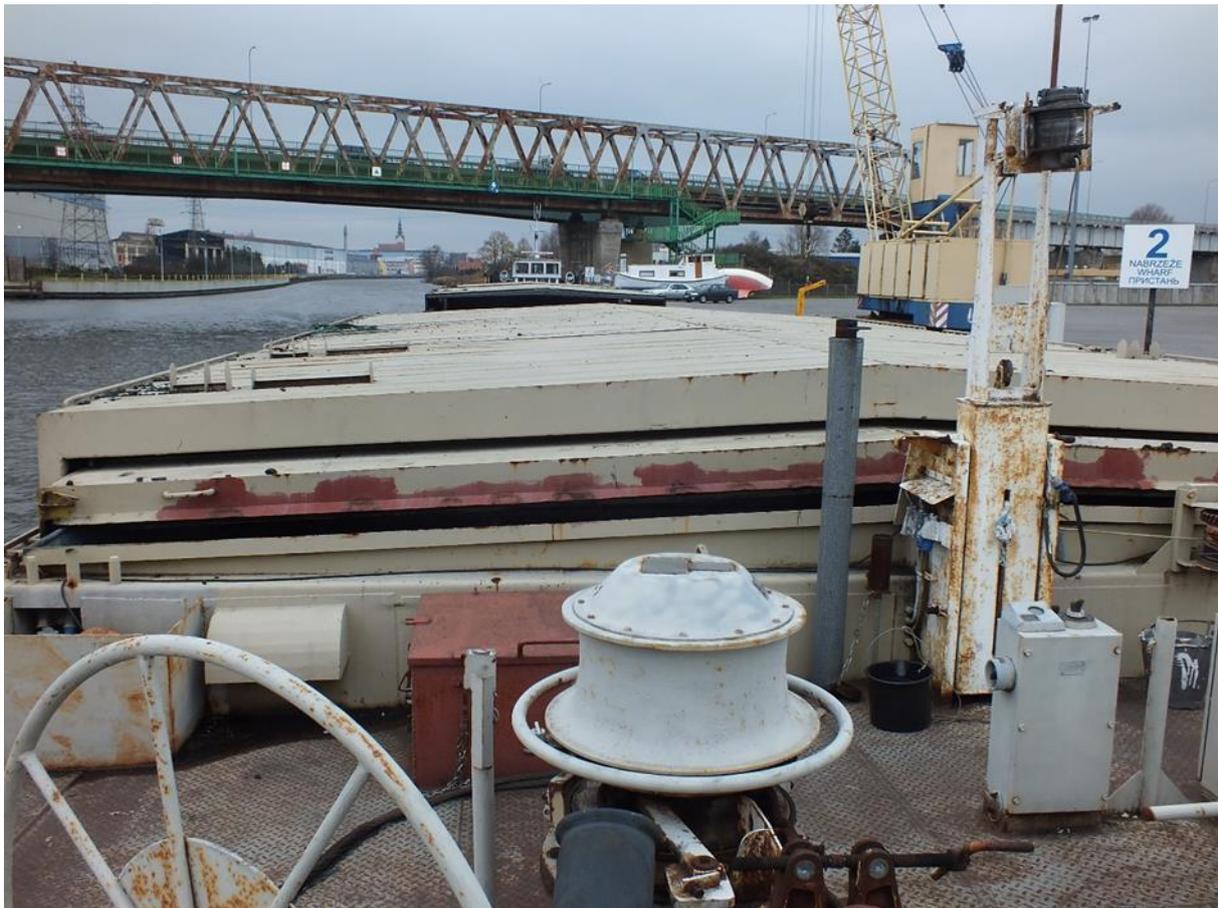
*Pic. 6 - View from the bow of the Ulan 72 barge towards the Atlant 1 Pusher tug*

the wheelhouse of the pusher was at the bow, very close to the low coaming of the cargo hold. At this point, the working height of the coaming from the deck is 77 cm. Shortly before the accident, the captain observer stood with his feet on the coaming which, during the violent lateral movement of the barge being the result of hitting the dolphin, was the cause of the captain losing his balance and falling into the cargo hold.
