PAŃSTWOWA KOMISJA BADANIA
WYPADKÓW MORSKICH

FINAL REPORT

112/19

**Yacht thrown onto the beach after overturning
on the approach to the port of Klaipėda
on 15 September 2019**

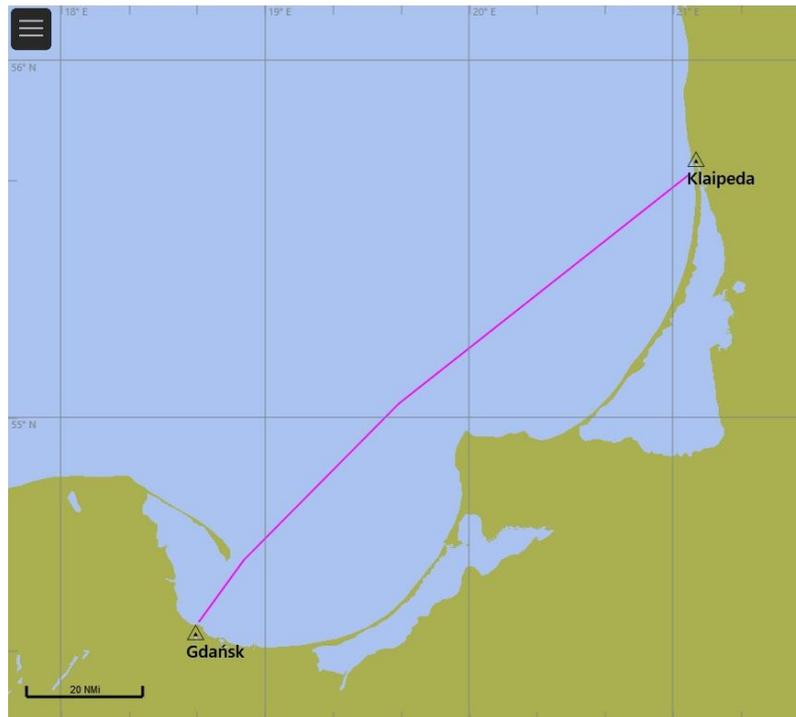
Figure 1. The cruise route of the “Lilla W” yacht, 14-15 September 2019

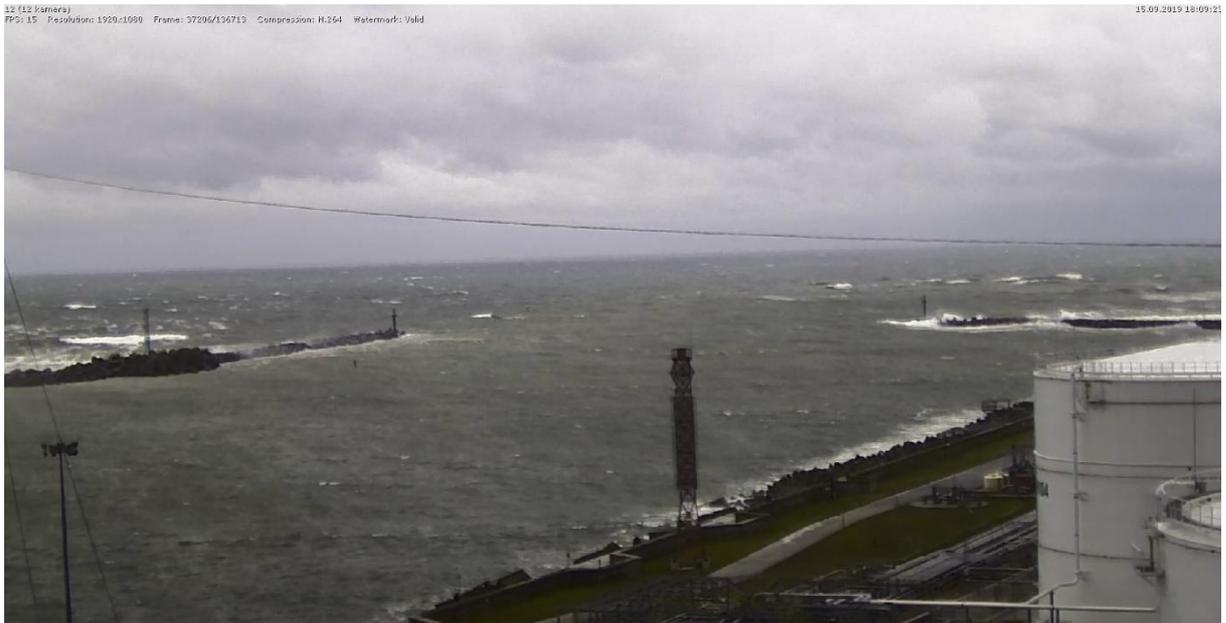
Photograph 2. Image from the monitoring camera at 18:09 LT (EEST).

Photograph 2 above shows the view on the entrance range line (the front light is visible) near the moment the first wave hit the yacht. The yacht (and the accident site) is to the left – south.

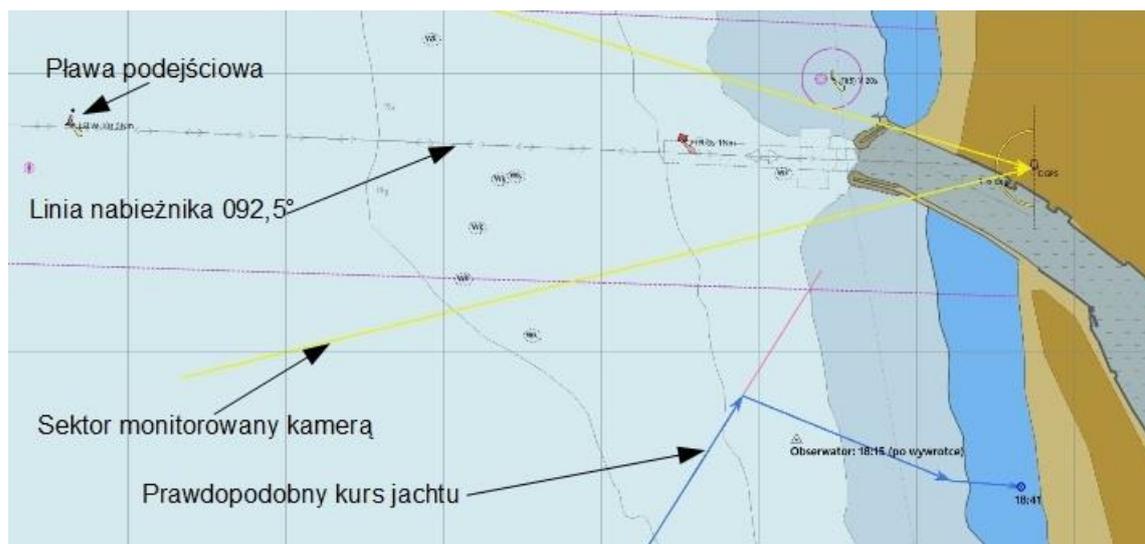
Figure 2. Approach of the “Lilla W” yacht to the port of Klaipėda on the ENC S-57 map.

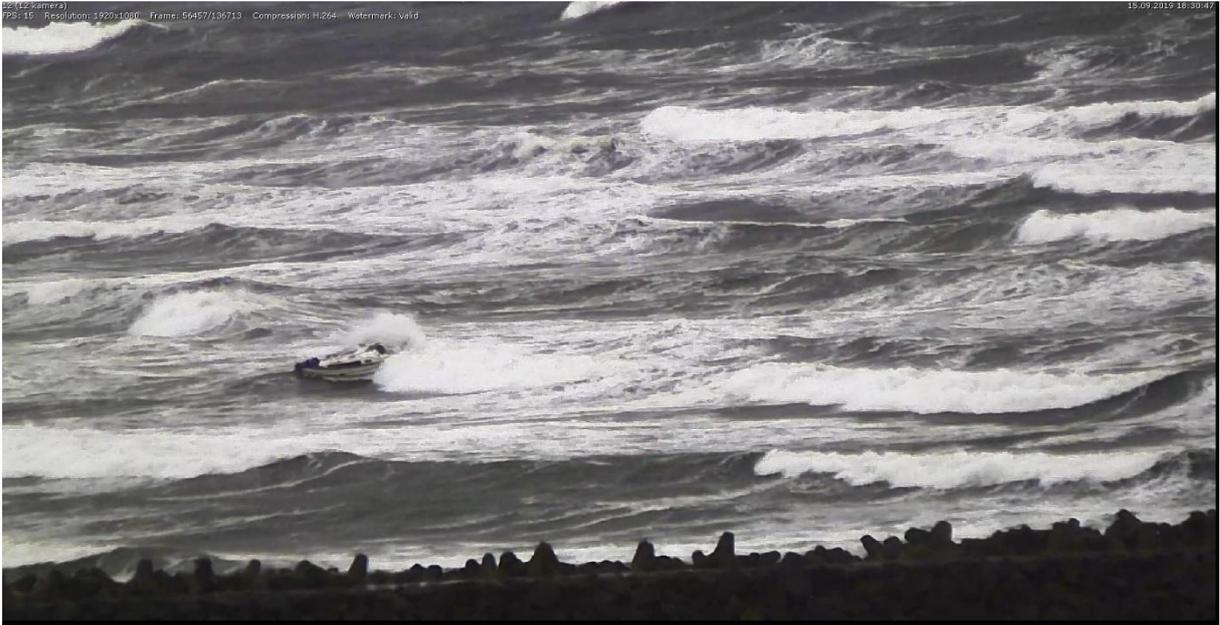
At 18:28 the operator of the port entrance monitoring camera received the incident notification and started searching for the scene. The camera, constantly directed at the entrance on range line, did not capture the approaching yacht so far. Since 18:29 the camera began to record the image of the mastless yacht and people in the water.

Photograph 3. Image from the monitoring camera at 18:09 LT (EEST).

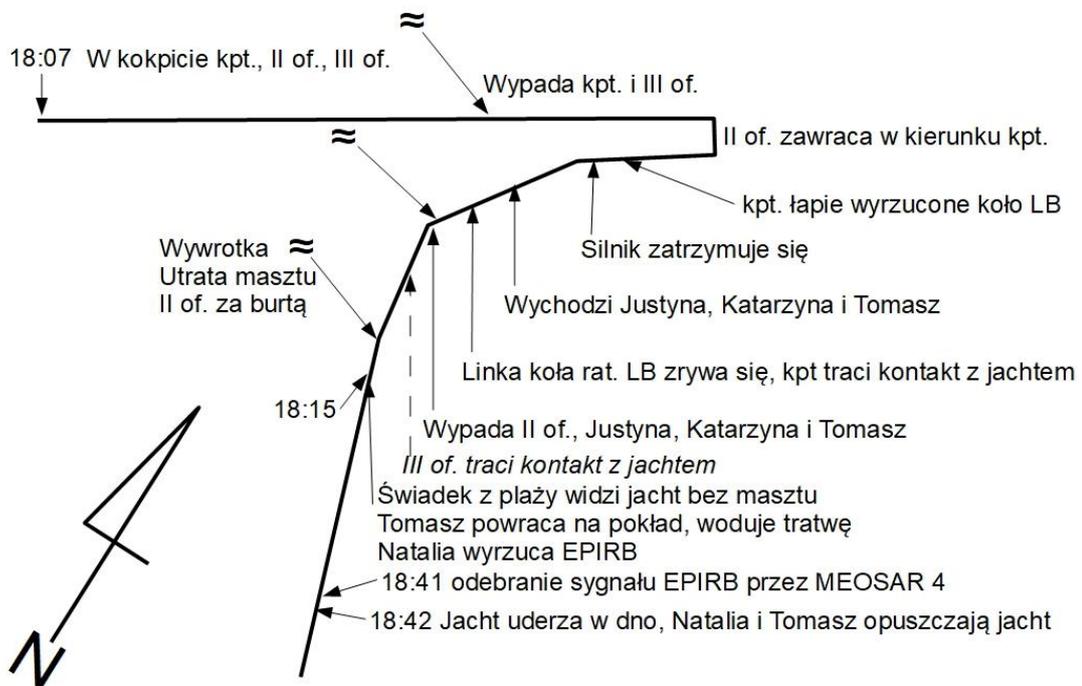
18:07 W kokpicie kpt., II of., III of. – 18:07 In the cockpit: captain, 2nd mate, 3rd mate

Wypada kpt. i III of. – Cpt and 3rd mate fall out

Figure 3. The chronology of events during the accident.

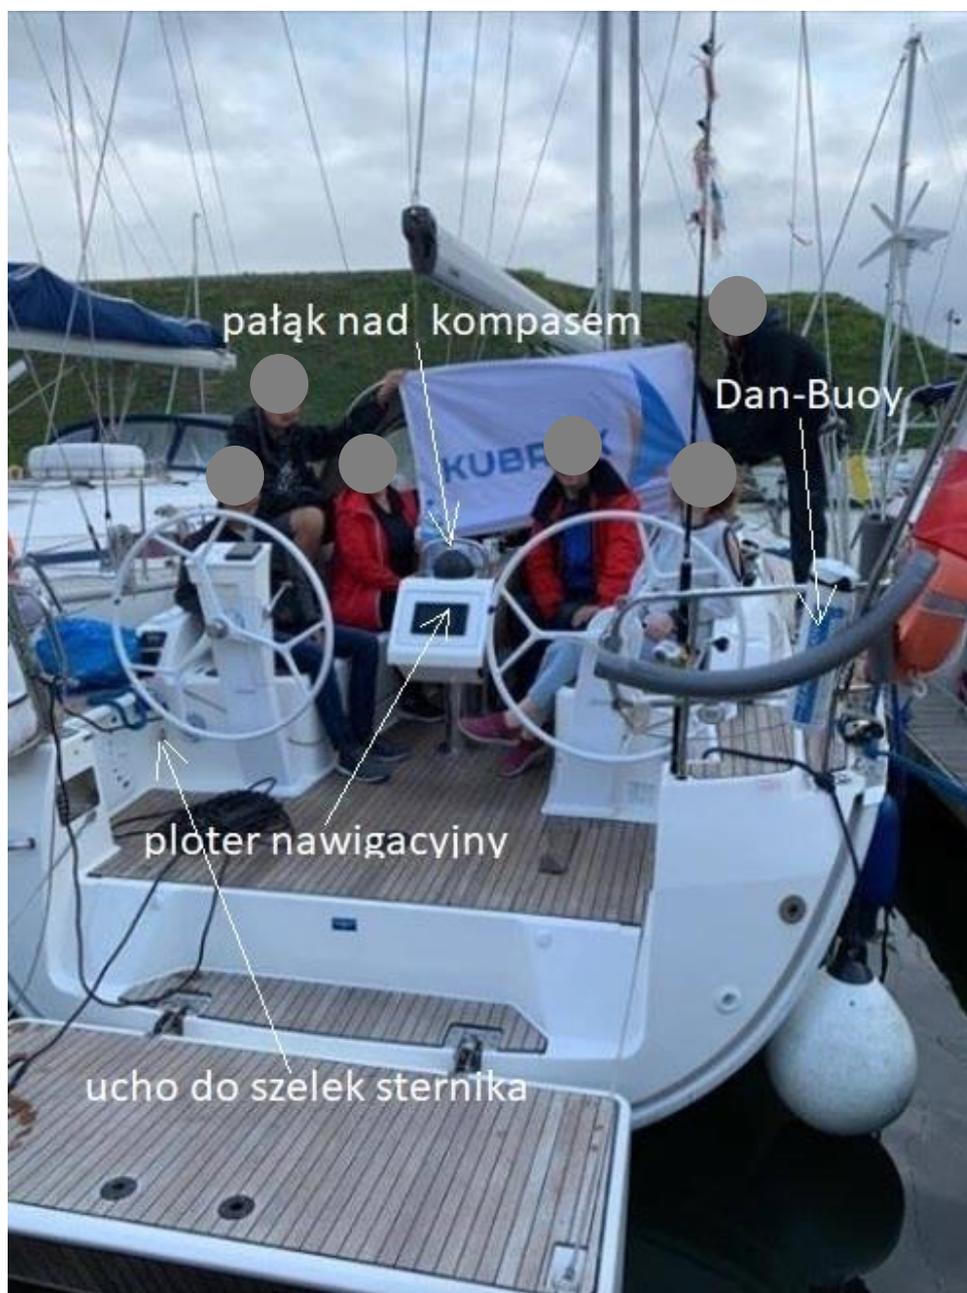
pałak nad kompasem – bail over the compass

The 2nd mate, also in a lifejacket, at the moment of the impact of the third wave was strapped to the bail protecting the magnetic compass mounted in the cockpit table. After the impact of the wave, he found himself in the water, but the table with the bail did not remained on the wreckage, so we do not know for sure which element did not withstand the impact. The bail over the compass is not intended to be the harness attachment point and is designed to protect the compass against a blow from the top and side rather than resist upward pulling forces. While swimming in the water in an inflated lifejacket, the 2nd mate had difficulties with the crotch strap, the plastic buckle of which unfastened causing the lifejacket to drastically rise over the head. He was dressed in a full oilskin and rubber boots, and as a result had to abandon all attempts of other actions and was constantly pulling the loose lifejacket towards his torso with both hands. This way he drifted ashore.

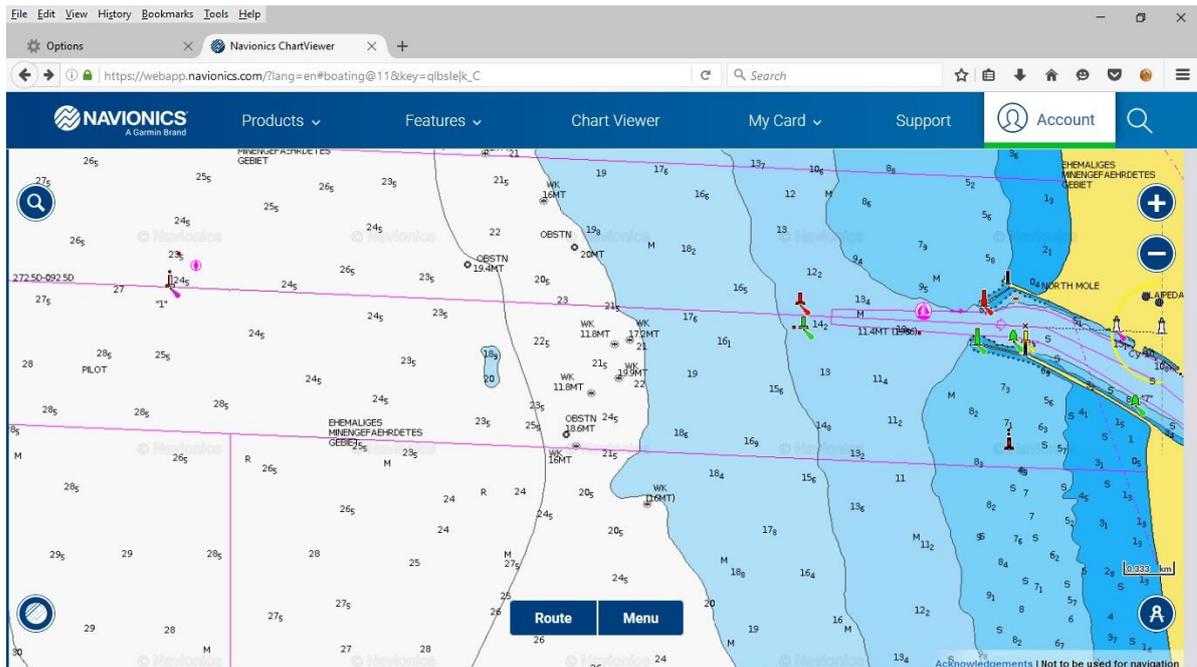
Figure 4. Approach on the Navionics map (source: Navionics, online preview).

During the approach, the captain did not discuss the approach plan with the mates and did not mention the specific direction of the range¹⁶ or the possible start of the approach near the deepwater buoy “1” put on the 092.5 range line and therefore the line of the recommended entrance course. Buoy “1” is situated around 3 NM from the heads. The accident took place a little less than 1 NM from the coast and a little less than 1 NM south of the heads. The description of the “Klaipėda-entrance” lower light of the range in the *List of Lights and Fog Signal* of the HOPN (Publication No. 523) available on the yacht indicates that it is “visible on range line.”

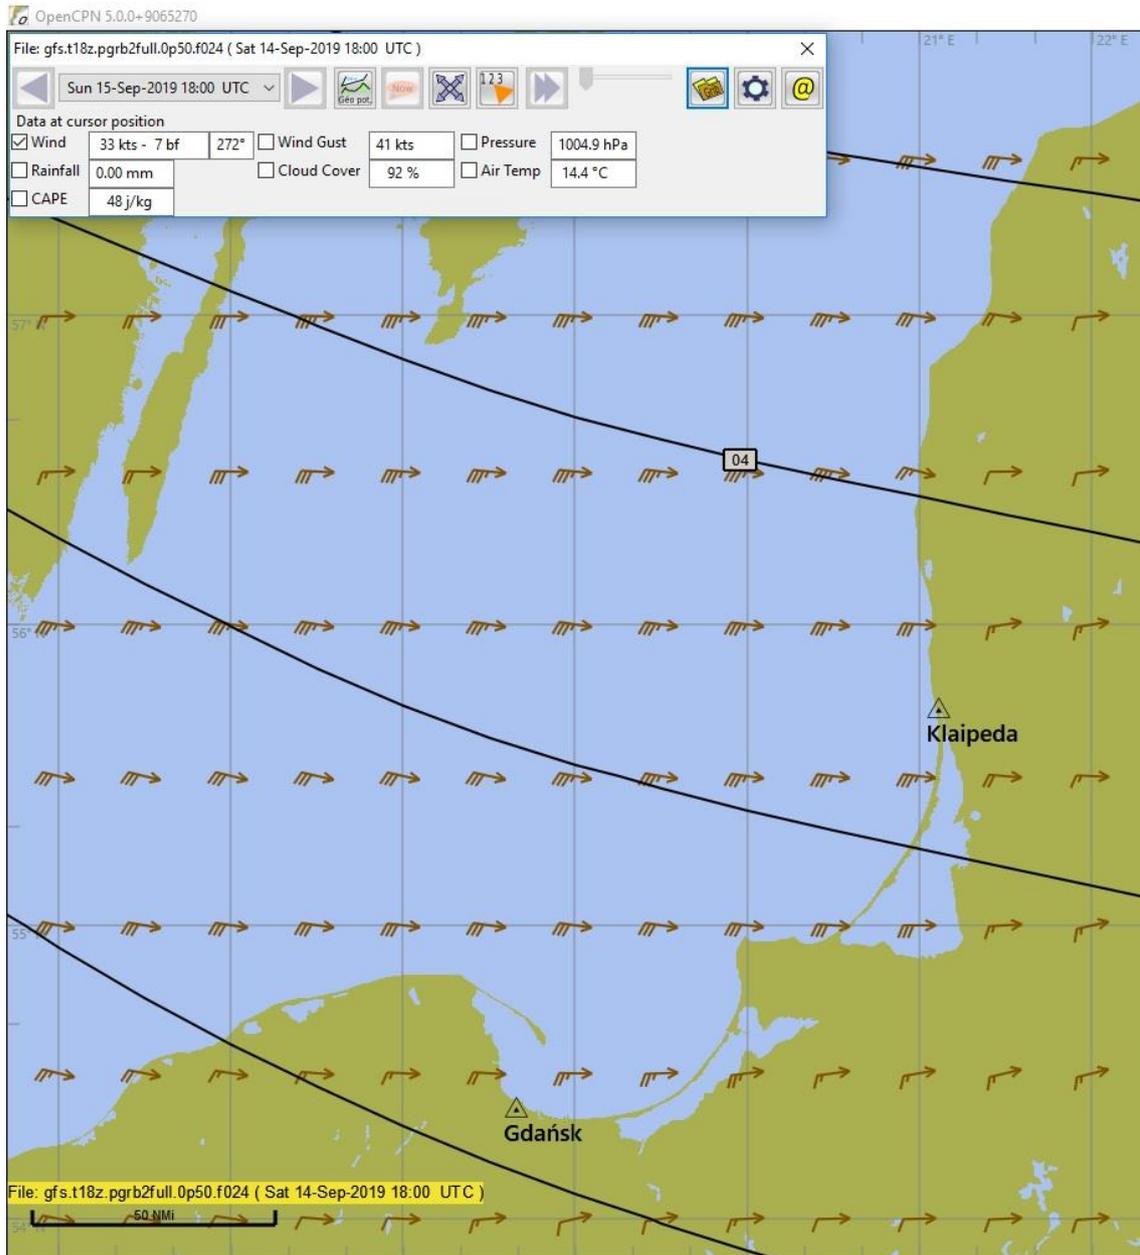
Figure 7. The GFS forecast visualised in the OpenCPN navigation programme.

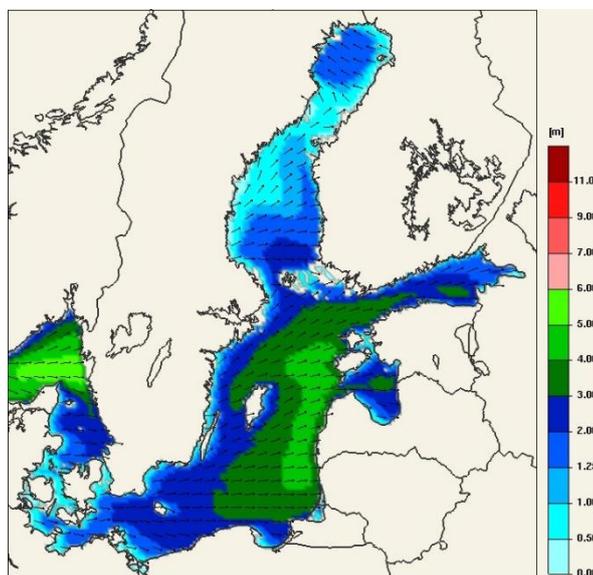
Figure 8. The ICM wave forecast.

Forecast 3 (although in a different visualisation) was taken into account at the beginning of the cruise. The received forecast 1 did not change the decision. The other forecasts were not received.
