SAFETY INVESTIGATION REPORT

REPORT NO.: 10/2021

MT MOUNT EVEREST

Serious injury to a crew member, during mooring operations in the port of Marsaxlokk, Malta 08 May 2020

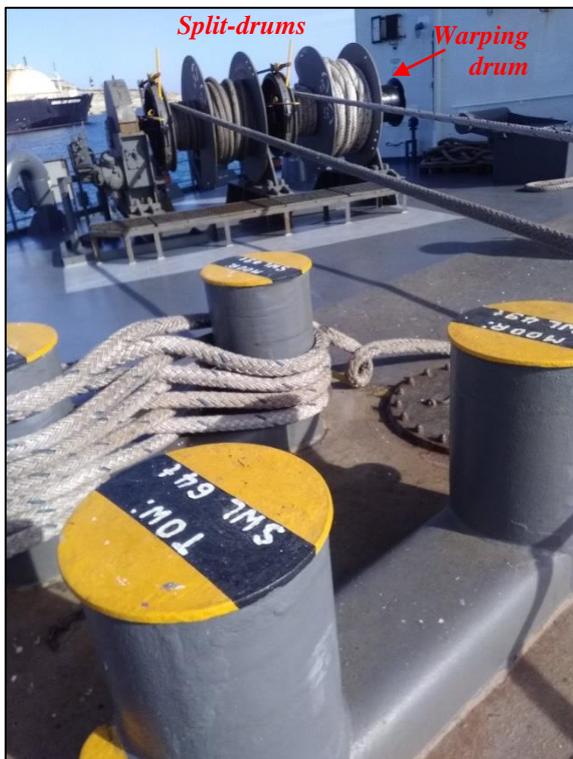
Figure 2: The aft, port side, twin split-drum mooring winch of *Mount Everest*

Each of the split-drums had their own brakes and could be disengaged from the winch, thus allowing for one to be isolated while operating the other. The vessel's records indicated that the brake holding capacity of each split-drum was 40.80 mt.

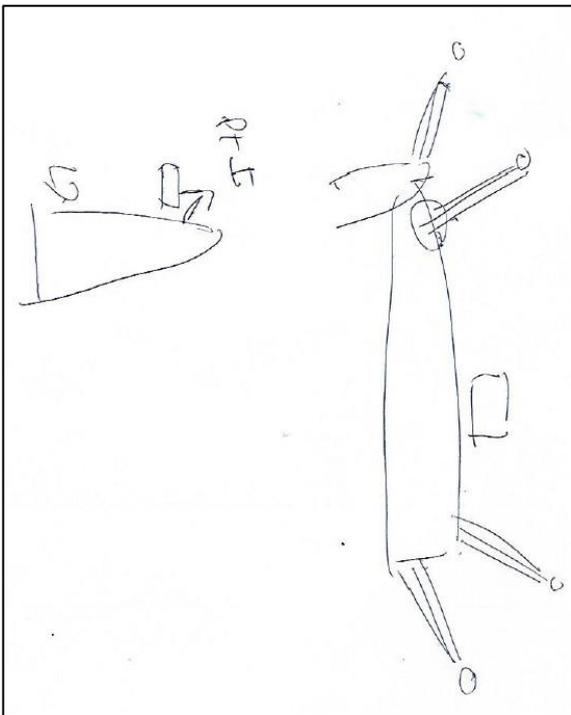
Figure 5: Sketch of the mooring configuration agreed during the master-pilot exchange

The mooring configuration agreed during the master-pilot exchange, necessitated the use of the port anchor, three headlines, three stern lines and three breast lines each, from the forward and aft (Figure 5).

The agreed mooring configuration sketch indicated that three stern lines were meant to be passed from the stern of the vessel (Figure 5). However, the intended mooring configuration (Figure 6), which was reportedly conveyed to the third officer, did not reflect this configuration.

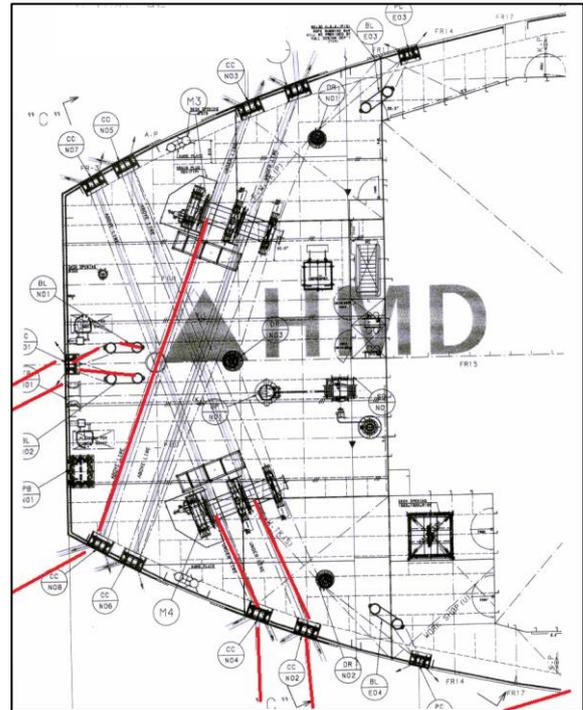
Figure 6: Aft mooring configuration intended by the master

The master stated that he had advised the third officer to send two loose mooring ropes through the centre fairlead and one mooring rope from the port side mooring winch, through the starboard quarter fairlead, as stern lines (Figure 6).

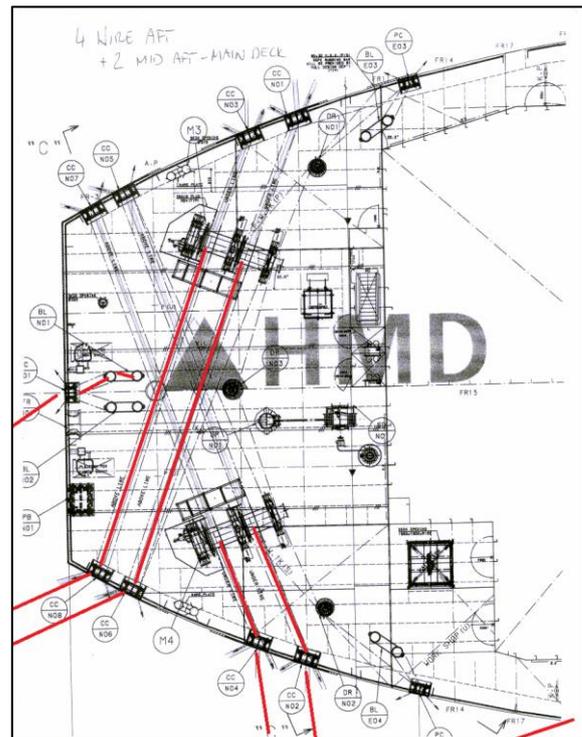
Figure 11: Mooring configuration after the accident

In the meantime, the pilot notified the vessel traffic services (Marsaxlokk VTS) on the accident and requested medical assistance to be organised and deployed. At around 1448, the vessel was moored with a different configuration (Figure 11) and the gangway was finally lowered at about 1518.
