PAŃSTWOWA KOMISJA BADANIA
WYPADKÓW MORSKICH

SIMPLIFIED REPORT

Tugboat “Uran”

**Tugboat’s bow hitting the XXX-lecia Quay in
Gdynia on 19 July 2020**

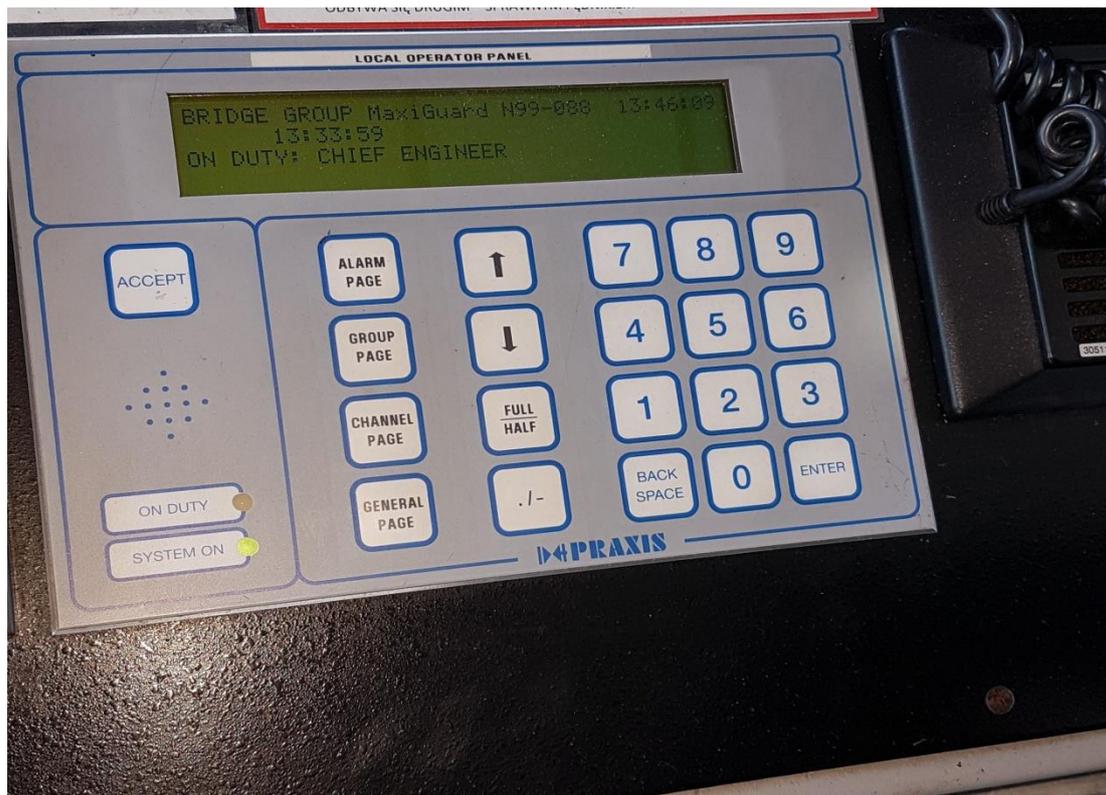
Photo 4. – Panel of alarms on the bridge

During the accident, the captain ordered the engineer to go to the engine room to check for any breakdowns. The examination did not reveal any irregularities. After the accident (while sailing to the berth), the drive was tested. This test showed the proper operation of the engines and thrusters, and that before and during the collision there was no alarm on the panel of alarms for engine operation on the bridge.

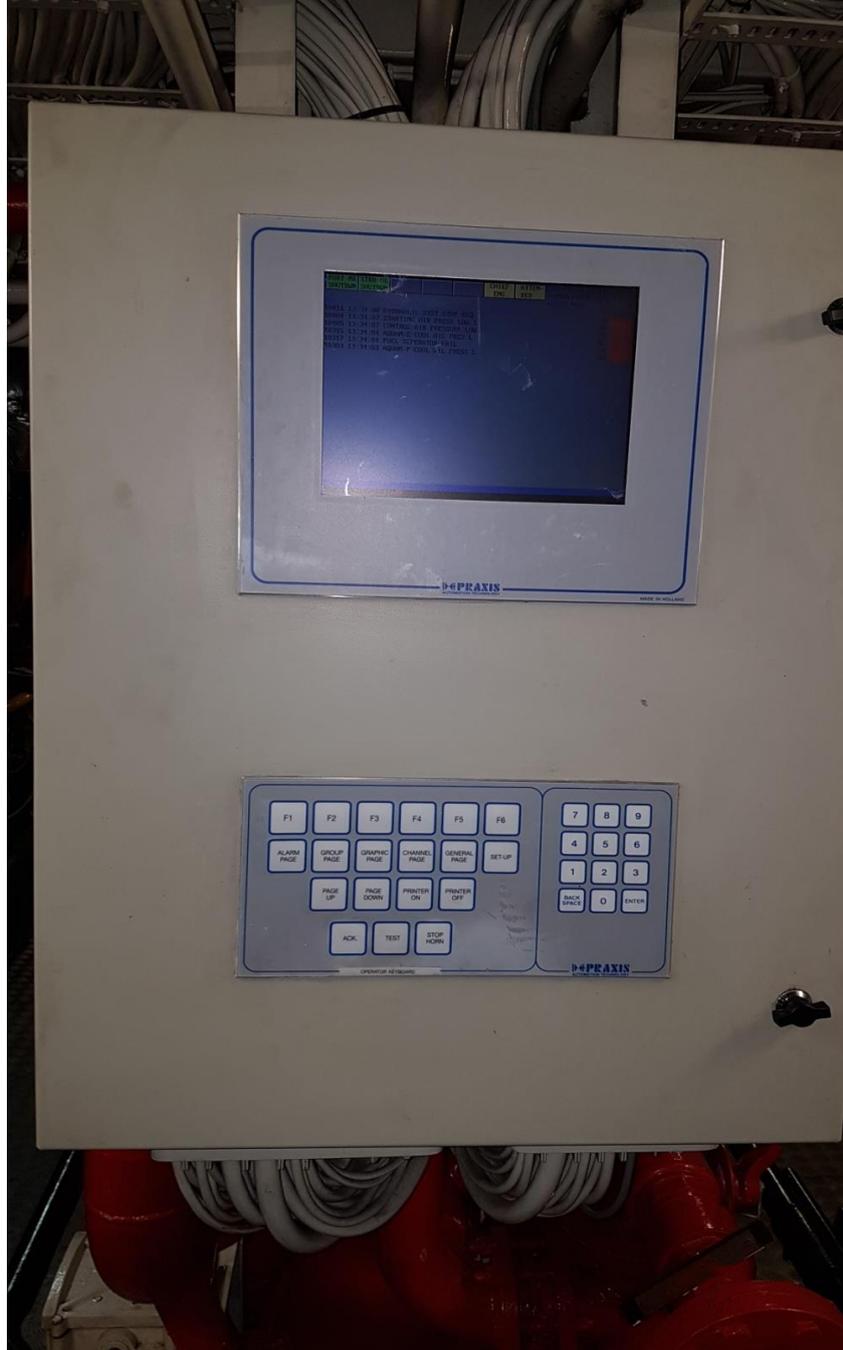
Photo 5. – Panel of alarms in the engine room

The engine room has an alarm and parameter control system from the Dutch company Praxis.
An alarm recorder is not installed.

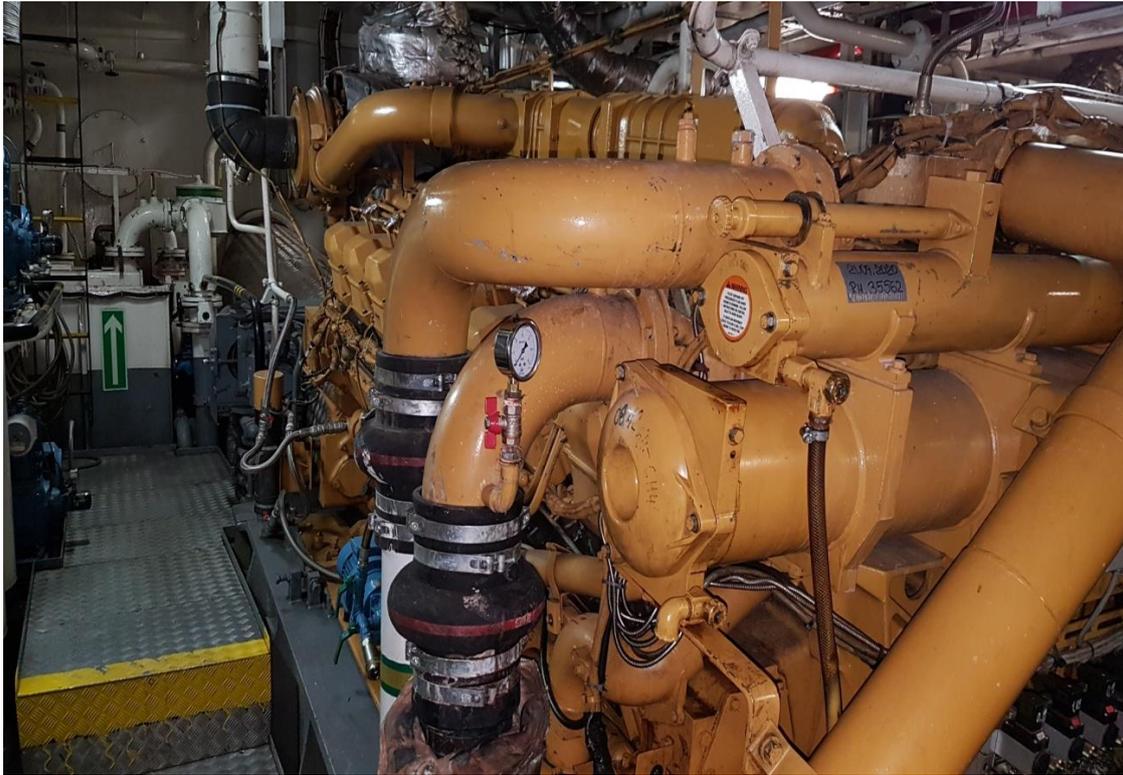
Photo 6. – Main engine PS

Main engine Caterpillar type 3516B, s/n 4BW00369 (left), 4BW00371 (right), 1600 rpm, operating hours 35367 (left) and 35385 (right).

CAT series 35 engines are the most popular engines fitted on ships, known for their high reliability. After the accident, at the request of the Operator, an engineer from the MG-CAT service authorised by the manufacturer inspected the engines and made a printout from the memory of computers on both engines. To ensure high reliability and constant control of parameters, the engines are equipped with backup computers.

According to the report of the MG engineer, “there are no indications/alerts regarding the moment of collision in the history stored in the computers (main and backup) of the engines.” All repairs, inspections and service works were carried out in accordance with the technical and operational documentation of the engines.

It is unlikely that a CAT 35 engine, reliable according to popular opinion, in a good technical condition, regularly serviced and not causing technical problems, would suddenly increase its speed just ahead of the quay. Each mechanical failure of the fuel dose control link and, consequently, an increase in the engine speed would require a necessary intervention of the staff to control the situation. After the collision, the operation of all devices was checked and no damage to the mechanisms was found.

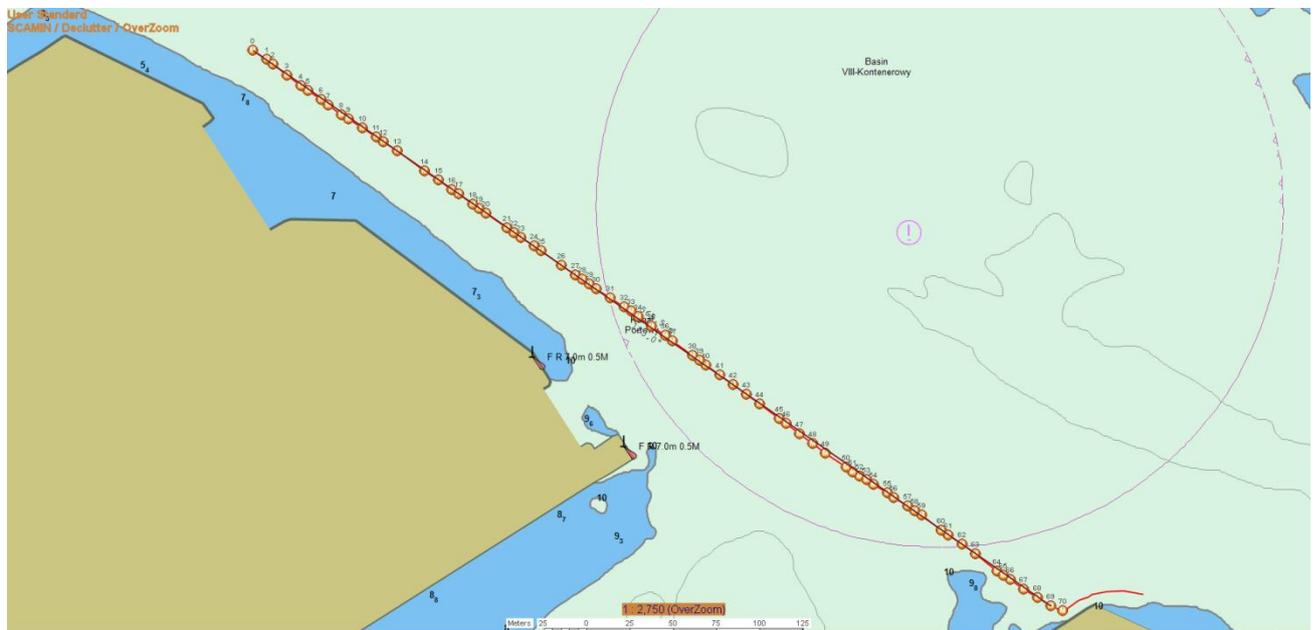
Figure 5. Graphical presentation of data from Table 1

The next part focused on determining the route, course and speed of the vessel on the studied section of navigation. Points on the route from **Table 1** are presented in **Figure 5**.

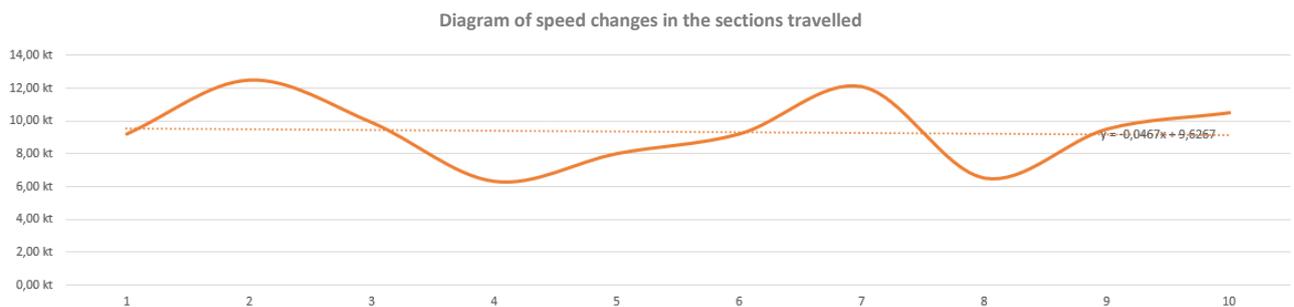
Taking into account the maximum speed of the tugboat $V_{\text{max}} = 13.2$ kt, it should rather be assumed that the observed high speed values ($v > 12$ kt) should be considered as measurement errors of the GNSS device. On this basis, the expert believes that an independent GNSS receiver with poor accuracy was connected to the on-board ECS.
