# FINAL REPORT

# 072/20

## **S/Y Gmina Police Sharki**

**The collision of the yacht with a buoy at the Wadden  
Sea on the day of 11 August 2020**

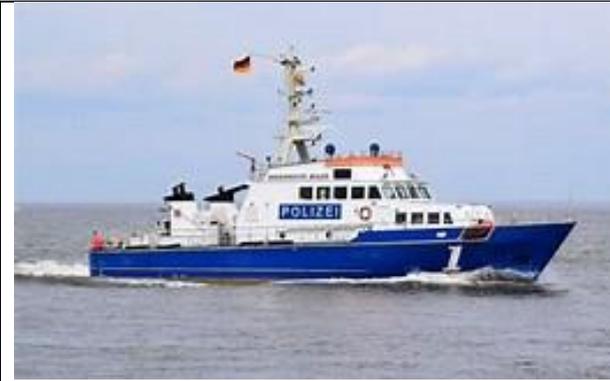
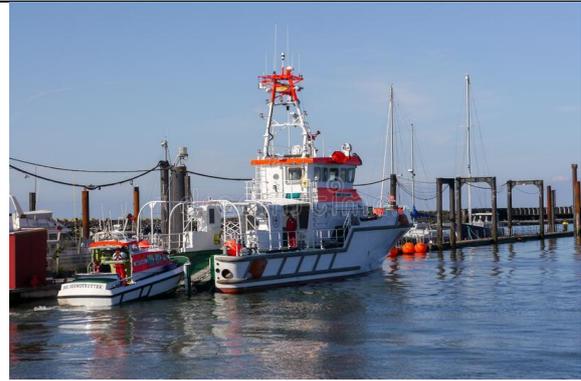
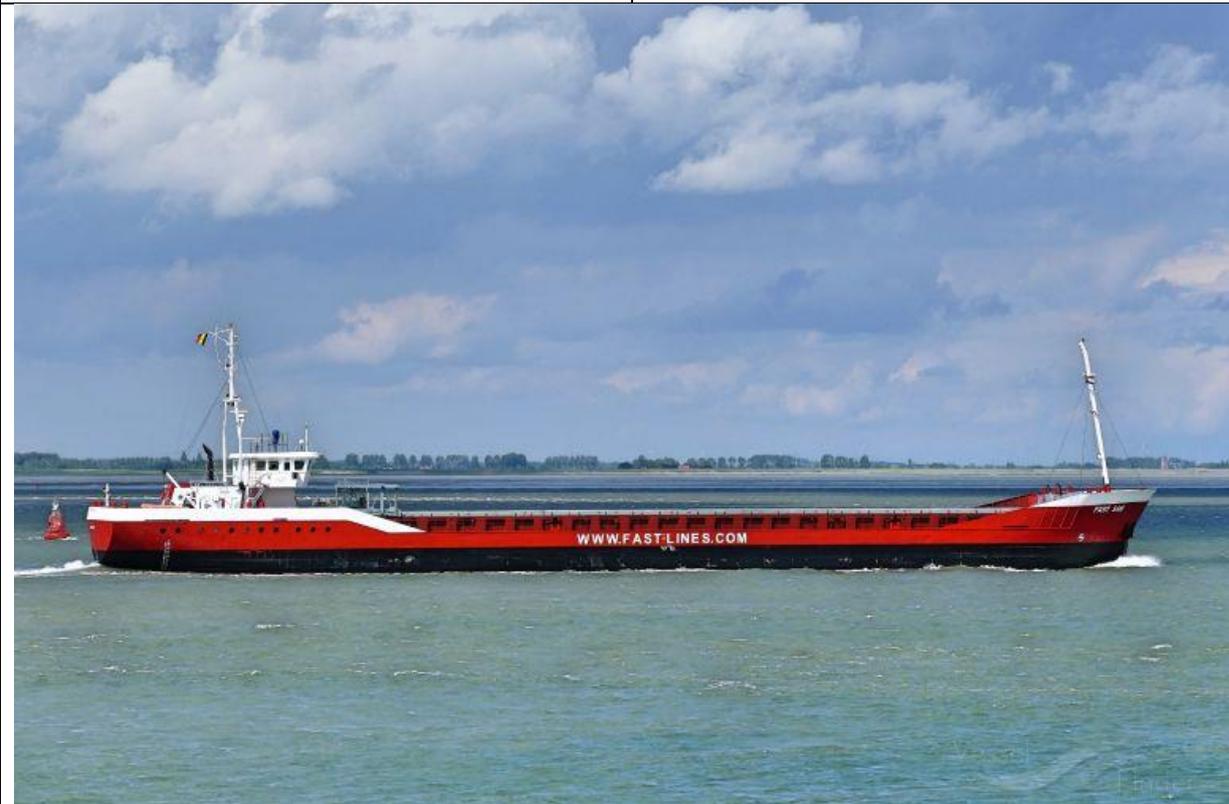
*Photograph 2: Vessels participating in the rescue operation*

the crew of the yacht rescued and safely transported to the shore, the yacht sank.

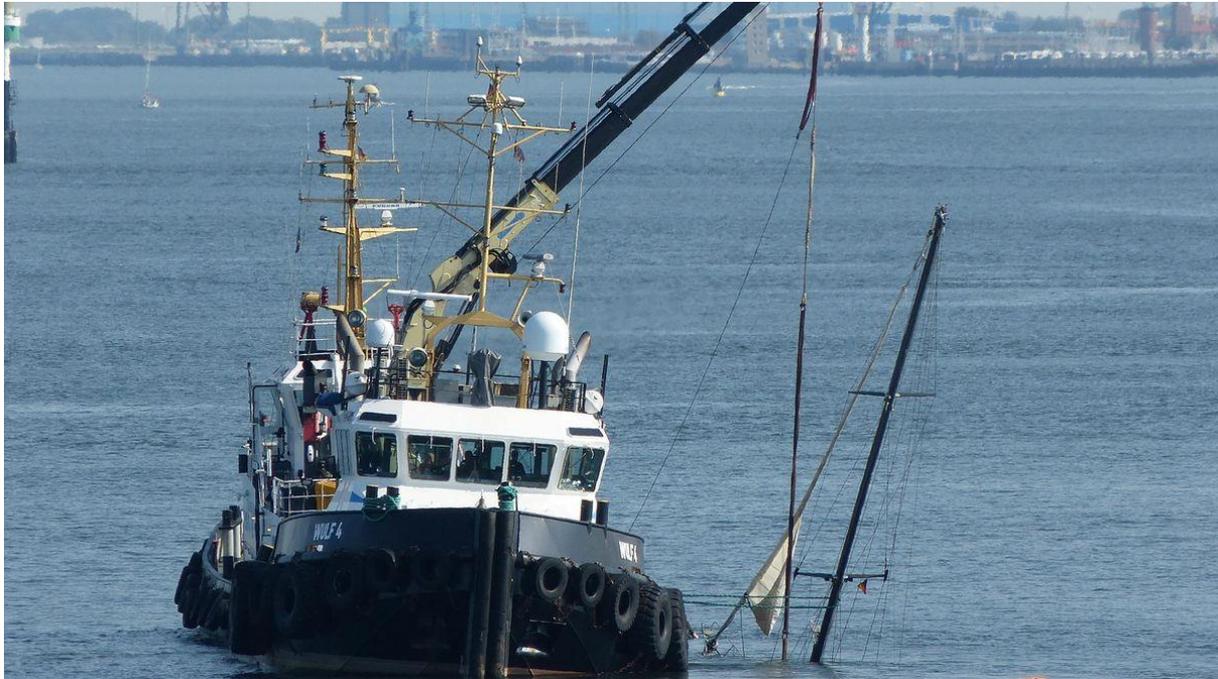
*Photograph 4: Lifting the yacht from the bottom*

Under the influence of variable currents acting on the yacht lying on the seabed, she drifted onto the fairway and became a navigational obstacle. On the next day, i.e. 13 August 2020

before 18:00 the yacht was lifted from the bottom to the water-level by Otto Wulf, a diving and excavating company and towed to the Otto Wulf's site in Cuxhaven. The yacht was pulled out ashore in the morning of 14 August 2020.

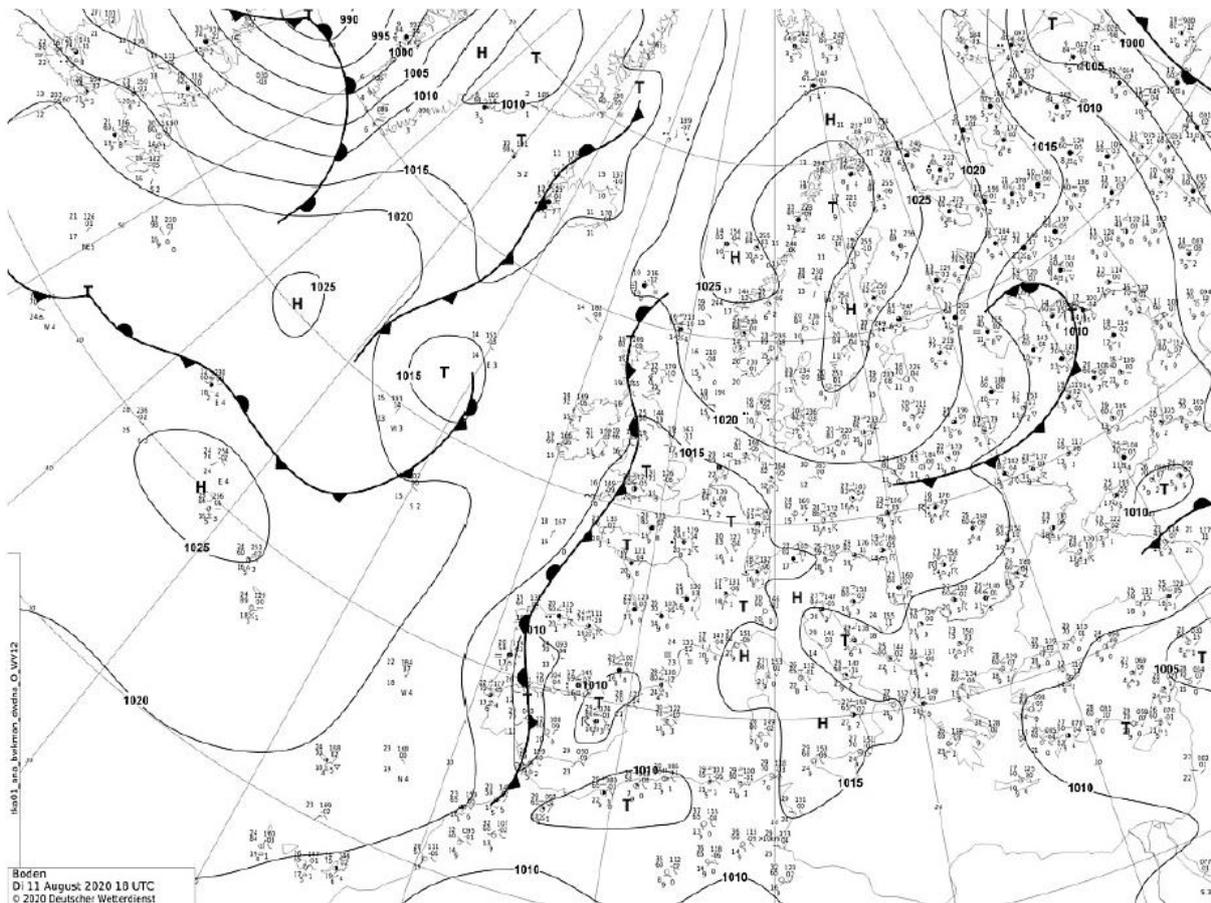
*Figure 2: Analysis of the atmospheric pressure and currents*

Based on the analysis of atmospheric pressure and weather fronts on 11 August 2020, at 20:00 it was established that there was a wide area of high pressure over Scandinavia, reaching the ridge over Central Europe. From Great Britain, through France, to the Iberian Peninsula, there was spreading out the area of low pressure with violent storms in some places. On the other hand, the region of the accident was covered with dry and stable air masses.

At the time of the accident, the conditions were largely clear and dry with a visibility range of more than 20 km.

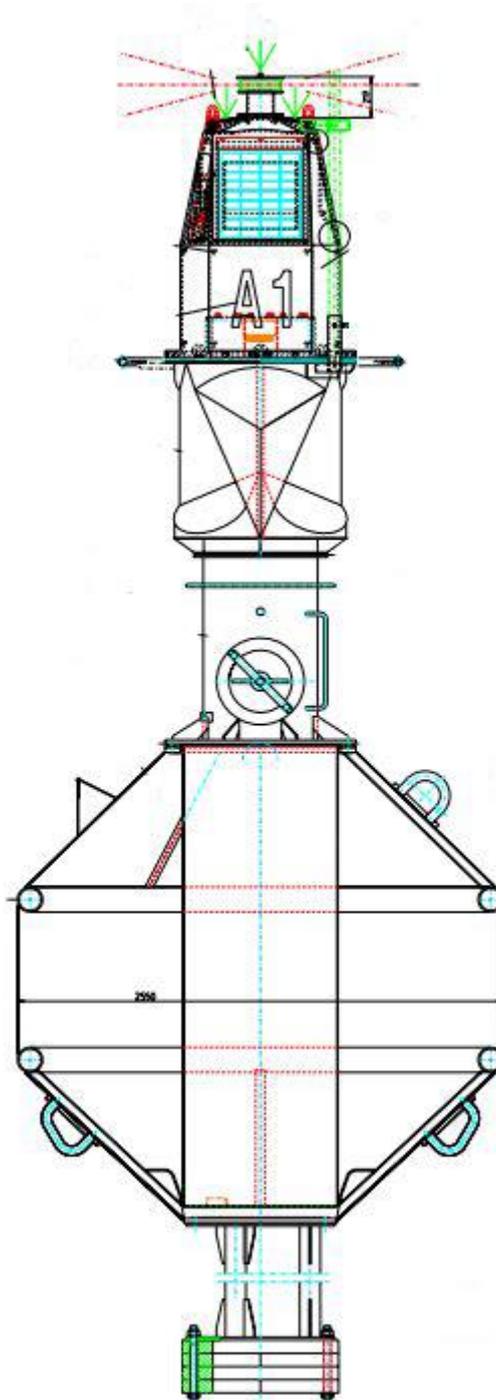
*Figure 4: Schematic drafting of the buoy*

the lighting characteristics: flashing, duration 4 s. (Fl, G. 4s.)

The buoy was attached to the bottom with a ca. 50 m long chain and a mooring block.

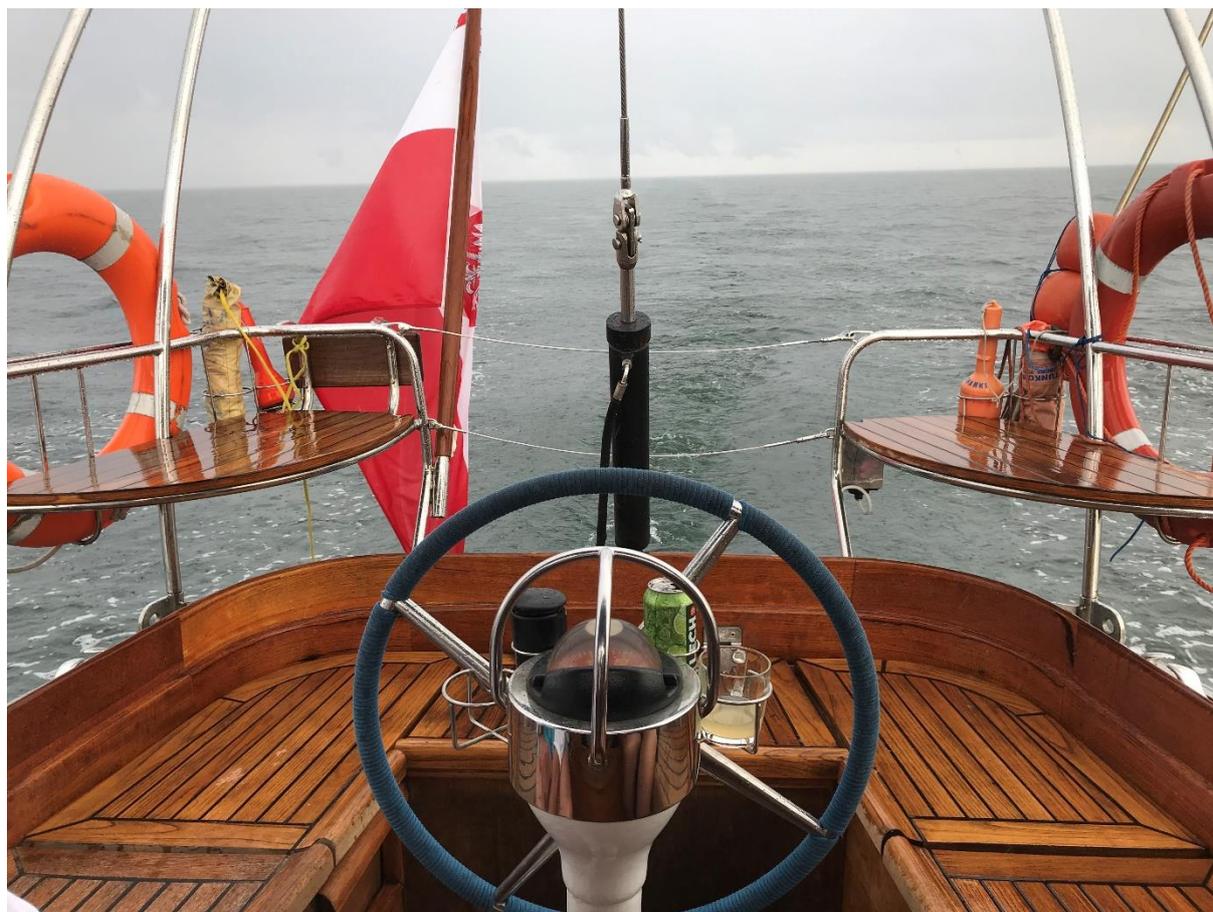
*Photograph 4: The cockpit of Sharki*

Good visibility ensured full field of vision of all objects on the river, especially the glowing fairway buoys.
