STATE MARINE ACCIDENT
INVESTIGATION COMMISSION

FINAL REPORT

m/s SMP Novodvinsk

**Grounding by a vessel passing the Świnoujście-Szczecin
Fairway on 12 January 2022**

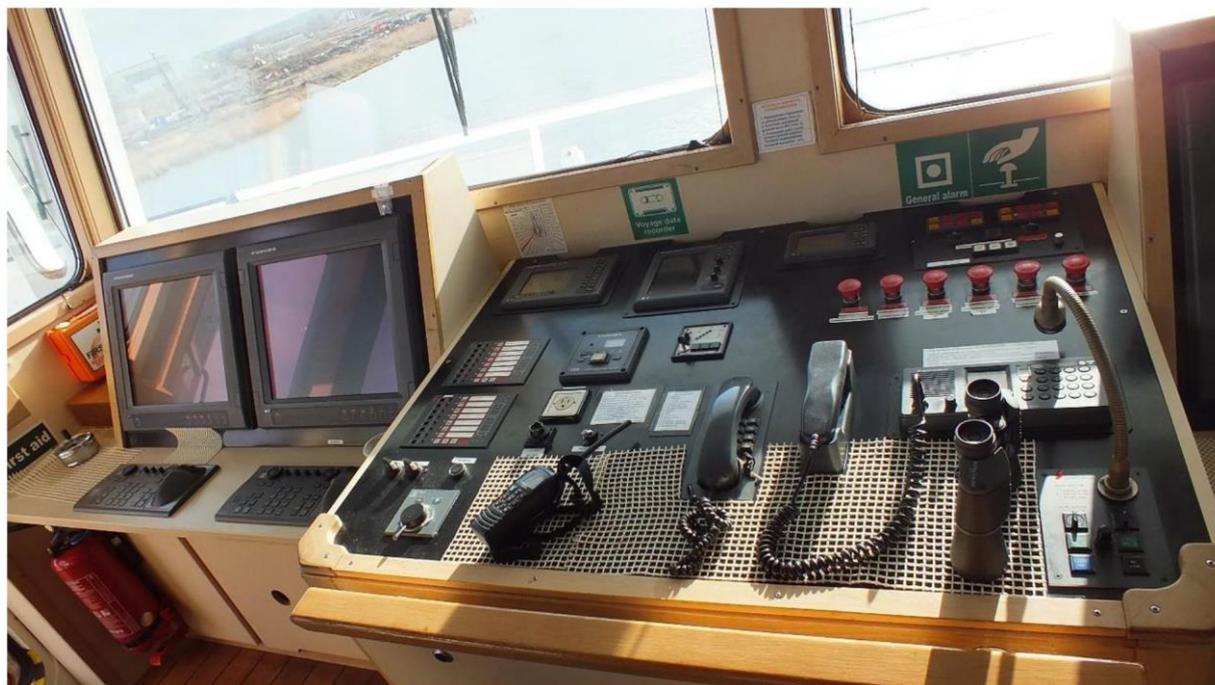
Photo 4. Port side of the vessel's bridge

The vessel, built in 2008, is equipped with a Wartsila 6L26A2 right-hand-drive 2040 kW main engine and a pitch propeller allowing the propulsion to be switched from full ahead to full astern in 30 sec. Steering of the vessel is provided by a Becker rudder with a maximum 45° pivot to both sides and a turnaround time from one side to the other of 38 sec with one rudder pump switched on and of 19 sec when two pumps are in operation. In addition, the vessel is equipped with a 280 kW bow thruster. Electricity supply is provided by two auxiliary engines and a shaft generator switched on during manoeuvres when the bow thruster is used. According to the crew, two generators and both rudder pumps were switched on when navigating with the pilot. No information on signalled alarm conditions has been found in the equipment recorder logs. All equipment was operational before and during the accident.

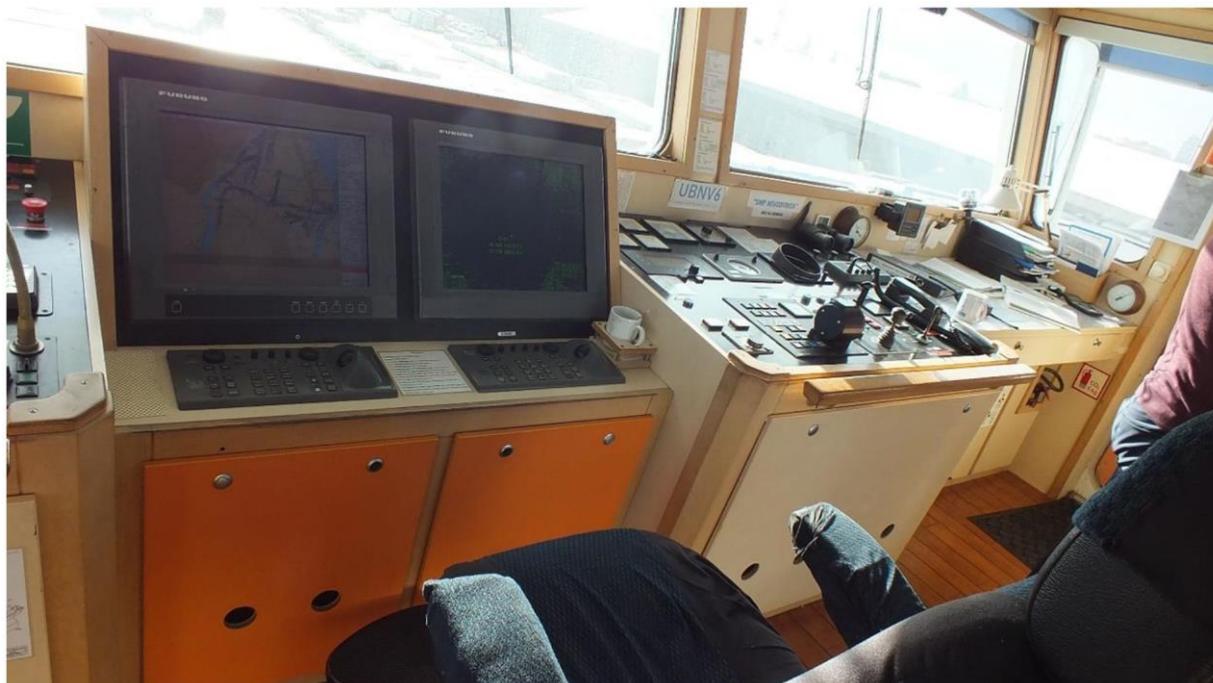
Photo 5. Starboard side of the vessel's bridge

The vessel is equipped with radio and navigation equipment, as required by regulations. The radio equipment was in working order. The navigational equipment is from FURUNO and includes two radars with ARPA and ECDIS, one being a 3 GHz (10 cm) radar and the other a 9 GHz (3 cm) radar. In addition, there is a Doppler log and two GPS units. All the navigation equipment listed was operational at the time of the accident.
