STATE MARINE ACCIDENT
INVESTIGATION COMMISSION

FINAL REPORT

**SAILING YACHT
'YACHTING'**

**Fall overboard of a sailing yacht crew member on
the Baltic Sea on 23 February 2022**

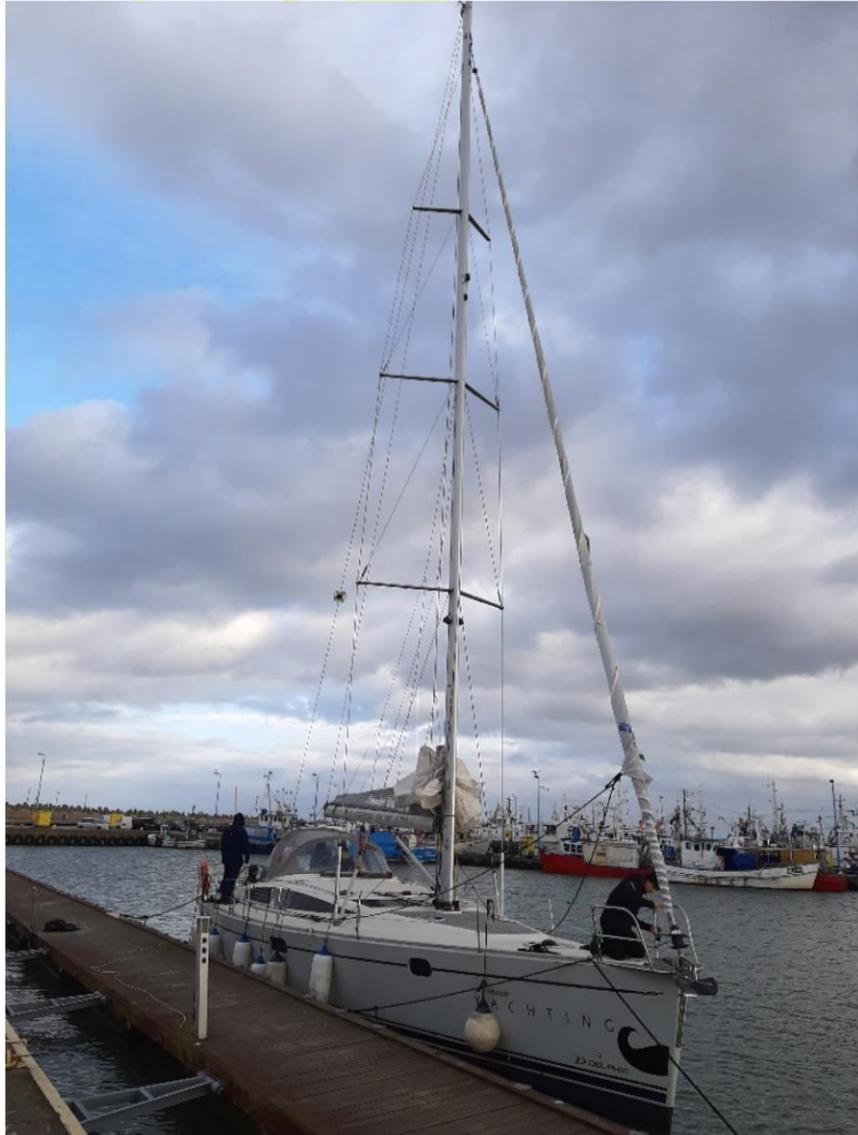
Photo 1. Sailing yacht 'Yachting' in the port of Władysławowo

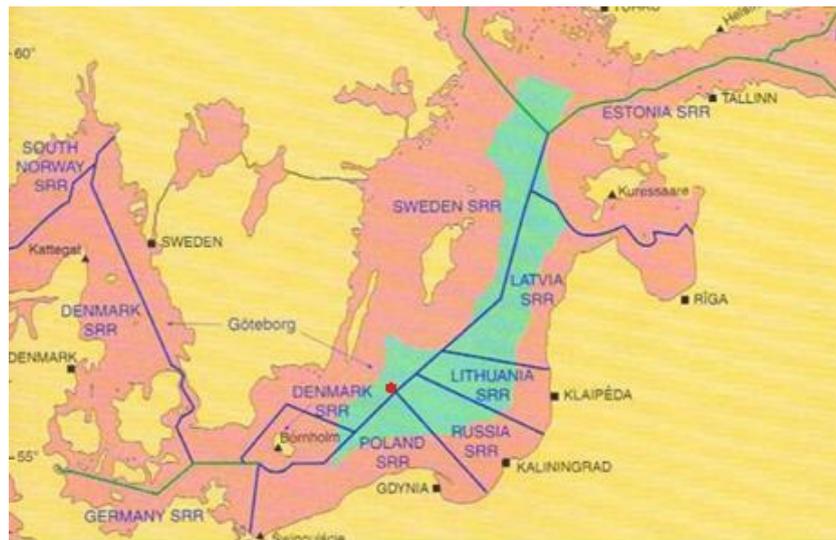
Figure 1 - Location of search and rescue regions (SRR) on the Baltic Sea. The red dot indicates the approximate position of the sailing yacht 'Yachting' at the time the crew member was reported to fall overboard.

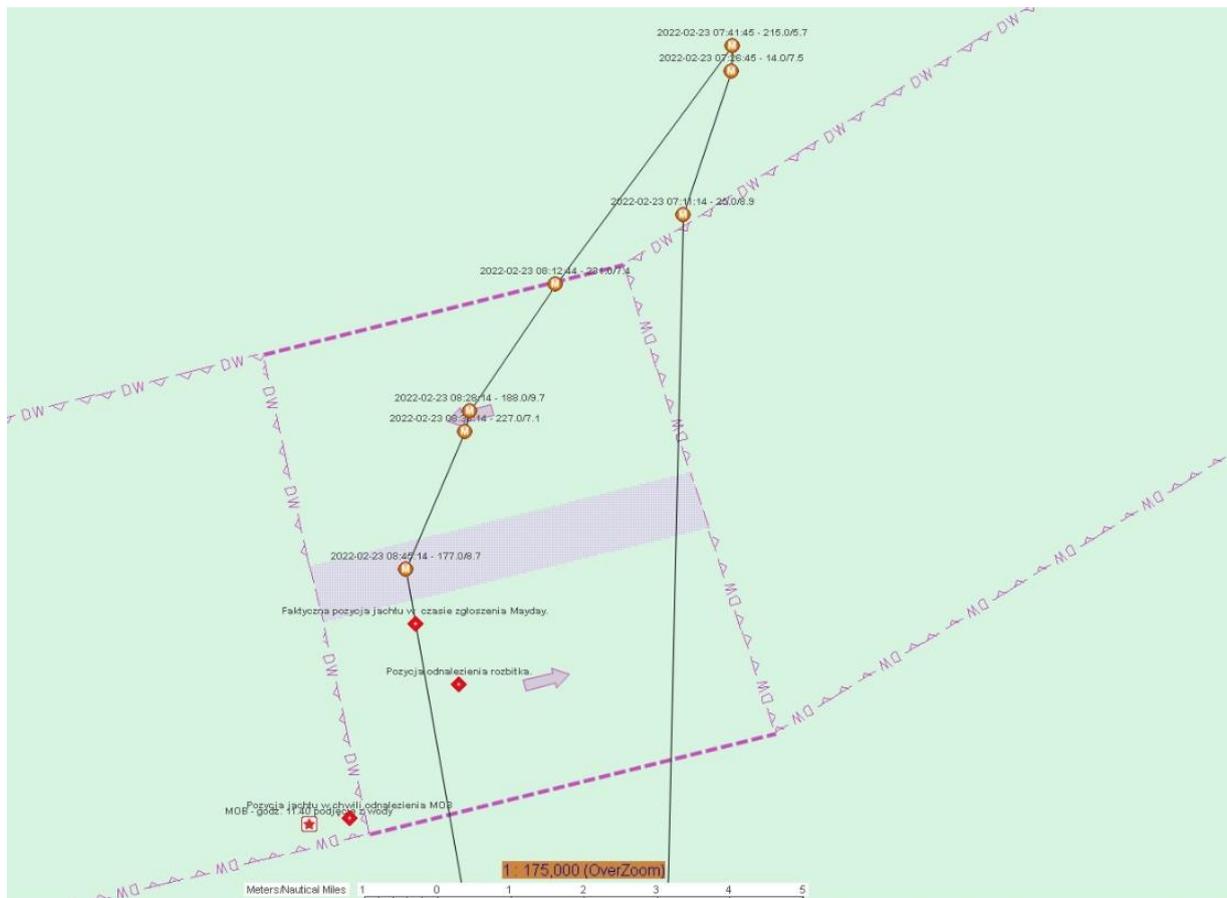
1. - Position of the yacht (Mayday position) at the time the man overboard was reported: $\varphi = 55^{\circ}55.348$ N, $\lambda = 017^{\circ}35.000$ E.
2. – Position of the man overboard at the time he was found: $\varphi = 55^{\circ}54.508$ N, $\lambda = 017^{\circ}36.046$ E.
3. – Position of the yacht at the time the man overboard was found: $\varphi = 55^{\circ}52.670$ N, $\lambda = 017^{\circ}33.380$ E.

Figure 2 - Record of yacht movement during rescue operation.

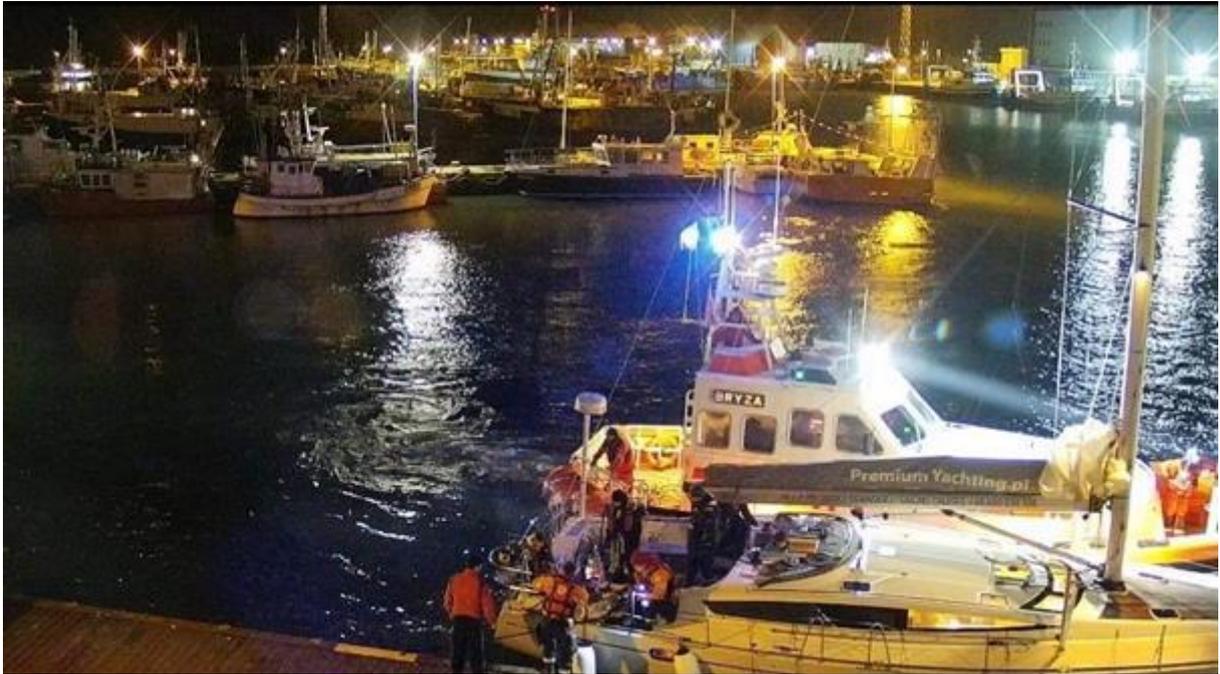
Photo 4. Mooring the yacht in the port of Władysławowo after the towing operation.

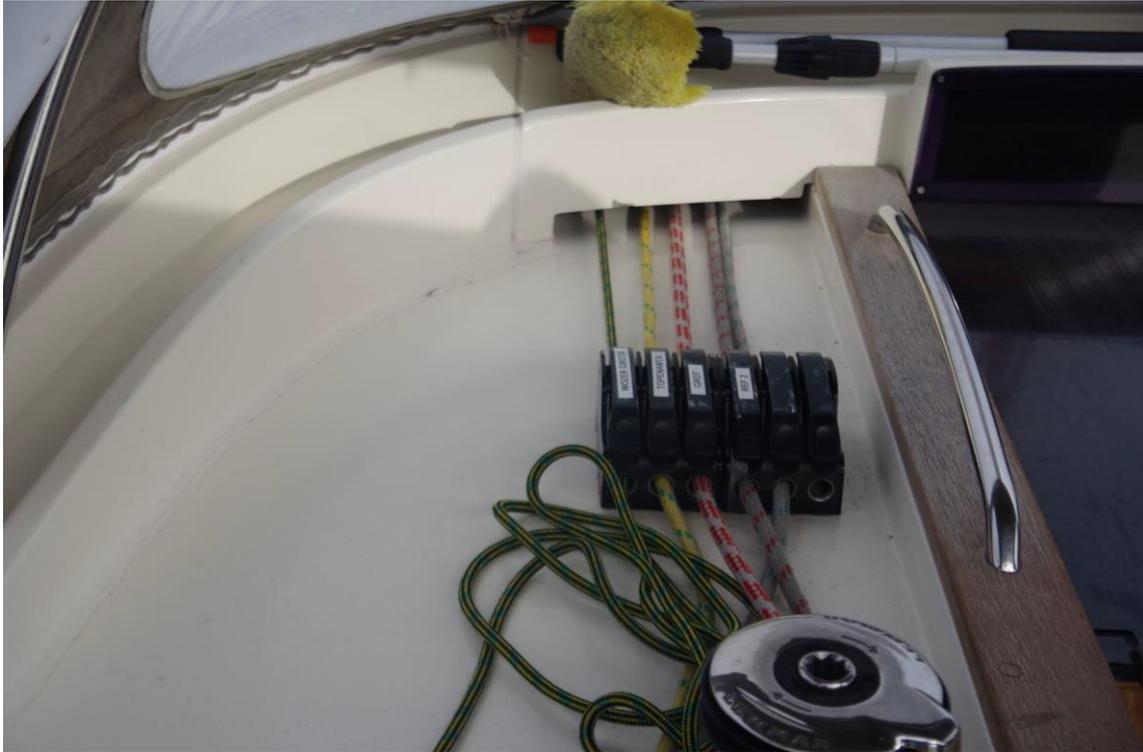
Photo 11. Access to the reflines from the cockpit - port side

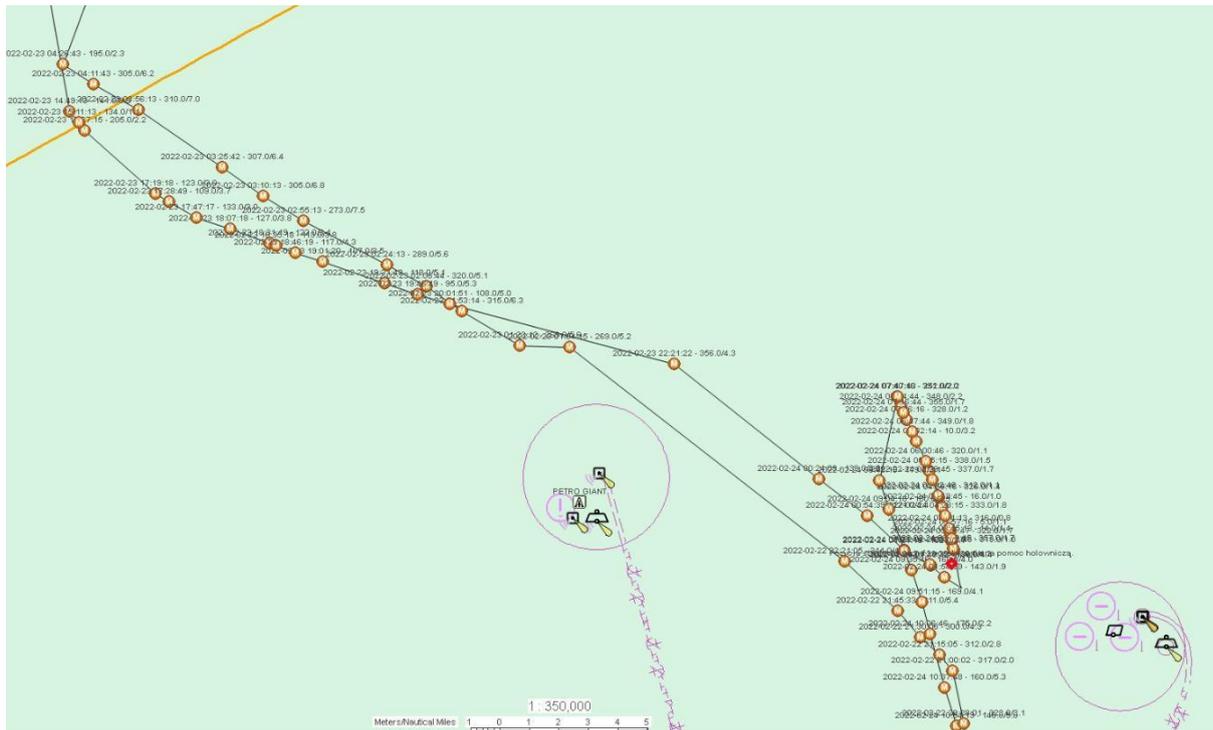
1. Drifting position, waiting for towing assistance

$$\varphi = 55^{\circ} 25,800 \text{ N}, \lambda = 018^{\circ} 32,000 \text{ E}$$

Figure 3 - The red mark indicates the stopping position of the yacht. In addition, the marked positions show the direction of drift while awaiting assistance from the SAR vessel 'Sztorm'.

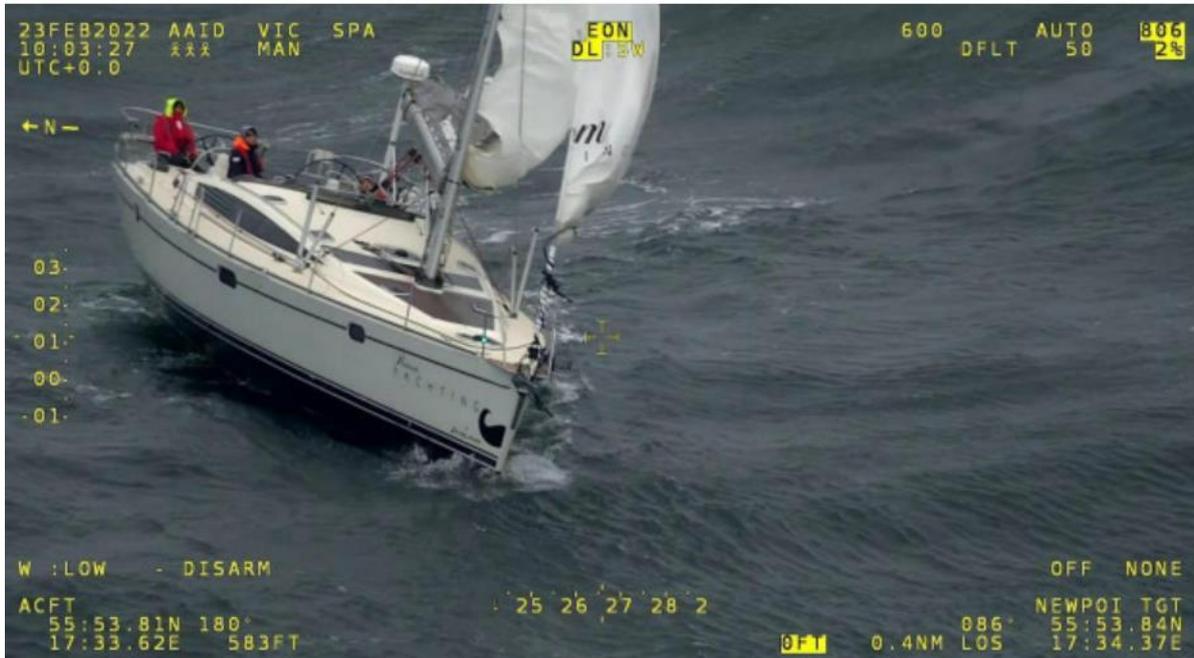
At 10:38 hrs, Swedish rescuers informed each other of 3 metre 'heavy' waves at the yacht's position.

Photo 12. Photo taken by Swedish rescuers.

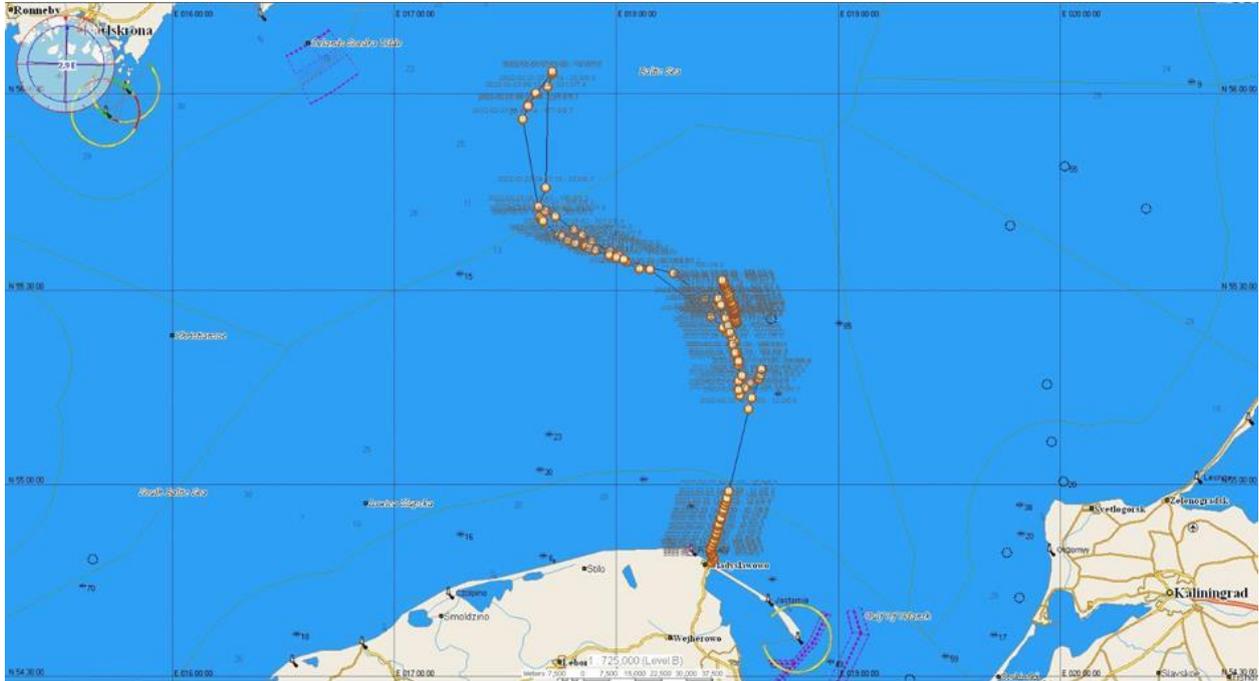
when a low state of battery voltage caused the signal from the AIS transmitter with which the yacht was equipped to disappear.²⁶

Figure 4 - Record of vessel movement in the 'VesselFinder' system.

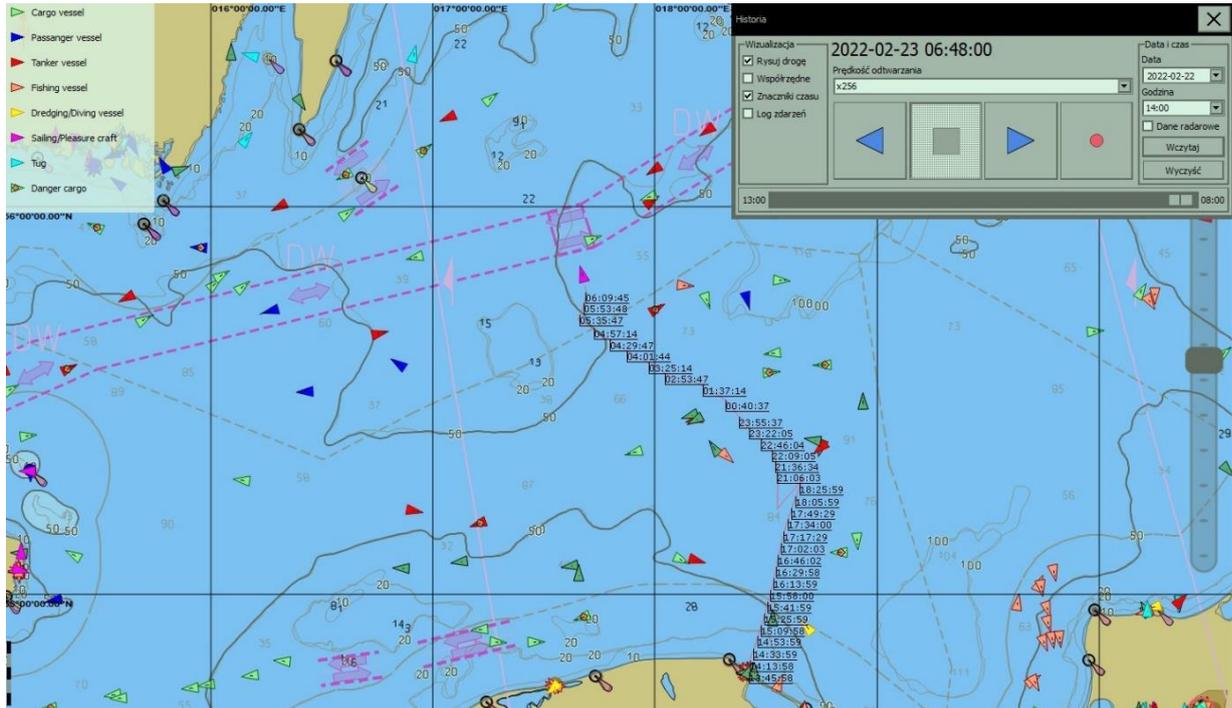
The yacht's movement recorded using the Shipping Safety Information Exchange System (SWIBŻ)²⁷ covered only part of the route travelled by the yacht. AIS signal reception is limited in this system to the range of receiving stations located on the Polish coast.

Figure 5 - Record of the sailing yacht 'Yachting' movement as recorded in the SWIBŻ application.
