STATE MARINE ACCIDENT
INVESTIGATION COMMISSION

FINAL REPORT

024/22

**Drowning of 3 yacht crew members on the Gulf of
Gdańsk on 8 April 2022.**

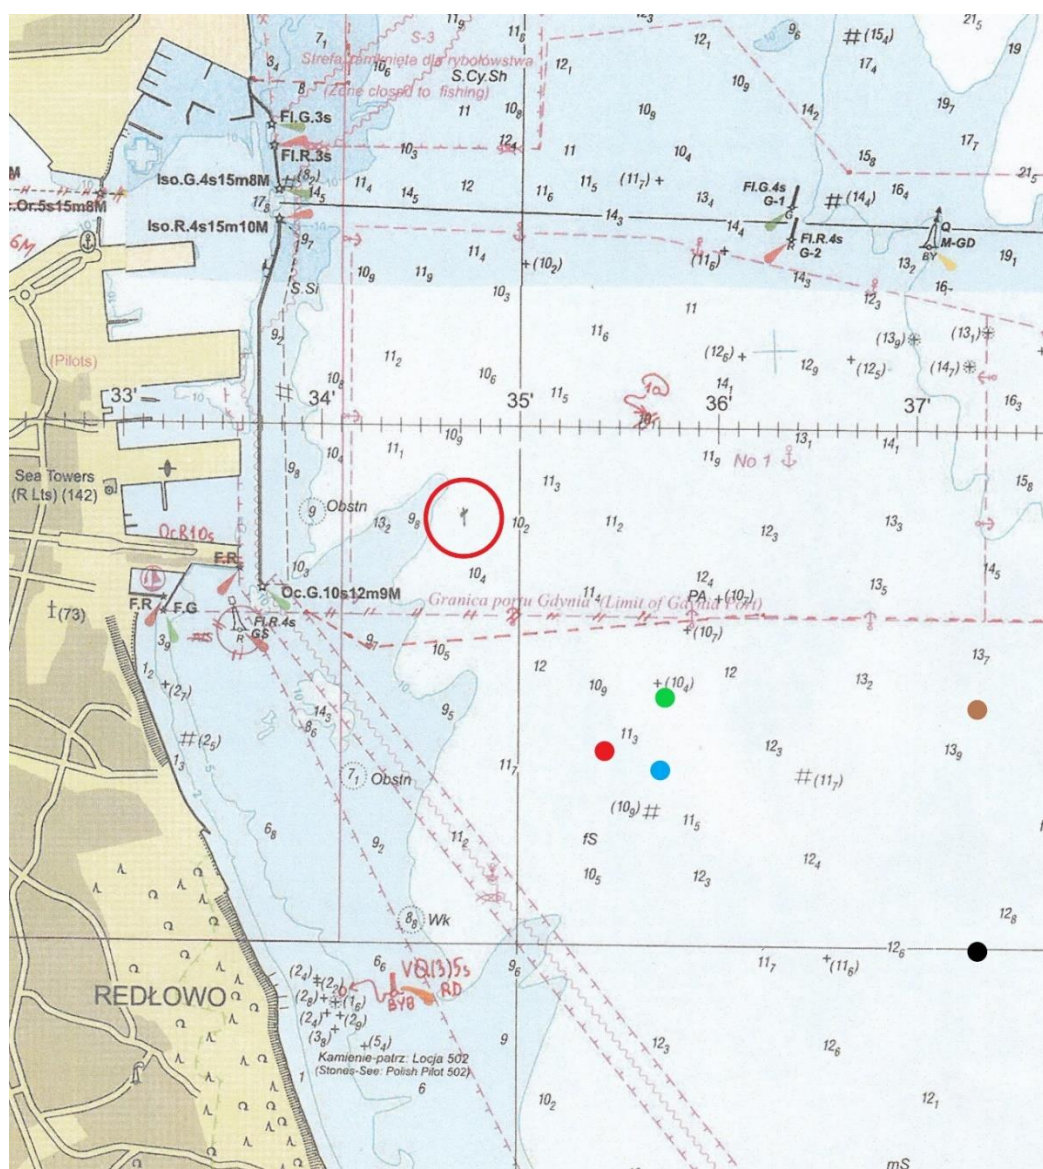
Fig. 1 – Chart with marked positions

1. Red circle, approximate position where the helmsman of the yacht was found (at 16:51 hrs).
2. Red dot, position of the yacht capsizes.
 $\varphi = 54^{\circ}30,5'N : \lambda = 018^{\circ}35,4'E$ (at 11:21 hrs).
3. Green dot, position reached by the drifting yacht at the time when the helmsman decided to swim ashore.
 $\varphi = 54^{\circ}30,7'N : \lambda = 018^{\circ}35,7'E$ at about 12:50 hrs¹³.
4. Blue dot, position of finding the yacht.
 $\varphi = 54^{\circ}30,5'N : \lambda = 018^{\circ}35,7'E$ (at 17:09 hrs)
5. Brown dot, position of finding one of the crew members.
 $\varphi = 54^{\circ}30,0'N : \lambda = 018^{\circ}37,3'E$ (at 17:15 hrs)
6. Black dot, position of finding of another crew member.

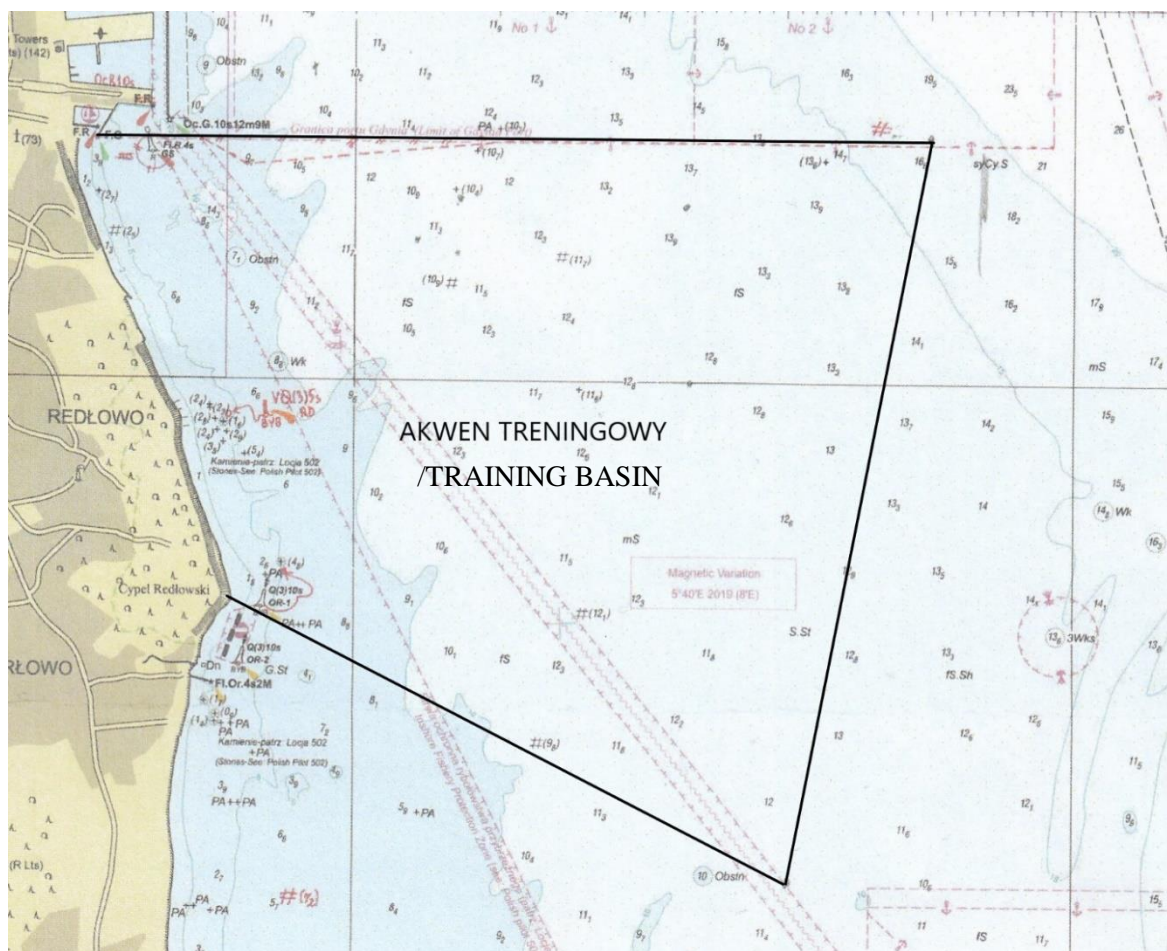
Fig. 8 – Chart with the marked training basin

The coastal region of the training basin, close to the high shore, causes wind direction and speed to change rapidly, especially with strong winds blowing from and to the shore. The air streams cause rapid changes in wind speed and this phenomenon is called the "shore effect"¹⁹.

It was this wind phenomenon that the helmsman of the second yacht noticed when he sailed from the Yacht Basin for a short time. He described the wind as very strong with violent gusts (turbulence) from an unspecified direction, but mainly from the land side. Therefore, he decided that the conditions were not suitable to continue training and sailed back to the Yacht Basin.
