Marine Safety Investigation Report

into a man overboard from Star Peace on
23 October 2021

Date of Issue: 30 June 2023
Bahamas Maritime Authority
120 Old Broad Street
LONDON
EC2N 1AR
United Kingdom

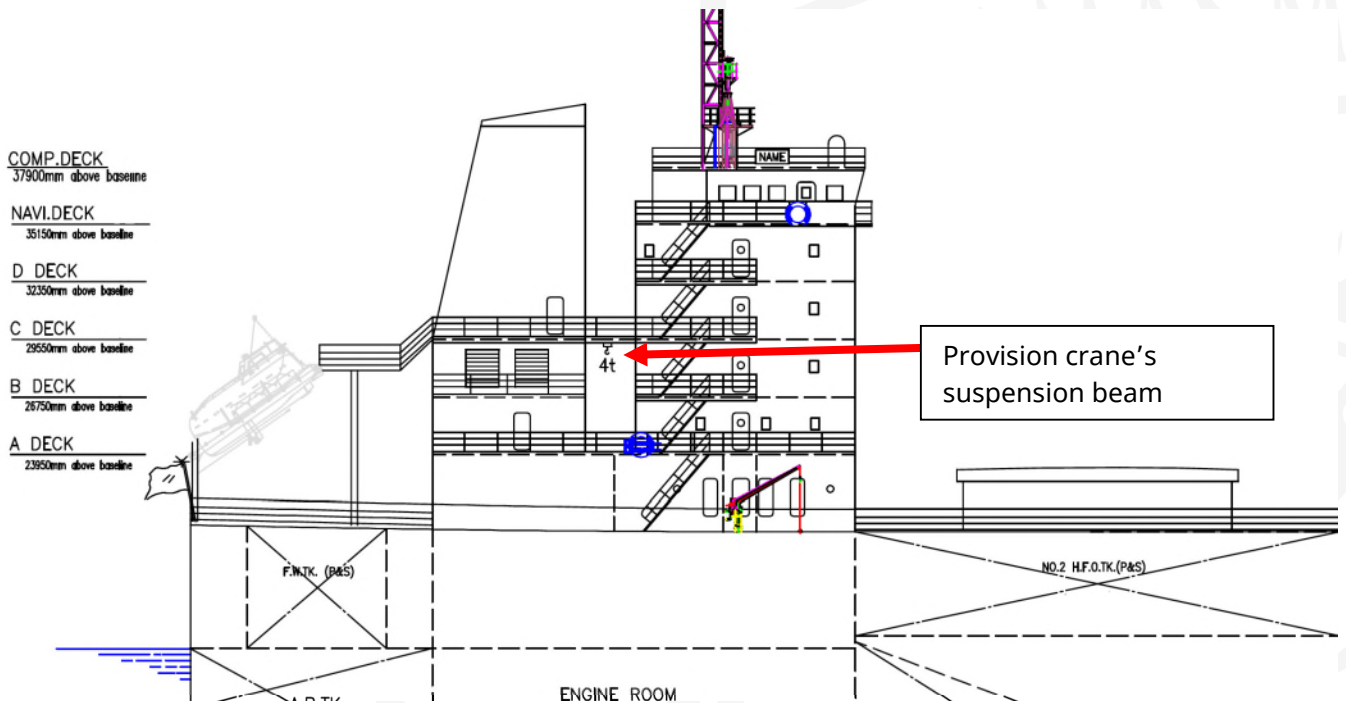
The crane was located on the cross deck, between the aft bulkhead of the accommodation and the forward bulkhead of the engine funnel casing. At the vessel's departure loaded condition, it was located 16.25m above the water line.

Star Peace: extract from general arrangement, arrow indicates location of provision crane
