114/22

Marine casualty

Towing unit – tug Odys and pontoon TRD Voyager

FINAL REPORT

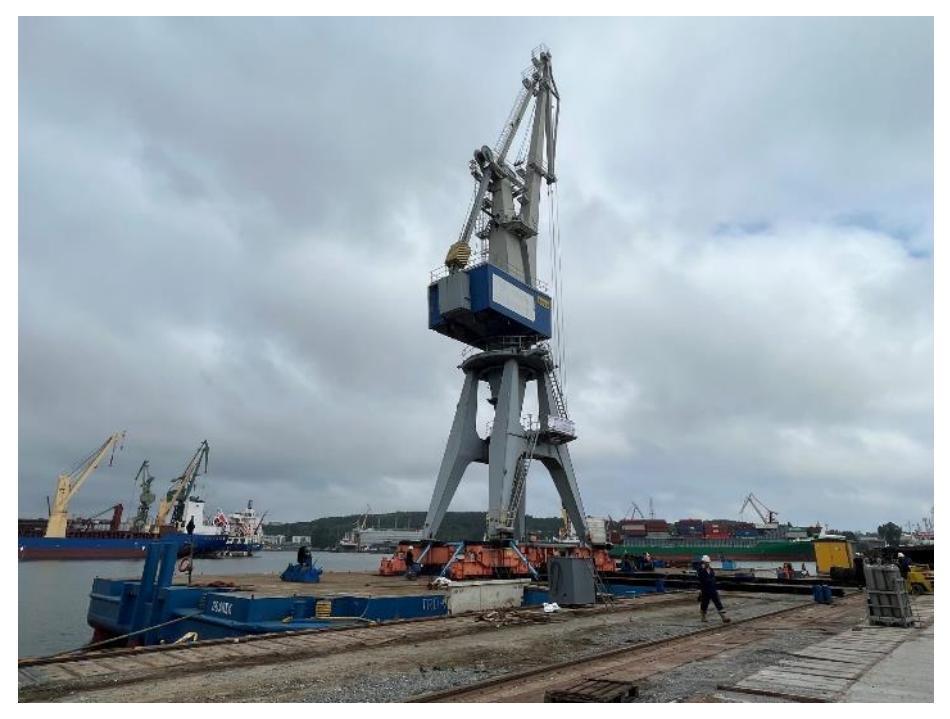
Photo 1. Lashed shipyard crane on board TRD Voyager – Port of Gdynia, Hungarian Quay.

On 23 August 2022, a 255-tonne, 46.8m-high shipyard crane (also called the shipbuilding crane) has been loaded onto the pontoon TRD Voyager at the port of Gdynia, Hungarian Quay. It was lashed to the pontoon's deck by a designed lashing system with a declared strength of 60 t (588.6 kN).

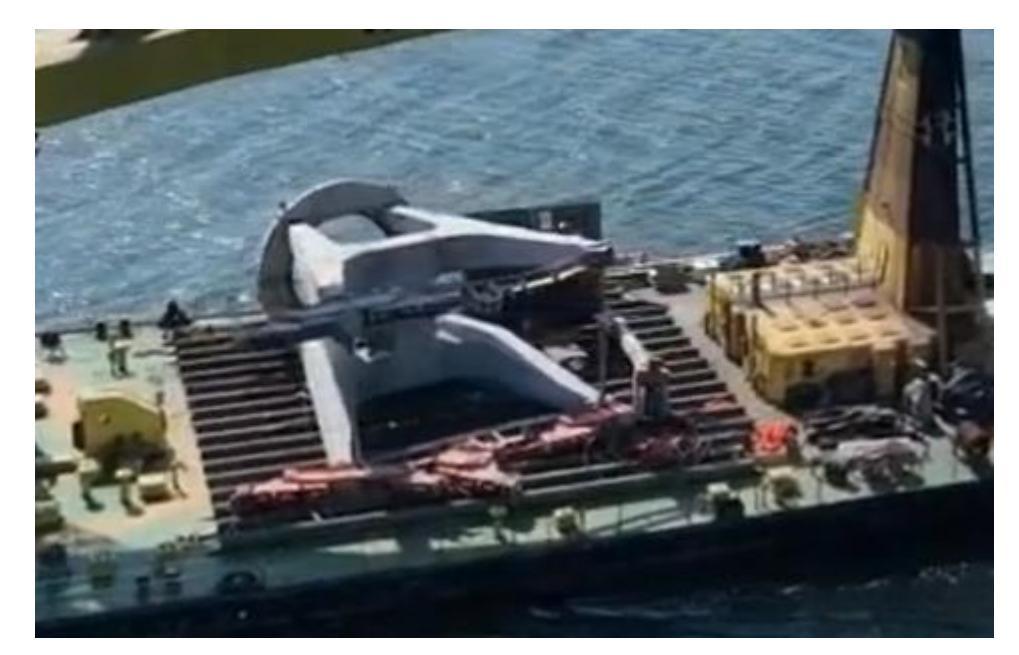
Photo 3. Picked up mobile part of the shipyard crane on board the Maja floating crane.

On 24 May 2023, the main structure of the crane was picked up from the bottom of the Baltic Sea using the 'Maja' floating crane and transported to Gdańsk (Photo 3 from 'Portal Trójmiasto.pl').

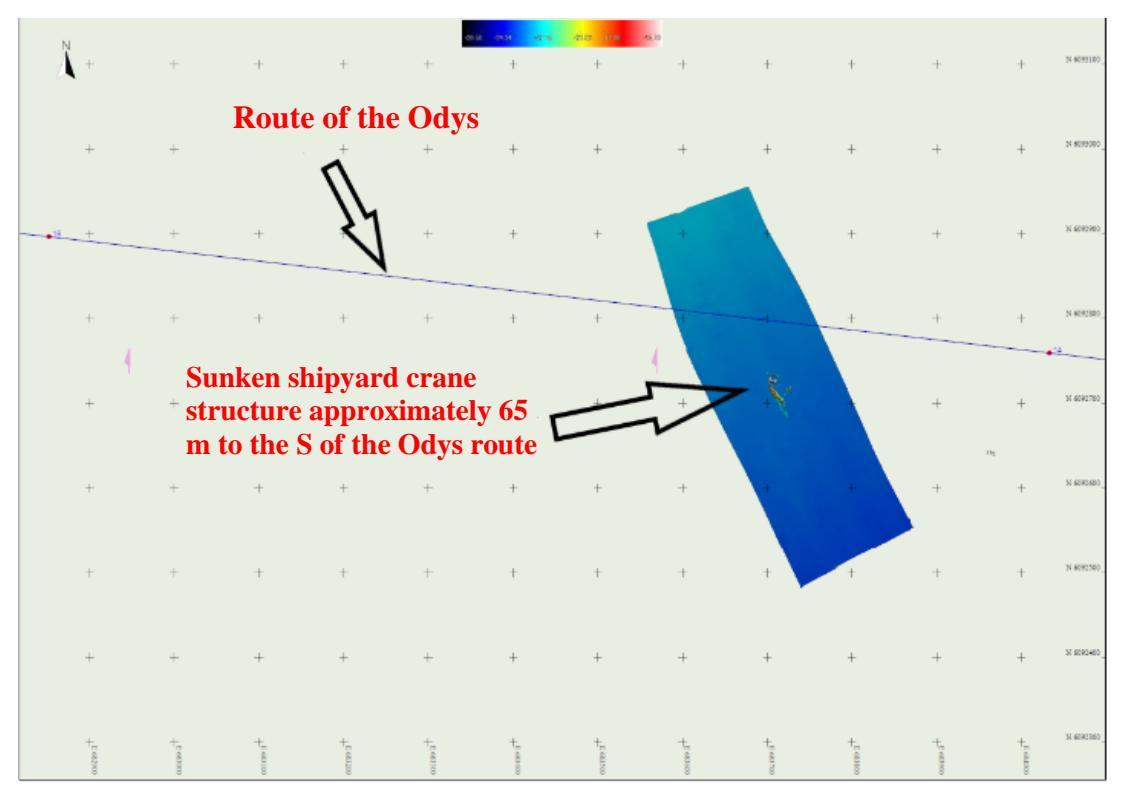
Figure 4. Position of the sunken crane – 65 m from the route of the Odys

The found sunken shipyard crane was lying on its side with its arm facing SE^3 . The minimum depth above the object was 15.7 m while the depth of the area was approximately 23 m. In May 2023, the main structure of the shipyard crane (the portal section including the rail mechanism) was picked up from the bottom of the Baltic Sea so that it would not pose a navigational hazard to deep-draught ships.

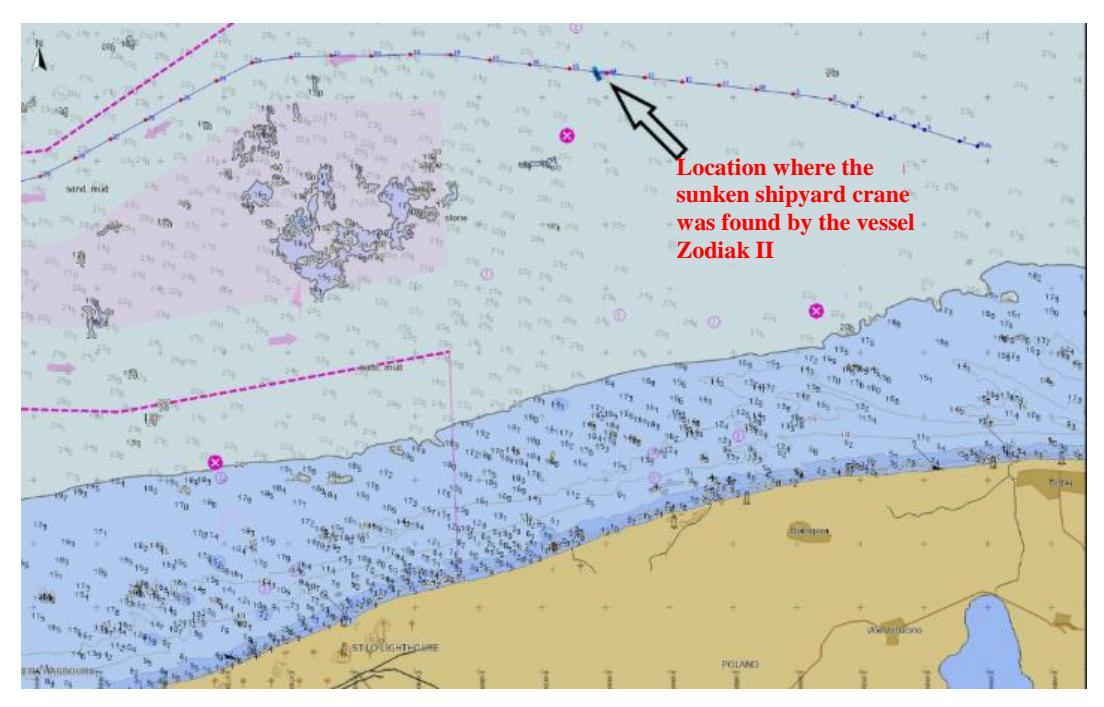
Figure 5. Location of sunken shipyard crane structure found by Zodiak II

On 26 August 2022, the multipurpose vessel Zodiak II, owned by Maritime Office in Gdynia, using a multibeam bathymetric system, surveyed the passage route of the towing unit and found the sunken shipyard crane on position $\varphi = 54^{\circ}56,51$ 'N; $\lambda = 017^{\circ}52,06$ 'E.

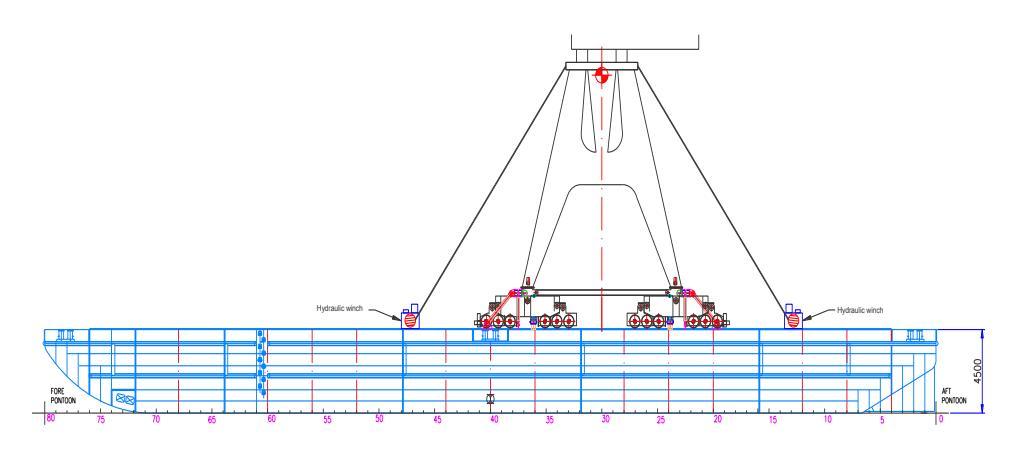
Figure 10. Additional crane lashing system (steel wire $-\emptyset$ 18 mm)

b) additional lashing system – steel wires (\emptyset 18 mm) attached to the winches (fixed with stoppers on the deck) and the top of the crane base. The steel wires lashing system was not included in the crane fixing due to the lack of information on its strength (wires, shackles, winch fixings, winch brakes) and due to a different elastic coefficient than the crane chassis securing.

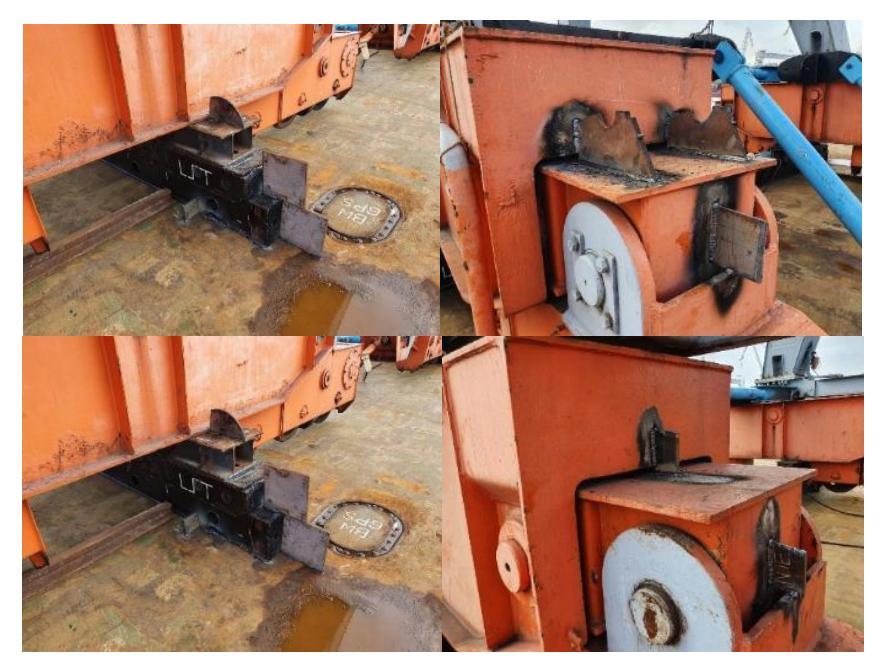
Figure 11. Welded stoppers for lashing the chassis and guides.

c) stoppers securing the guide rails and individual components of the shipyard crane chassis.

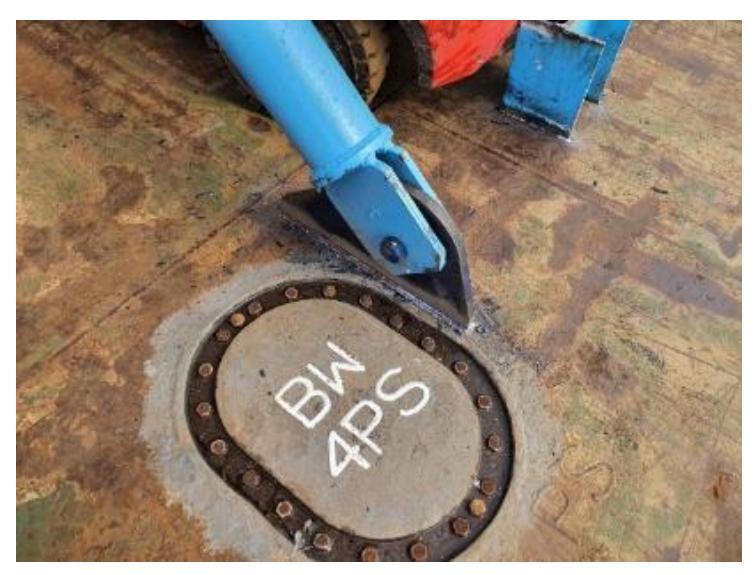
Figure 13. Lower fixing plate

The lower fixing plate of the main lashing system was welded to the pontoon shell with a 10 mm weld.

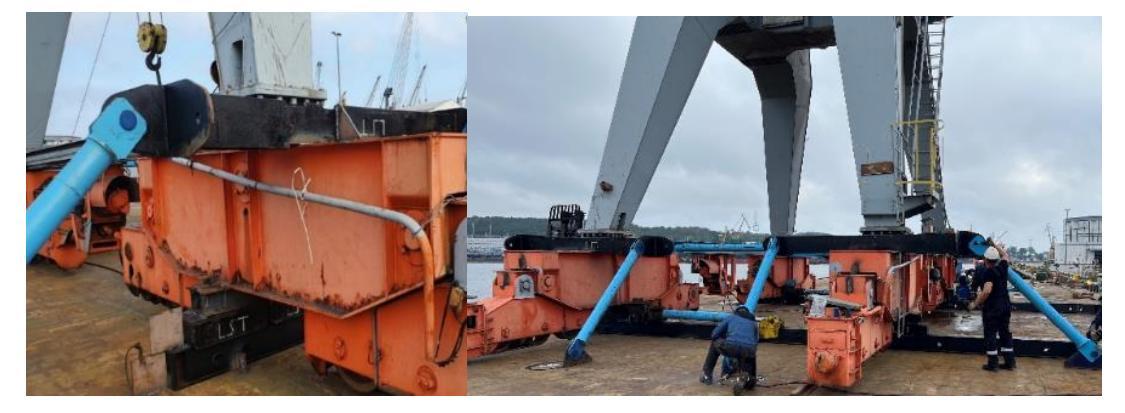
Figure 15. Upper fixing beams

Strength calculations showed that the stresses in the upper fixing plate exceeded the allowable working stress by 144%. The allowable load (MSL) of the beam should not exceed 400 kN. Below are drawings of the broken upper fixing beams.

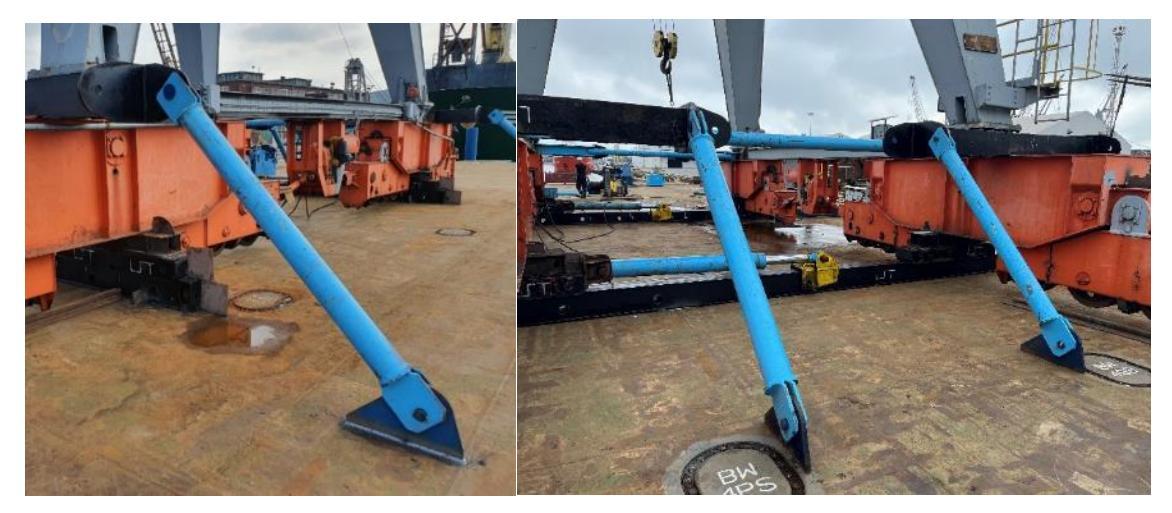
Figure 18. Fixing pipes

The strength of the cheek plates, due to the forces acting in the lashing, was met with a horizontal working angle of up to 0.5° . During the voyage, the working angles of the lashing exceeded the allowable load considerably, causing the cheek plates to bend – figure below.

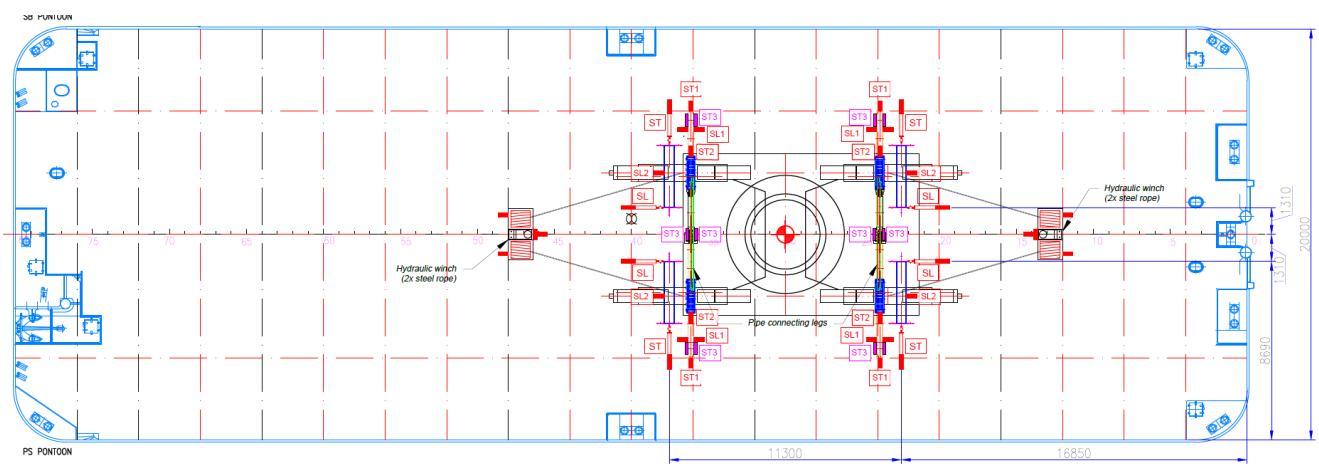
Figure 23. Layout plan of the shipyard crane and fixing beams on the pontoon

The crossbeam securing the crane chassis was welded to it using a weld with a declared dimension of 10 mm. To the fixing beams were added triangular gussets (Designation SL 2 on the fixing drawing) with dimensions: $300 \times 300 \times 12$ mm.

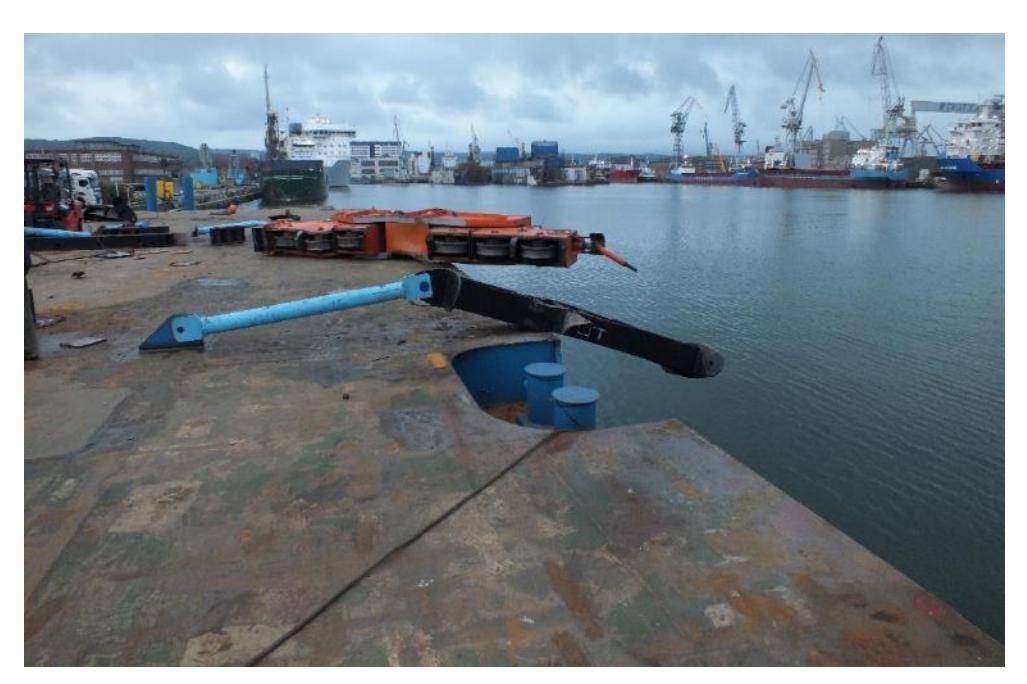
Photo 10. Crane guide rail element on board a pontoon from PS

On the pontoon, after the accident, parts of the lashing system with the fixing beams were left broken off.

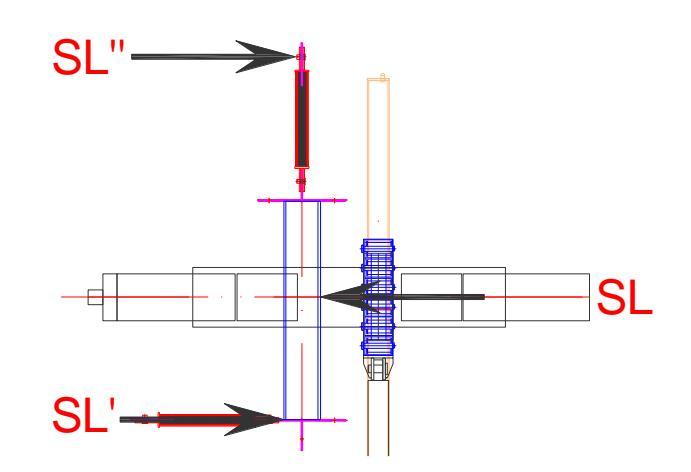
Figure 28. Torsional moment acting on the upper fixing beam.

- a. inadequate determination of the MSL of the lashing system. According to the design it was 60 t (588.6 kN), whereas from the strength analysis of the components it was determined to be only 20 t,
- b. the lashing of the shipyard crane was made as symmetrical with respect to its chassis but was asymmetrical with respect to its centre of gravity. The fixing beams were not secured symmetrically, which resulted in additional moments rotating them horizontally. No account was taken in the calculations of the additional torsional moments between the fixing beam and the crane chassis, which generated additional shear forces on the weld connecting the beam to the crane chassis (Figure. 28),

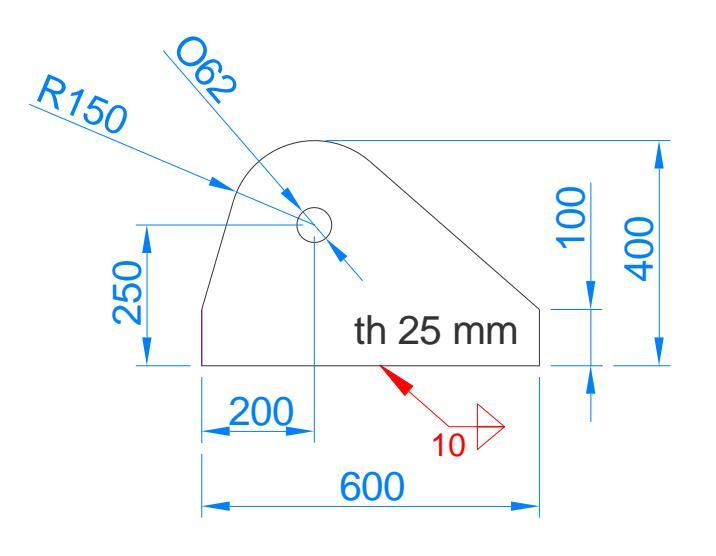
Rys. Dolna płyta mocująca

Dolna płyta mocująca głównego systemu mocowania była spawana po poszycia pontonu spoiną o grubości deklarowanej 10 mm.

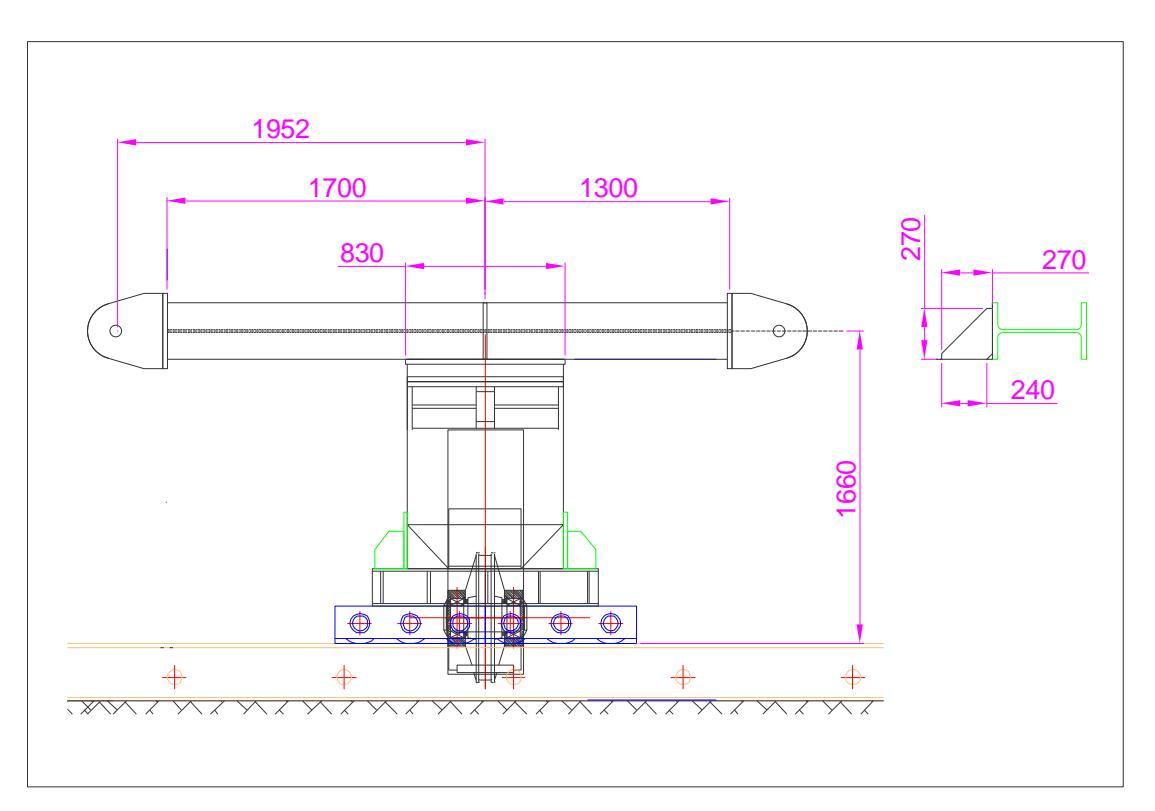
Rys. Poprzeczne belki mocujące

Belka poprzeczna mocująca podwozie żurawia została zespolona z podwoziem żurawia za pomocą spoiny o deklarowanym wymiarze 10 mm.
