STATE MARINE ACCIDENT
INVESTIGATION COMMISSION

FINAL REPORT

M/V Stena Nordica

Allision of the ferry 'Stena Nordica' with the chemical/oil products tanker 'Bull Kangean' at the Gdańsk Shiprepair Yard on 9 March 2023.

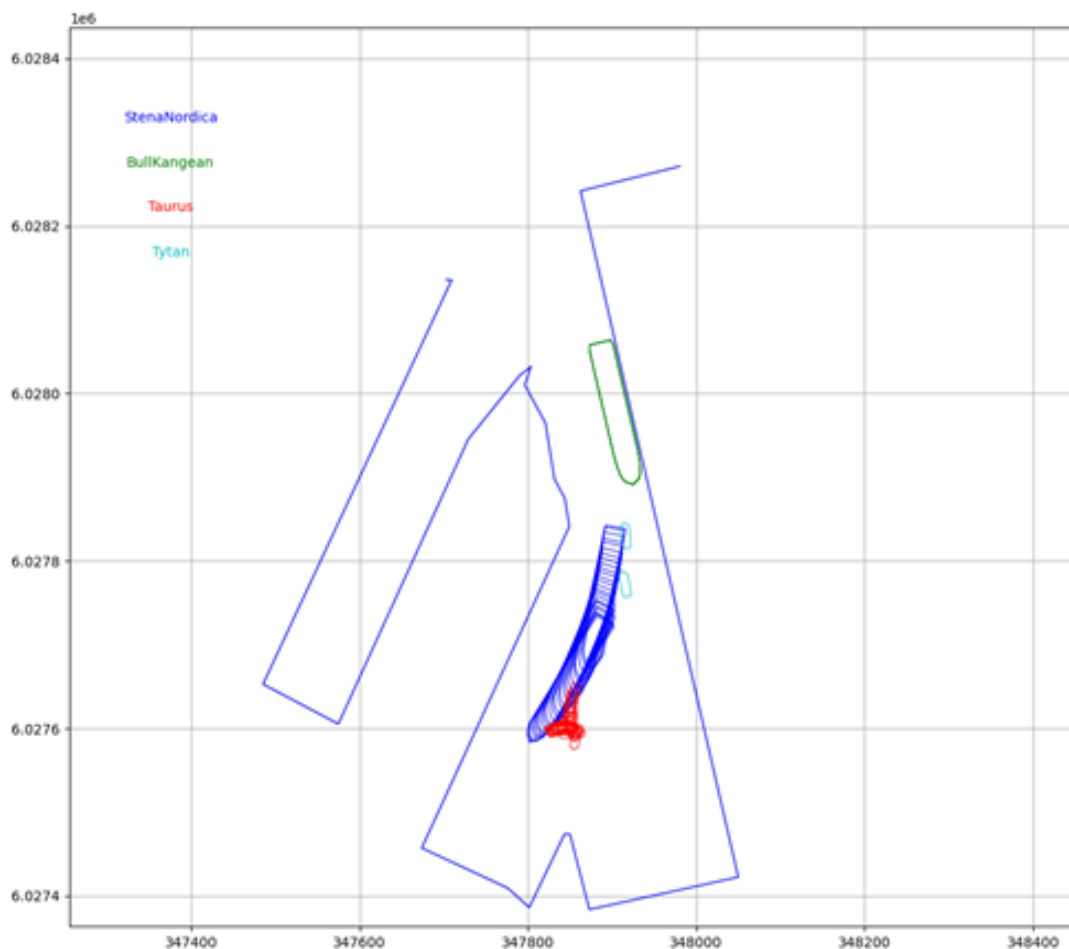
Figure 3 – Reconstruction of the SN towing set passage using combined AIS and VDR information of SN movement for stage 1 (UTM system, grid every 200m).

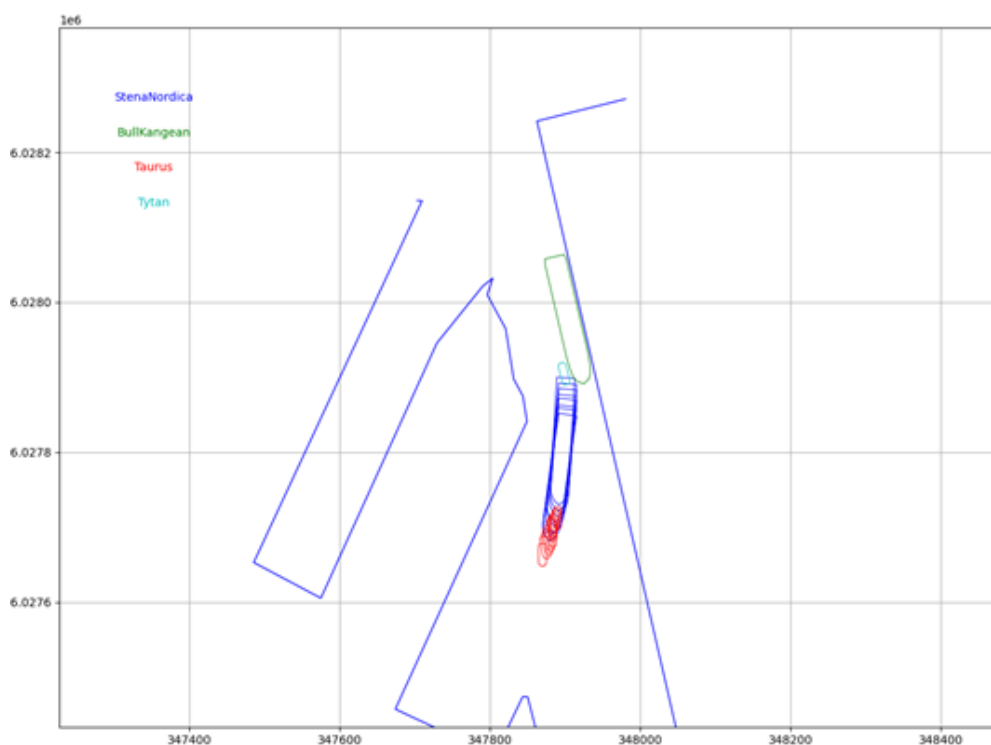
Figure 4 – Reconstruction of the SN towing set passage using combined AIS and VDR information of SN movement for stage 2 (UTM system, grid every 200m).

By analysing the vertical angles of the 'Titan' towing ropes and the length of the towing rope as determined by the AIS of approximately 30 m and knowing the heights of the fairleads above the waterline (SN approximately 10 m, Titan approximately 3 m), it is possible to determine the angle of view of the line (Figure 8). This was approximately 10 degrees which is an acceptable value. With the length of the towing rope shortened to a minimum, as the 'Taurus' had (<20m), the angle is still not great and is >15 degrees (Figure 4).

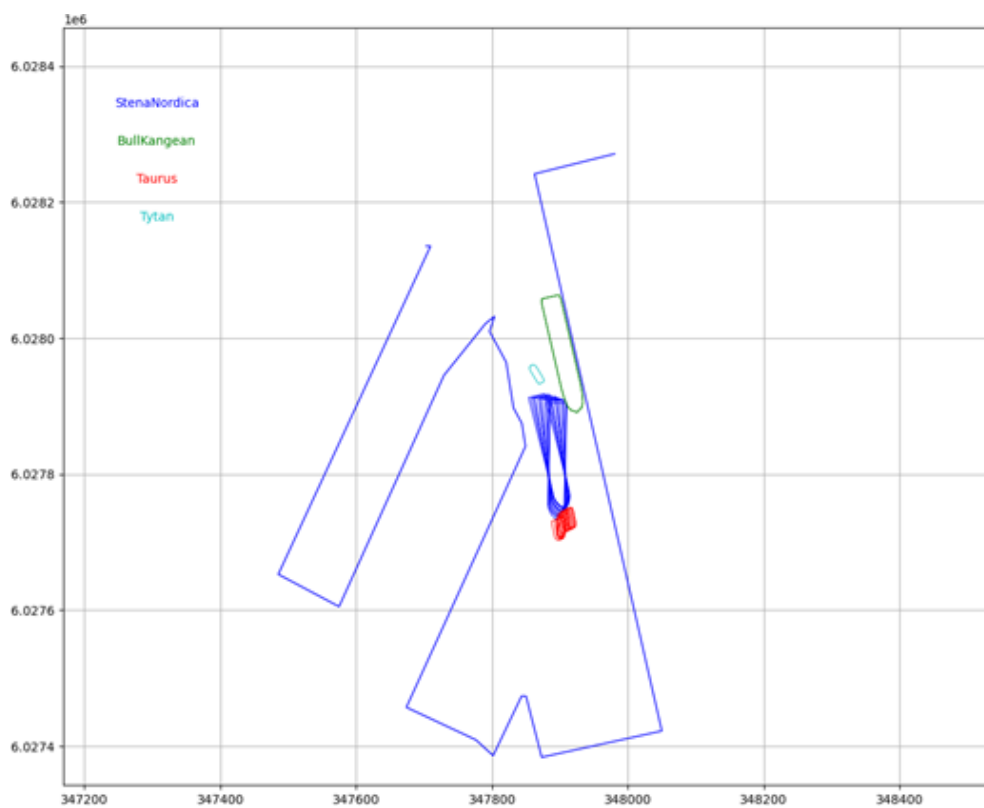
Figure 5 – Reconstruction of the SN towing set passage using combined AIS and VDR information of SN movement for stage 3 (UTM system, grid every 200m).

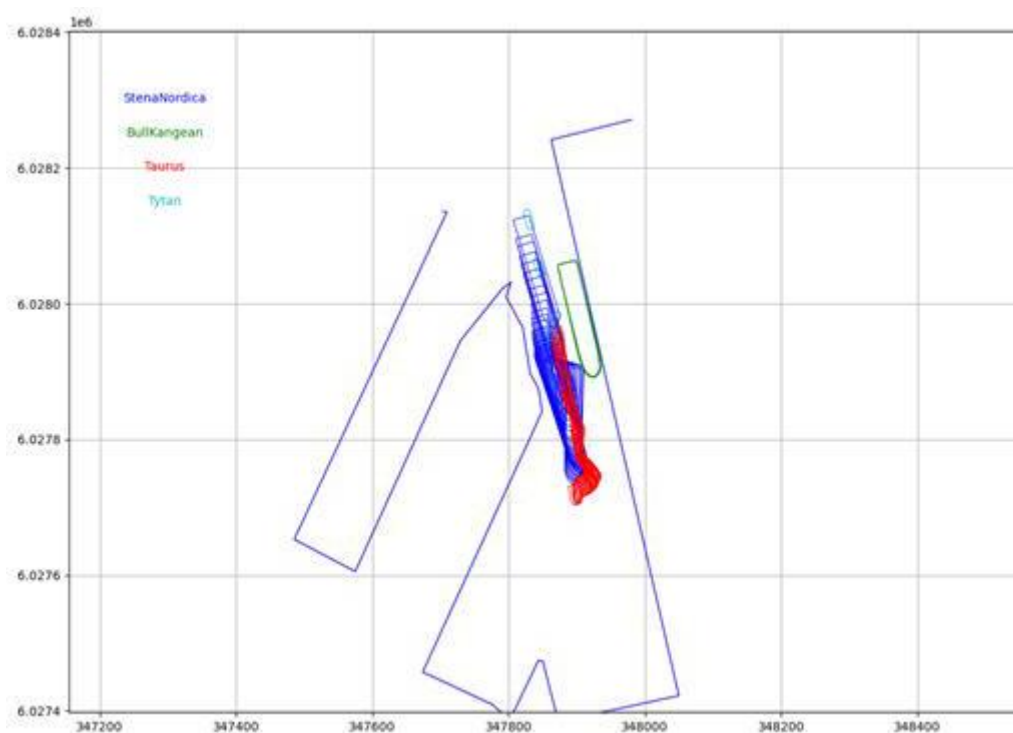
Figure 6 – Reconstruction of the SN towing set passage using combined AIS and VDR information of SN movement for stage 3.1 (UTM system, grid every 200m).

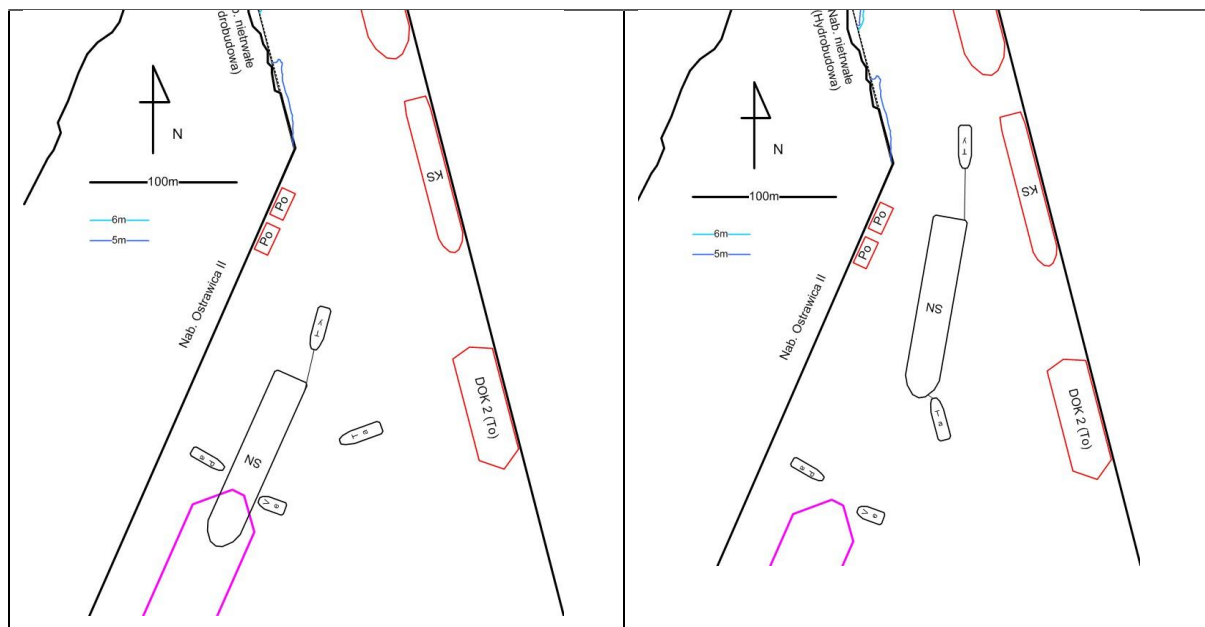
Figure 7 – Reconstruction of the manoeuvring situation Stage 1 (for legend see footnote 3)

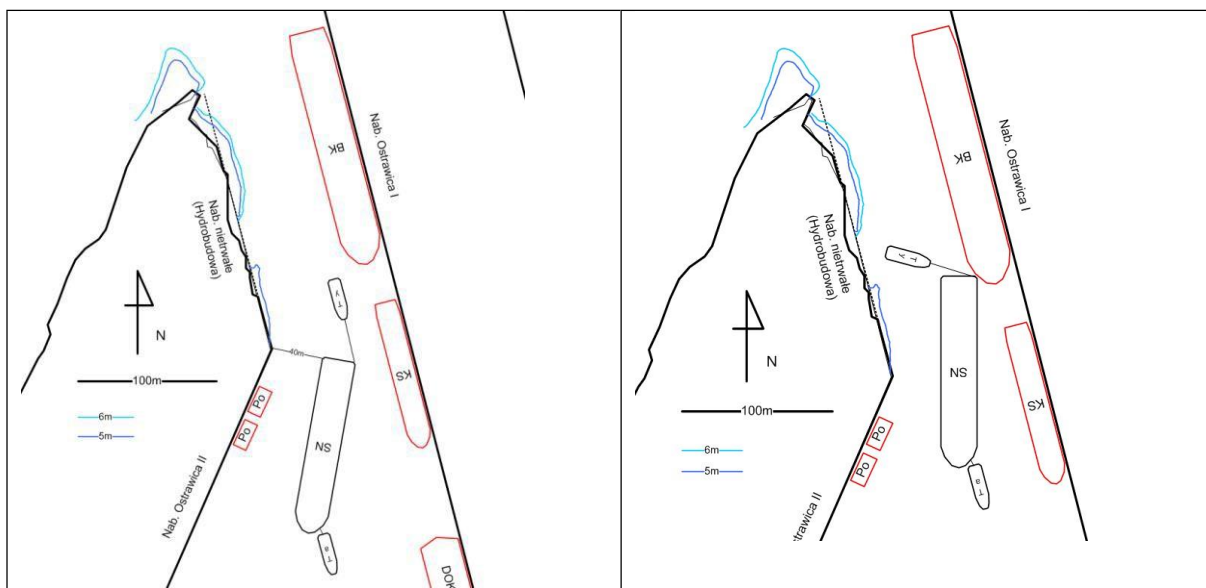
Figure 8 – Reconstruction of the manoeuvring situation Stage 2 (for legend see footnote 3)

In this case, the ASD at the bow (i.e., at the end of the towing set) could more actively manoeuvre the craft's course proceeding forward (shown on Figure 8).

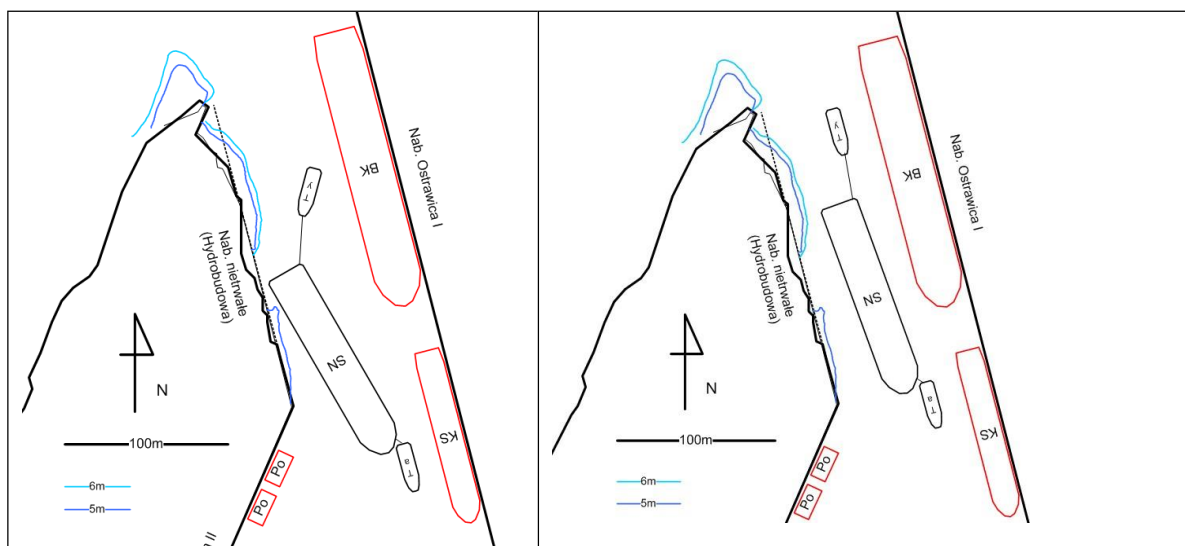
Figure 9 – Reconstruction of the manoeuvring situation Stage 3 (for legend see footnote 3)

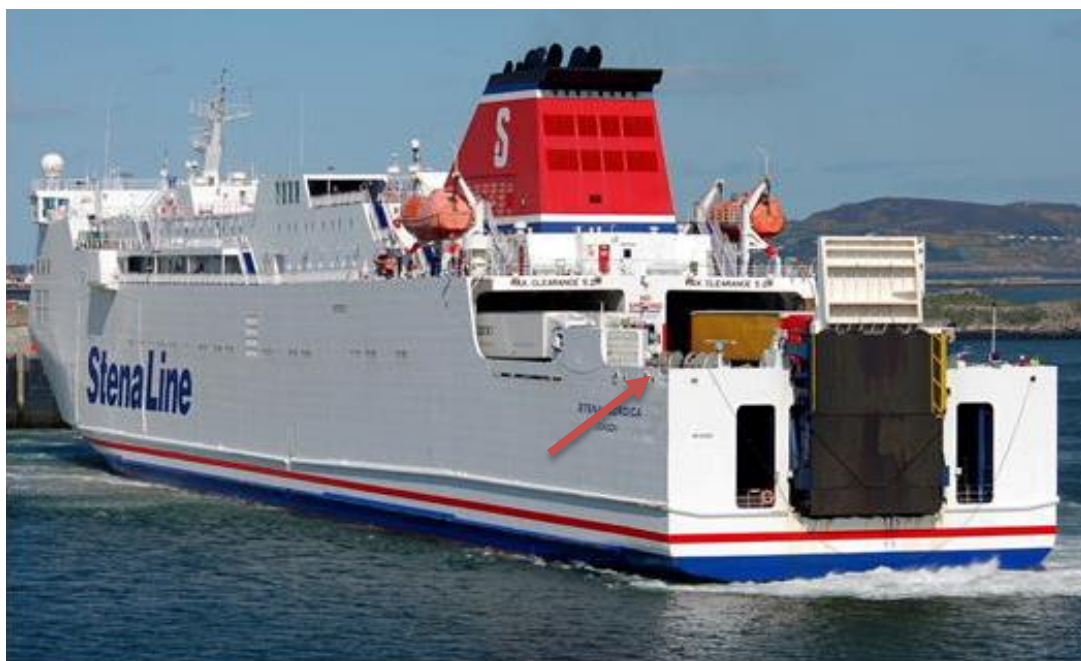
'Stena Nordica' has a ramp at the stern and a bow gate, thus lacking Panama-type central fairleads. Photos 5 and 6 show the available side fairleads for mooring/towing on the aft and fwd respectively. For towing at the stern, a large fairlead marked using the red arrow was used. For towing at the bow, the large fairlead, also marked with a red arrow (on the port side), was used.

Photo 5 – Fairleads arrangement and stern ramp, view on the PS aft of the 'Stena Nordica' (www.shipspotting.com, by Willie Ryan) – before rebuilding i.e., without the so-called Duck Tail on the stern.

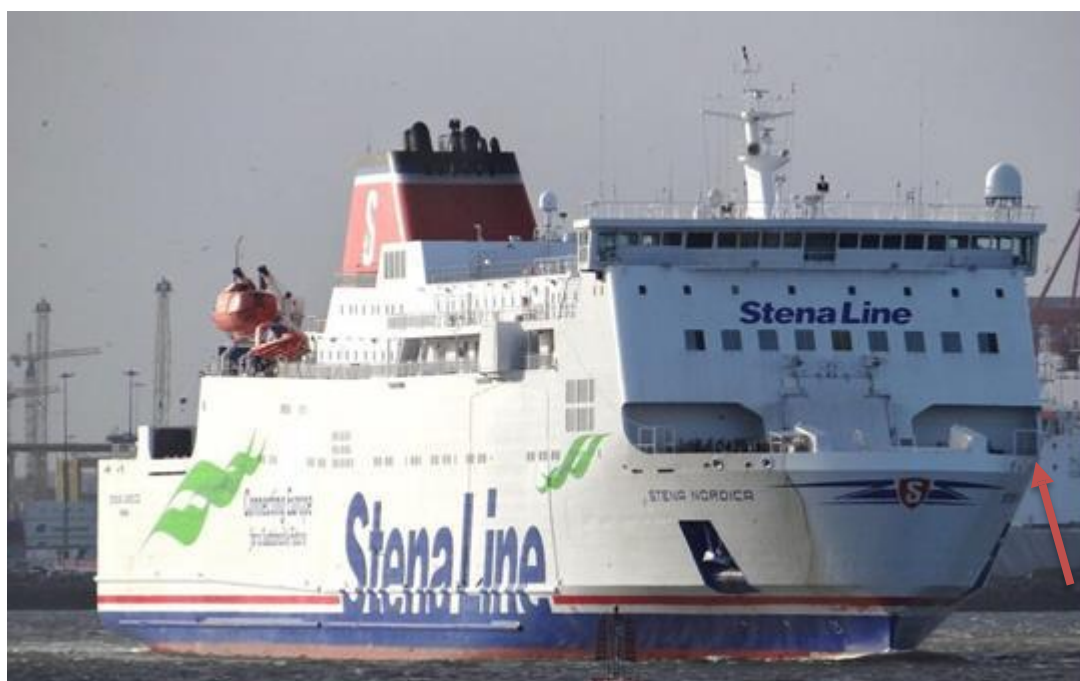
Photo 6 – Fairleads arrangement and bow gate, view on the stbd bow of the 'Stena Nordica' (www.niferry.co.uk, by David Faerder)

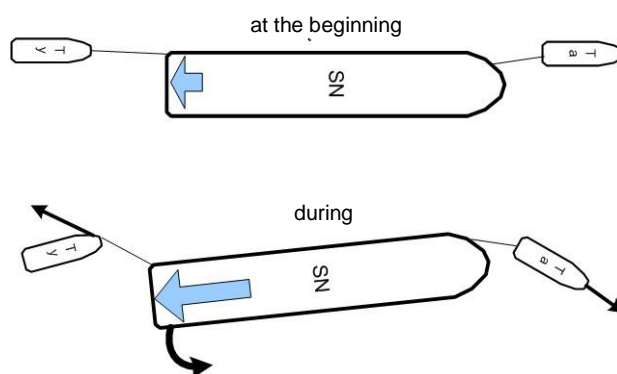
When towing a Ro-Ro ship astern, without a Panama (central) aft fairlead, there is a problem with unequal application of forces and asymmetrical water flow along the hull. This causes changes in the course of the towed ship and increases the area (clearance) required for both the ship and the tugs to manoeuvre.

The problem of manoeuvring with an asymmetrical position of the towing rope may be due to the fact that, to compensate the rotation of the hull, the tug must swing to the port side enlarging the manoeuvring area (Figure 10).

Figure 10 – Diagram of forces and moments that can be generated for asymmetric towing, and counteracting them using tugs, increasing the towing set manoeuvring zone (length).

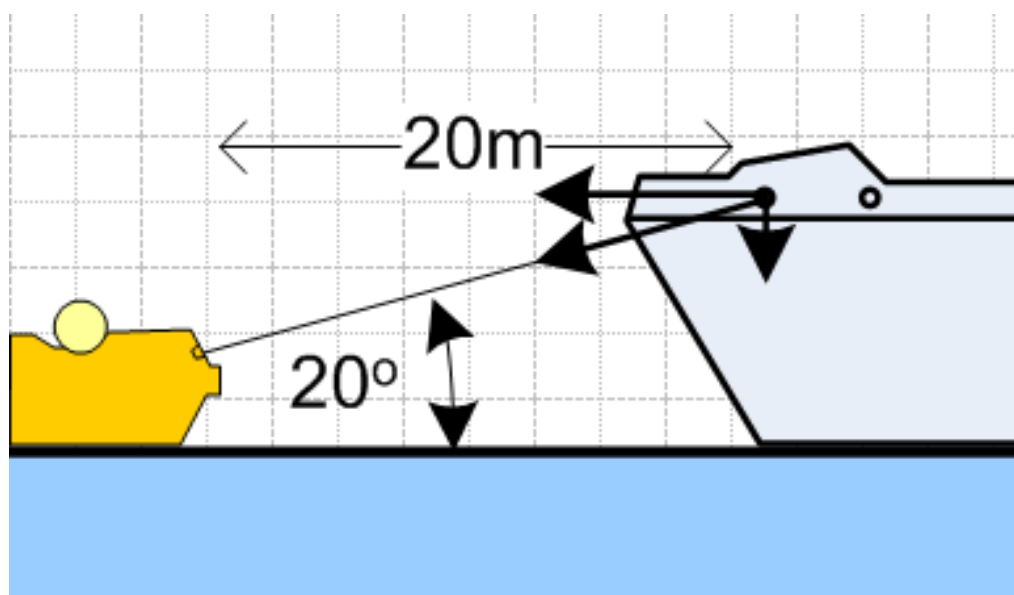
A big angle causes a distribution of unfavourable towing forces. In extreme cases, where the angle is very large (>30 degrees), due to the lifting force of the towing rope and the weight of the tug, the load on the line can increase significantly and the rope or ship bollard can exceed the load limits.

Figure 12 – Determination of towing rope angle for 'Taurus' (based on AIS her towing rope was shorter than 20 m).

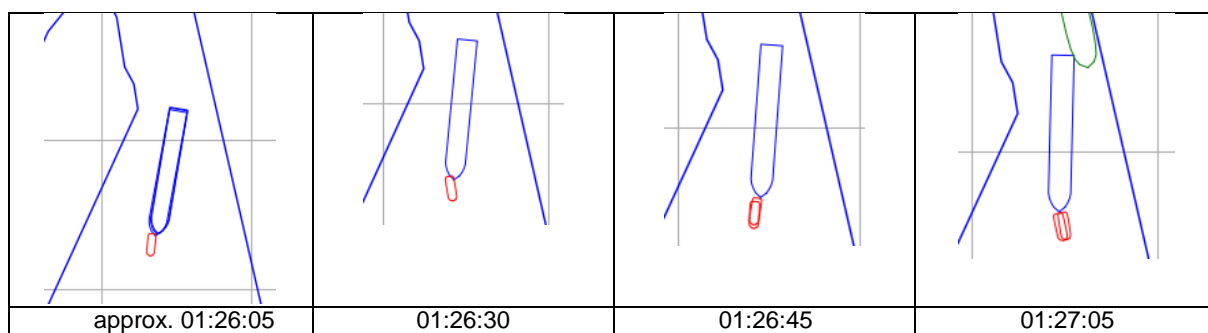
It can also be seen that the 'Taurus' often occupies a position from the starboard side of the 'Stena Nordica', which is rather strange due to the impossibility of obtaining torque while operating the towing rope (Figures 13 and 14). It is possible that the 'Taurus' was pushing the 'Stena Nordica' being fast on the towing rope, or there may have been interference in the form of multipath GNSS signals due to the proximity to the Stena Nordica's bow.

Figure 14 – Position of 'Taurus' in relation to 'Stena Nordica'.

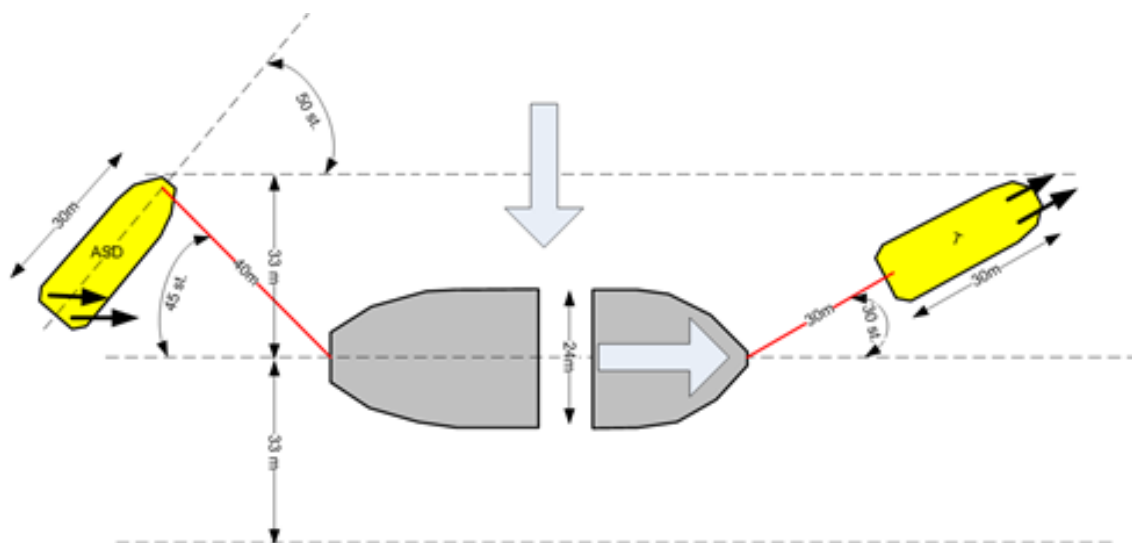
For the example towing set-up, assuming that the tractor-type tug is on the bow and towing directly and the ASD tug is on the aft of the ship and assisting 'not directly' (indirect), the minimum basin width should be within 66 m (Figure 5.1). It was assumed that the escort ASD needs a towing rope with the length of 40 m and swings of 45° for optimal operation by the

Figure 19 – Example scheme for determining the minimum waterway width for a towing set consisting of a towed ship, a tractor-type tug (leading) and an escort ASD using 'indirect' towing.

It follows that a body of water with an available width of 58 m ($2.4B$) constitutes a navigational difficulty for the safe manoeuvre of the towing set under consideration going astern.
