Investigation report / Relatório de investigação

Mv EF Ava, IMO 9389306 REGISTRY - GAMA 2019-012

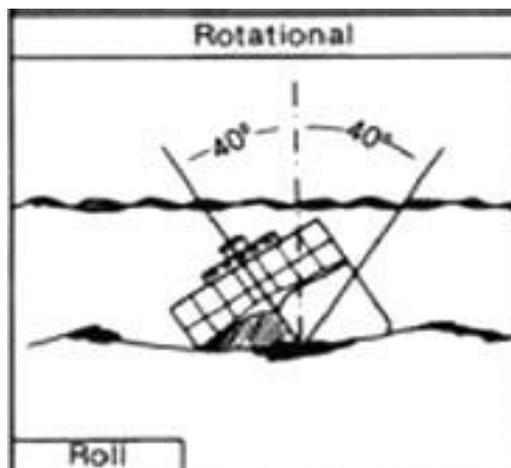
Figure 3 – Rolling acts in the transverse direction

At 20:00 hours on the 28th January the Master and one AB (Able-bodied Seaman) went on watch on the bridge. The vessel was under way using engine and steering under autopilot at course 040°. The engine room was running unmanned and the speed over ground (SOG) was 8.7 knots (Kts). During the watch the vessel was rolling through about 20° to either side of the vertical – this was occurring since the 26th January around noon time due to weather and sea state conditions.
