STATE MARINE ACCIDENT
INVESTIGATION COMMISSION

SIMPLIFIED REPORT

Tugboat VIRTUS Vessel BOMAR VICTORY

collision of a tugboat with a vessel
in the fairway to DTC in Gdańsk
on 24 June 2015.

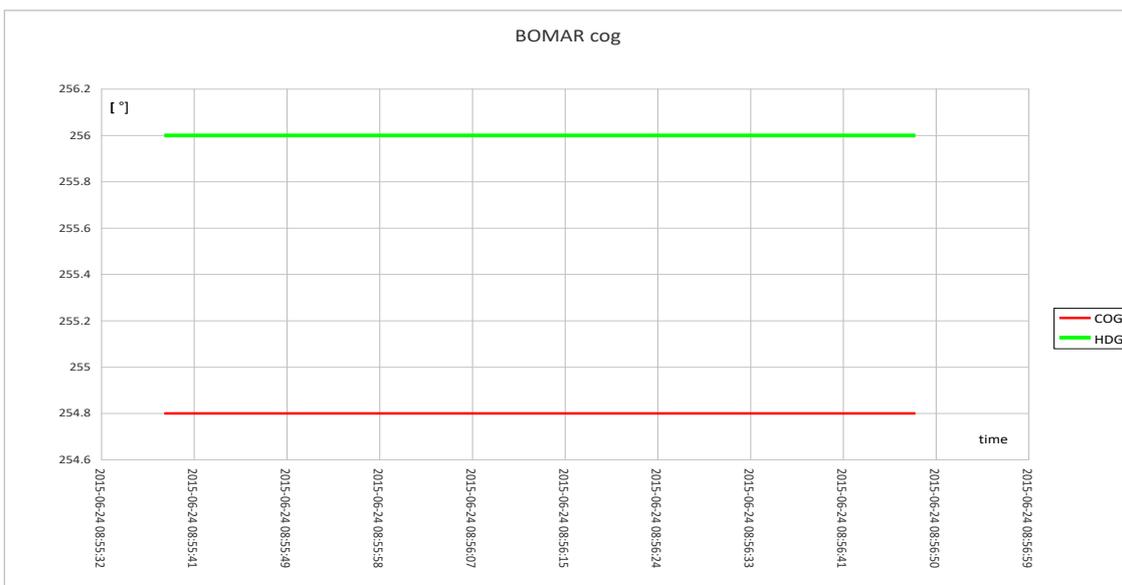
Figure 3: HDG and COG diagram of ‘Bomar Victory’

¹ *Bomar Victory* exceeded twice the speed permissible in that place, which at the roadstead of the Port of Gdańsk is 7 knots (Par. 101, subparagraph 1, point 1 of the Order No. 5 of the Director of the Maritime Office in Gdynia of 20 February 2013 Port Regulations (Official Journal of the District of Pomerania, item 1314).

When the vessel arrived at the pair of buoys "P13" and "P14" (about 8 cables in front of the port heads) she reduced the speed to about 7 knots and at that speed she passed the entrance head of the Island Breakwater of the Port Północny in Gdańsk.

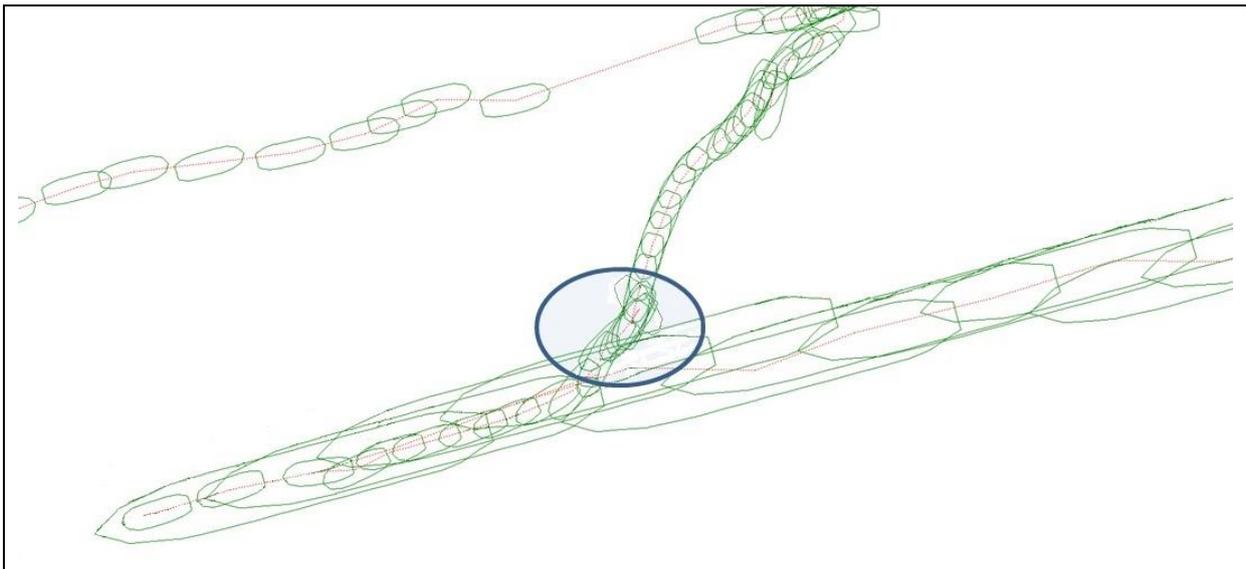
Figure 3: Visualisation of movement of 'Bomar Victory' and 'Virtus'

The tugboat *Virtus* sailed out of the Inner Basin of the Port Północny to meet the vessel and after passing the breakwater it increased the speed to over 10 knots². At this speed it initially was navigating on the left, and then on the right side of the fairway (Figure 1) until reaching the buoy "P9". After passing the buoy, the tugboat stopped and set perpendicularly to the course of the approaching vessel. The skipper of the tugboat turned at the steering position and started approaching the coming vessel with the stern taking courses appropriate to changing bearing (Figure 4), trying to go behind her stern and keeping as close to the vessel as possible at the time she would pass her by.

The skipper of the tugboat began to increase the speed (blue line in Figure 5) until reaching 6.5 knots. Then he realized he might have gotten too close and tried to slow down to avoid collision. In Figure 5, it can be clearly seen that after reaching the speed of 6.5 knots, it begins to rapidly decrease in a very short time to the value of 0 at the moment of impact³.

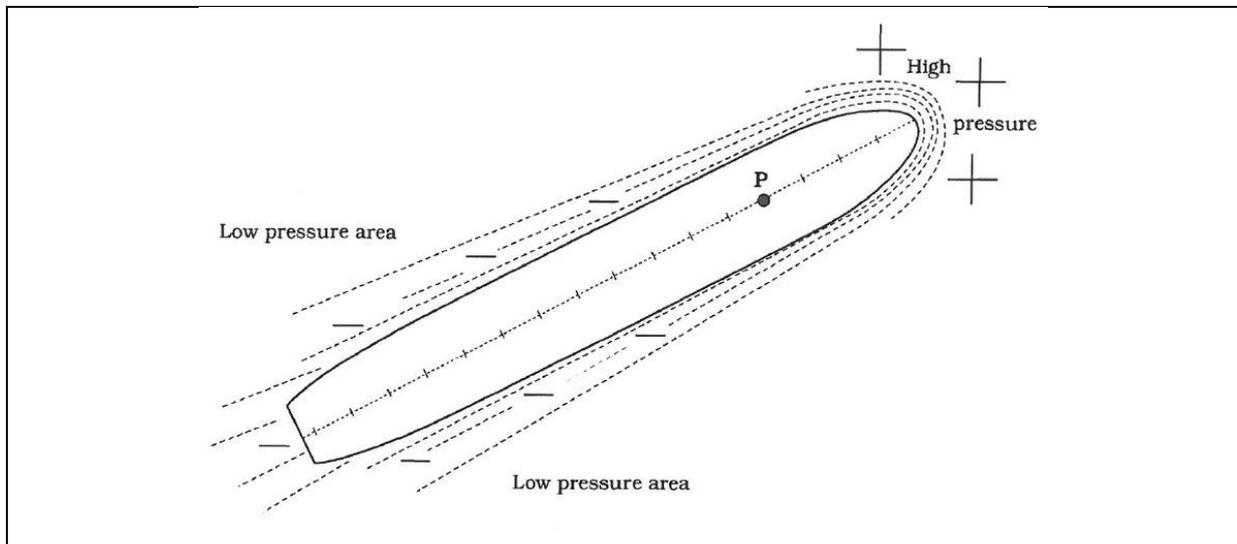
Figure 5: Simplified presentation of the distribution of pressure around the vessel in motion

Around the moving vessel, there are areas of varying pressure. There are high pressure areas around the bow, while along the sides of the vessel from the pivoting point of the vessel (P) towards the stern, there are areas of reduced pressure (Figure 6)⁷.

Hydrodynamic interactions are associated with the movement of vessels that produce areas of varying pressure around their hulls. Areas of varying pressure create attractive or repulsive forces and torque moments affecting the vessels. Interactive forces change and depend on a number of factors, such as the type of a vessel (the shape of a hull), its size, draft, trim, keel and fairway width.

The greater the speed of vessels the greater interactive forces. They increase with the square of speed, i.e. the speed increased twice causes the forces to increase four times. Interactive forces increase as the distance between vessels diminishes. Potential danger increases with the increase of difference between the size of vessels. A smaller vessel is subjected to greater impact than the larger one.

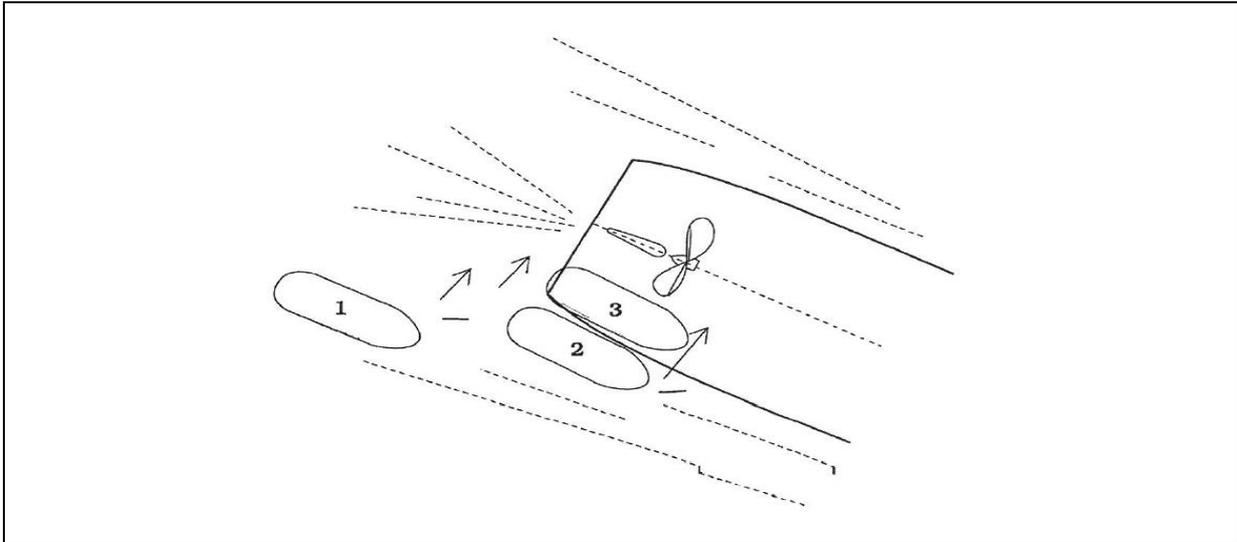
Figure 6: The effect of hydrodynamic forces on a tugboat approaching the stern of a vessel

Larger impact forces and a much higher risk of collision exist in the case of a tugboat approaching the bow of a ship than its side or stern. Nevertheless, the tugboat approaching the stern of a vessel, not directly in the ship's jet stream but approaching it slightly from the side (Figure 7), especially to a vessel that has not reduced speed, is exposed to the attracting forces of the ship's hull.

The skipper of a tugboat coming up from the stern, when in the position No. 1, must expect an unforeseen increase of the tugboat's speed due to reduced resistance of water in the area. If the tugboat skipper does not stop this additional movement immediately, it will most likely be at the ship's side in the position No. 2. When the area of lower pressure is strong, in the event of a delayed response, wrong steering and lack of adequate engine power to depart from the hull of the vessel, the tugboat can be found in the position No. 3 and can be pulled under the overhang of stern and suffer severe damage to the hull and superstructure⁸.

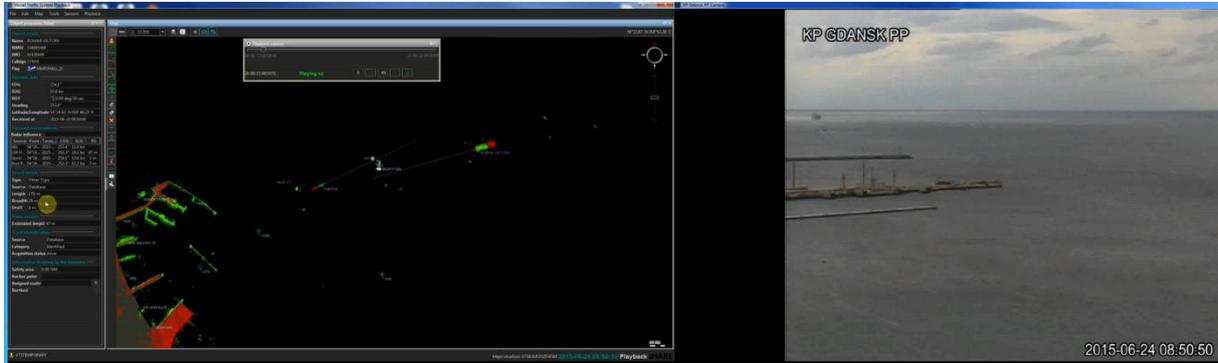
08:50:50: *Virtus*, having passed a pair of buoys “P13”-“P14” is heading towards *Bomar Victory* approaching a pair of buoys “P5”-“P6”

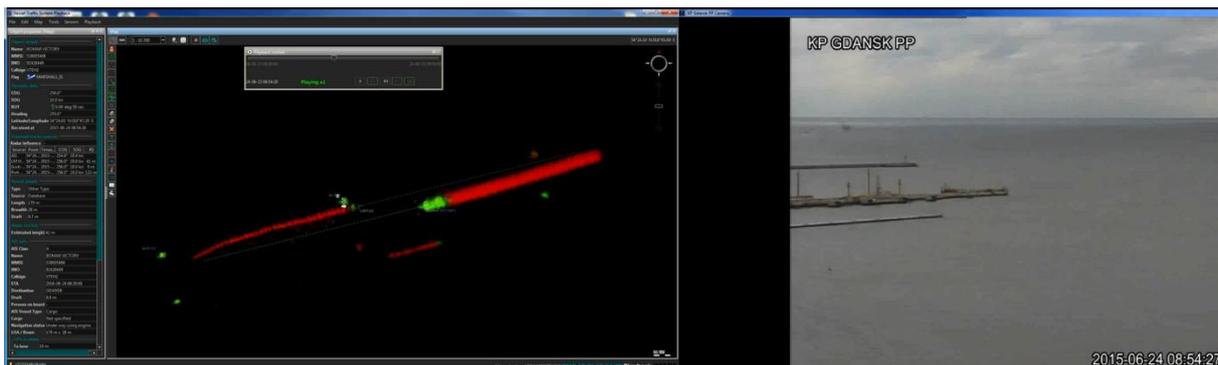
08:56:26: *Virtus* is passing by a buoy “P9”. *Bomar Victory* is found between a pair of buoys “P5”-“P6” and a pair of buoys “P9”-“P10”

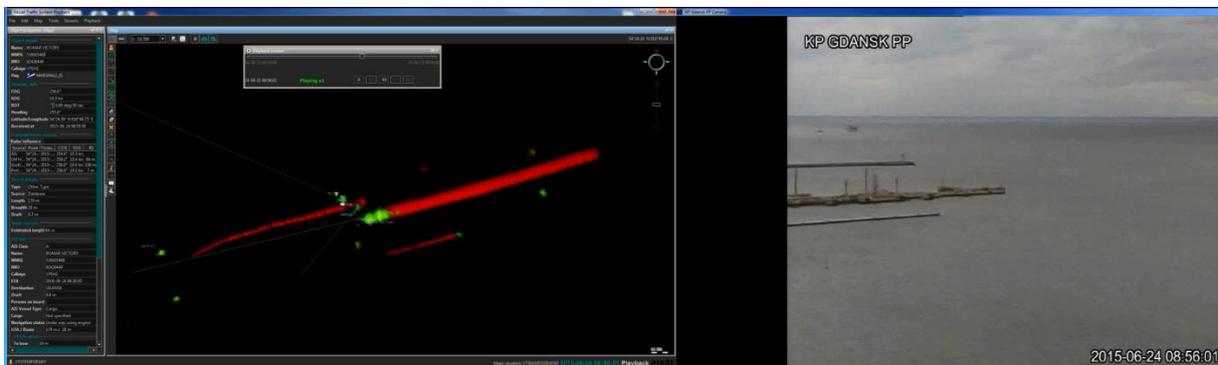
08:56:01: *Virtus* stops and then starts approaching *Bomar Victory*

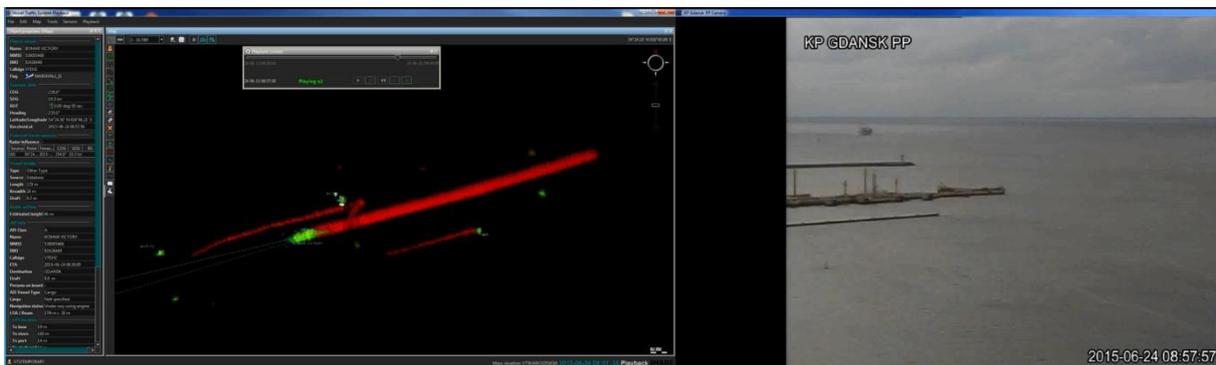
08:57:57: *Virtus* navigating in the wake of *Bomar Victory*
