FINAL REPORT

Marine casualty

M/V City of Rome

Damage to the fender frame of the eastern breakwater while exiting the port of Gdańsk on the day of 29 January 2018

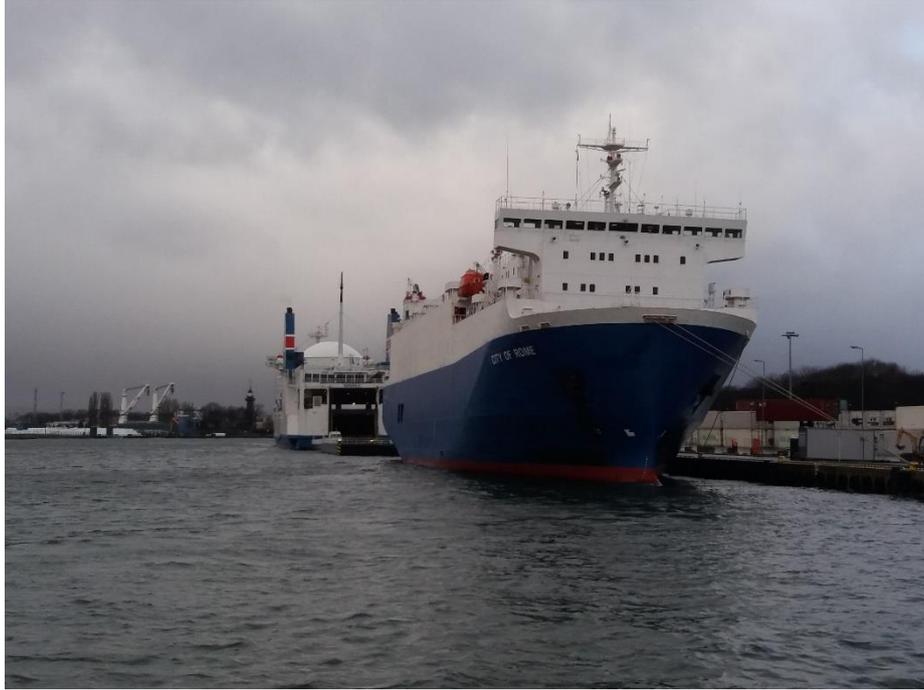
Photograph 1: The vessel, City of Rome, in the port of Gdańsk 30 January 2018

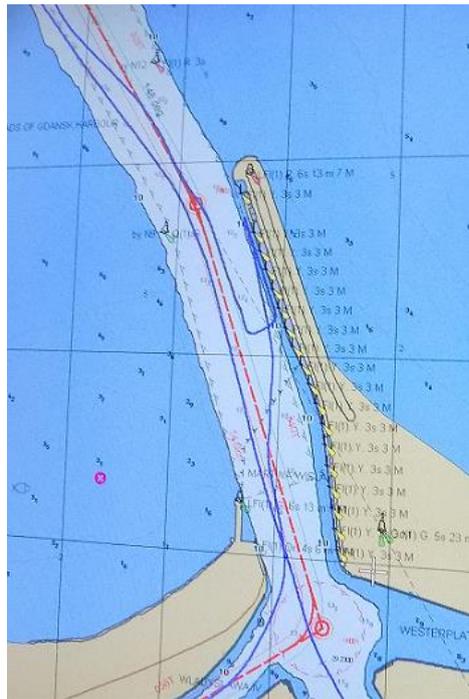
Despite the increase of speed to 4 knots, after passing the head of the western breakwater the vessel began to drift towards the eastern breakwater passing to the eastern side of the port channel.

Photograph 5: Screenshot from the electronic chart from the vessel, City of Rome
