STATE MARINE ACCIDENT  
INVESTIGATION COMMISSION

# FINAL REPORT

# 39/15

## **M/V GREEN EBERSUND**

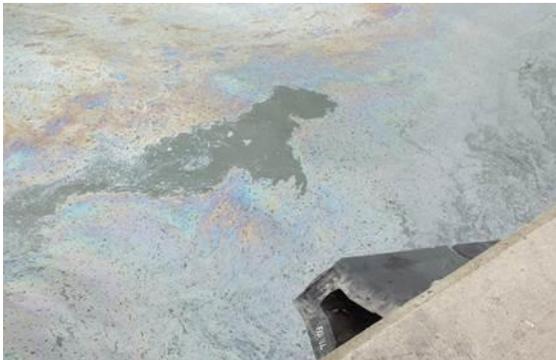
*Photograph 3: The Pilotowe Wharf*

Kind:	very serious marine casualty
Date and time of event:	27.08.2015 at 17:14 LT (15:14 UTC)
Geographical position of the event:	$\varphi = 57^{\circ} 32.2' N$ ; $\lambda = 18^{\circ} 32.3' E$
Geographical area of the event:	the Port of Gdynia
Nature of the water region:	internal sea waters
Weather during the event:	wind SW $3^{\circ} B$ , very good visibility, air temp. $21.6^{\circ} C$ , water temp. $18^{\circ} C$
Operational status of the vessel during the accident:	vessel under classification survey, without main propulsion, ballasted
Place of the accident on board:	stern of the vessel, starboard, plating of the service tank for heavy fuel no 15
Effects of the accident to the environment:	polluted water and port wharfs with a layer of petroleum substance 0.5 – 2.5 cm thick

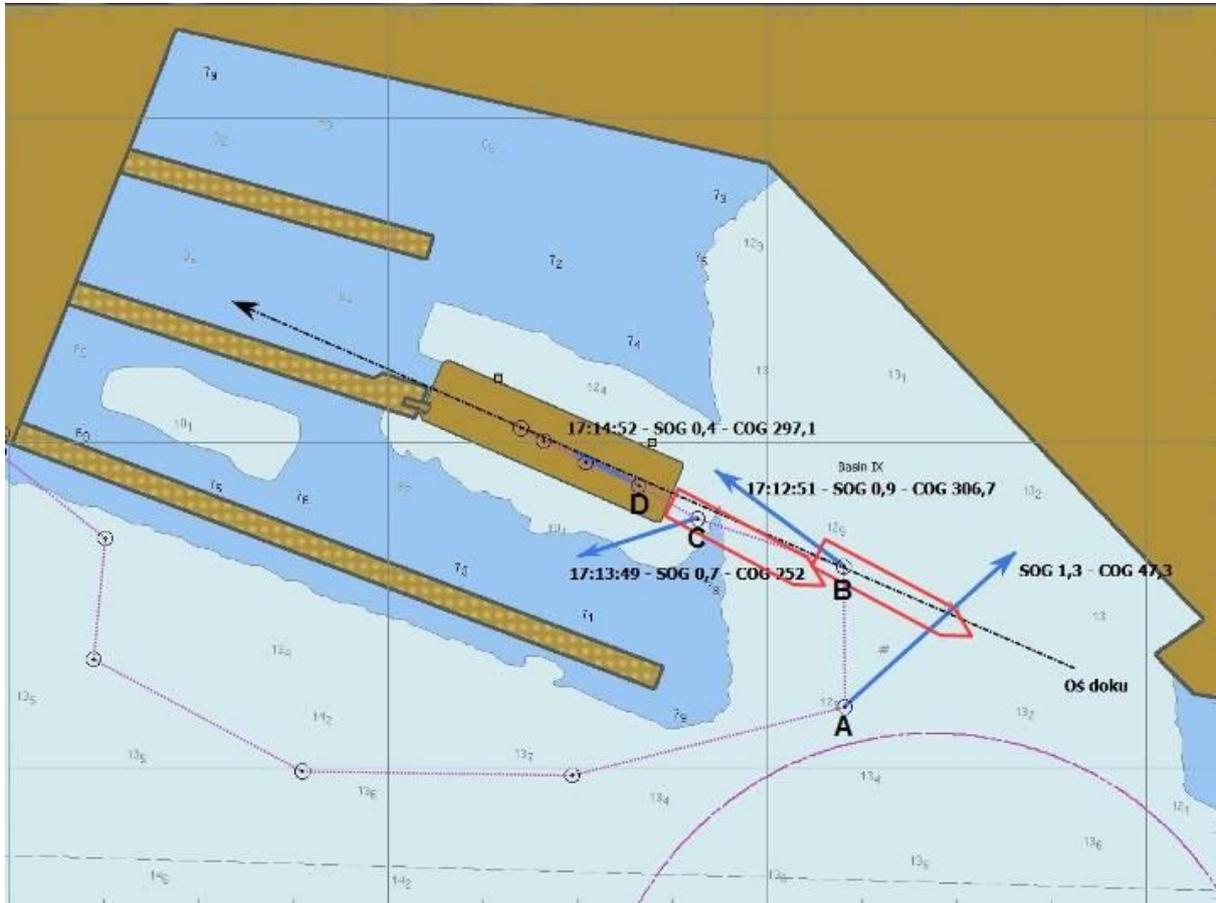
Figure 1

south of the dock's axis of symmetry, and at ca. 17:11 started to bring the vessel into the dock on the 305° course (Figure 1).

: The route of the towing unit from the Południowe Wharf to the entrance to the dock

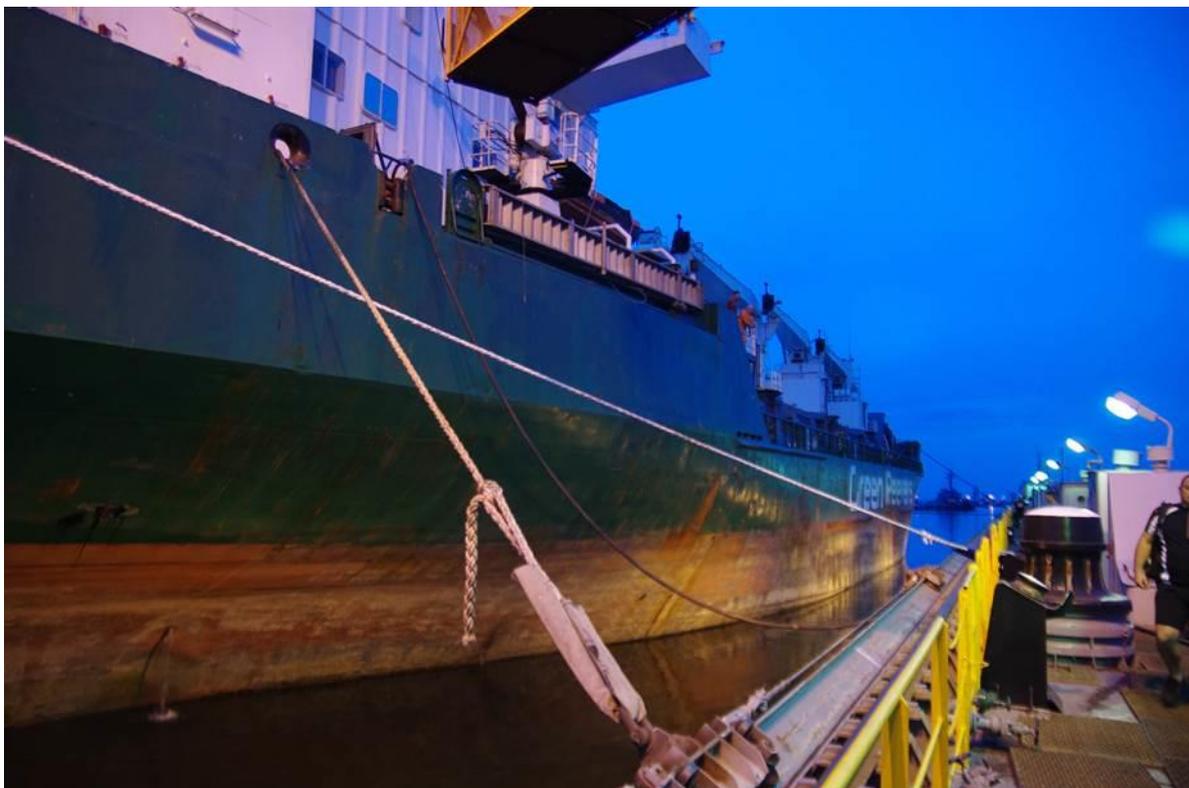
At ca. 17:40 the vessel was set at the position (Photograph 13). The Naval Shipyard dispatcher informed “Delfin R.M.” company about the spill and the necessity of starting to collect spilled fuel as soon as possible.

*Photograph 13: „Green Egersund” held in the position; at starboard stern there is a towline (passed from the winch) and mooring line (passed from the vessel)*

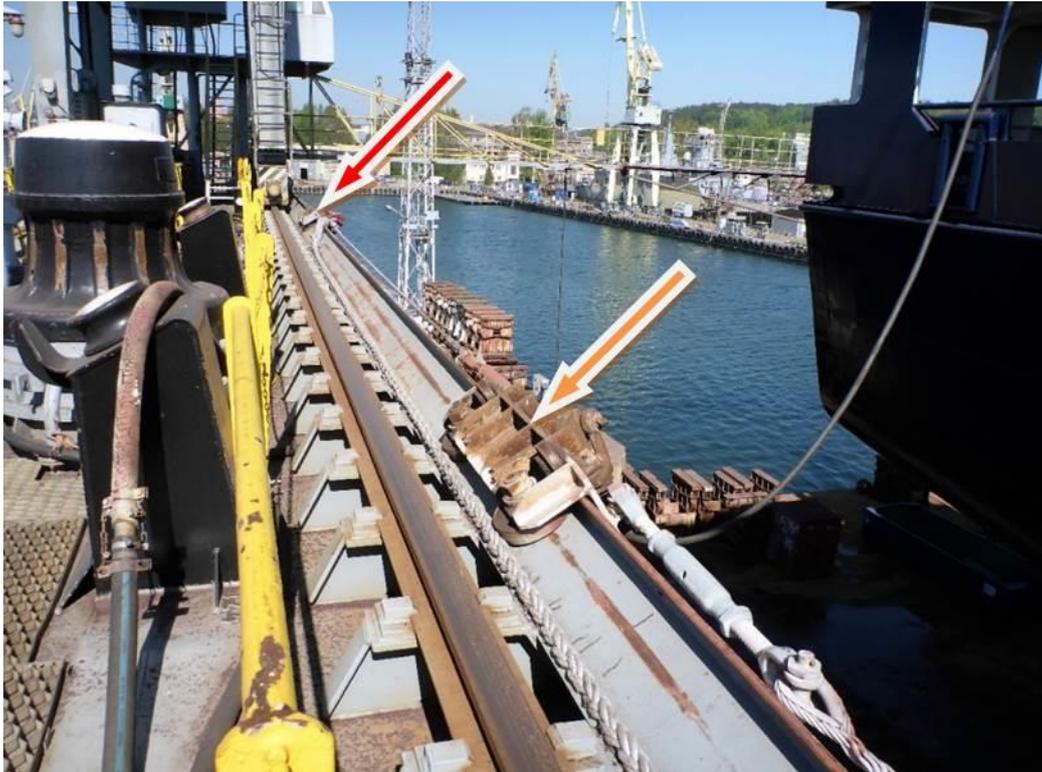
*Photograph 19: Towing and mooring winches at the right side wall of the floating dock*

Winches are about 10 m apart and connected in such a way that they move at the same time and speed. The speed of a pair of winches on each side wall may vary. The first of the winches (marked with an orange arrow on Photograph 19) stops at a short distance from the dock front face, but is not used in practice. The towline is given to the vessel from the other winch (marked with a red arrow; the towline is shown on Photograph 13). If the towline was given to the vessel from the first winch, then it would not be possible to pull the vessel to the end of the dock<sup>8</sup>.

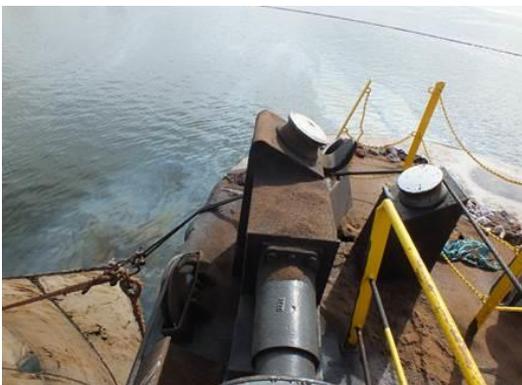
Consequently, about 9 m<sup>3</sup> of heavy fuel flowed out of the tank contaminating the shipyard's basin, a part of port basins, 13 wharfs and a part of the main detached breakwater under the management of the Port of Gdynia Authority SA. The degree of contamination of individual basins and wharves was different and it depended mainly on the wind direction during the first hours after the accident. The "SMW-1" dock itself, mainly its southern side wall, and the sides of *Green Egersund* (Photographs 22-25) were also contaminated with heavy fuel.

*Photograph 22:* View to the Basin IX from the southern head of the "SMW-1" dock

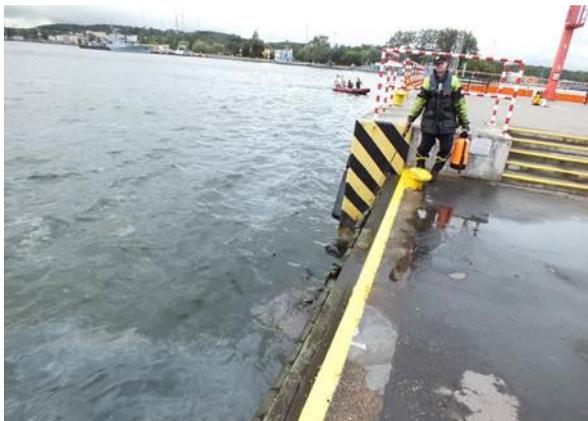
Some of the oil stains could be removed by means of dispersants (Photographs 26, 28 and 29). In cases where the fuel accumulated at the wharves in larger quantities, specialized equipment was required for collection (Photograph 27).

*Photograph 26:* Cleaning of oil spill at the Pilotowe Wharf

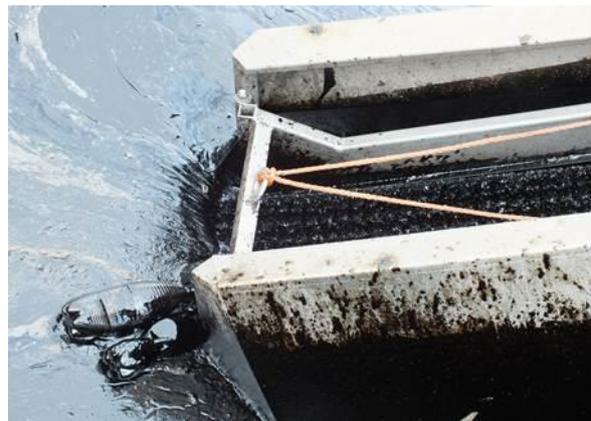
*Photograph 27:* Heavy fuel collected at the Fińskie Wharf by “Delfin II” catcher

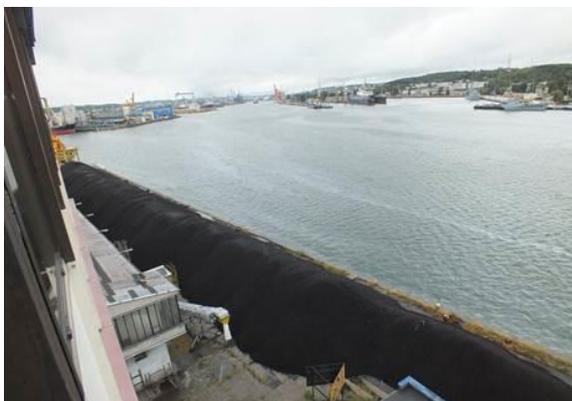
*Photograph 28:* Traces of oil spill in the inner port

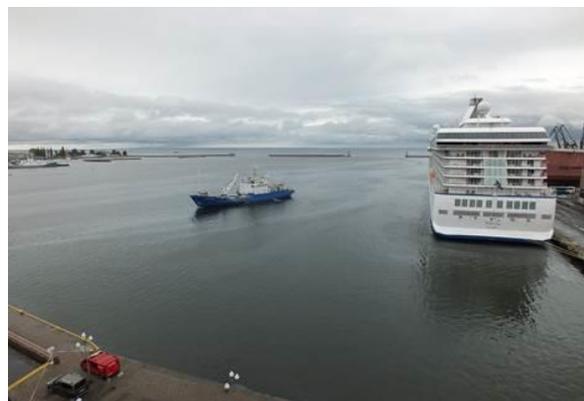
*Photograph 29:* Traces of oil spill in the outer port

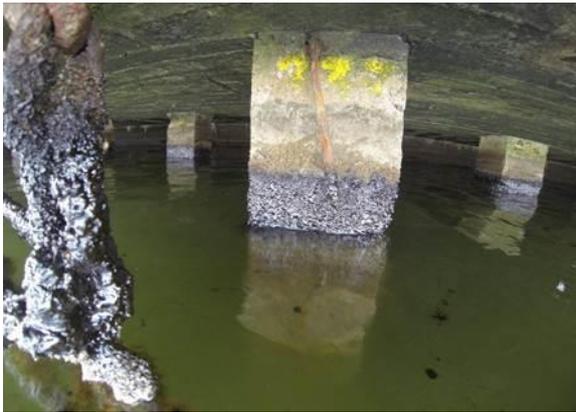
*Photograph 30: The Polskie Wharf*

The inspection of port basins carried out by a diver from the “Aqatech” company and photographs of thirteen wharves affected by the spill show the extent of contamination caused by spilled fuel. Photographs of four selected wharves are presented below (Photographs 30 - 33).
