# **STATE COMMISSION ON MARITIME ACCIDENT INVESTIGATION**

## **FINAL REPORT 41/13**

**Collision of Annemieke and Tao Hua Hai  
during exit manoeuvres from the port of Świnoujście  
on 19 December 2013**

**February 2015**

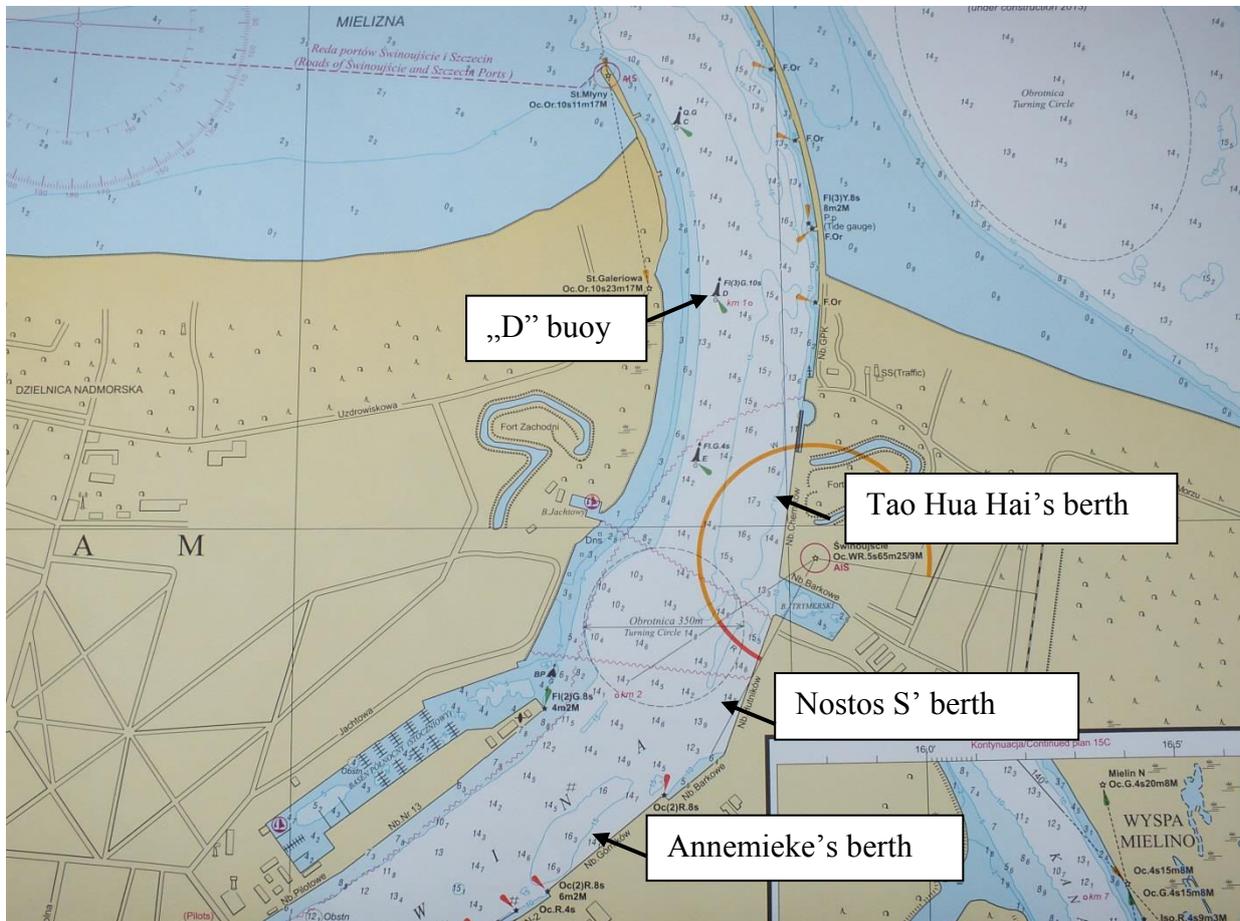
Photograph 1: Section of the HOPN chart no 15C (the plan of the port of Świnoujście) with indicated berths of the vessels that participated in the event
