STATE COMMISSION ON MARITIME ACCIDENT INVESTIGATION

FINAL REPORT 29/13

M/T HORIZON APHRODITE

Bumping against a concrete cap of the head and damaging the fender frame
of the eastern breakwater at the exit from the port of Gdańsk on 22 September 2013

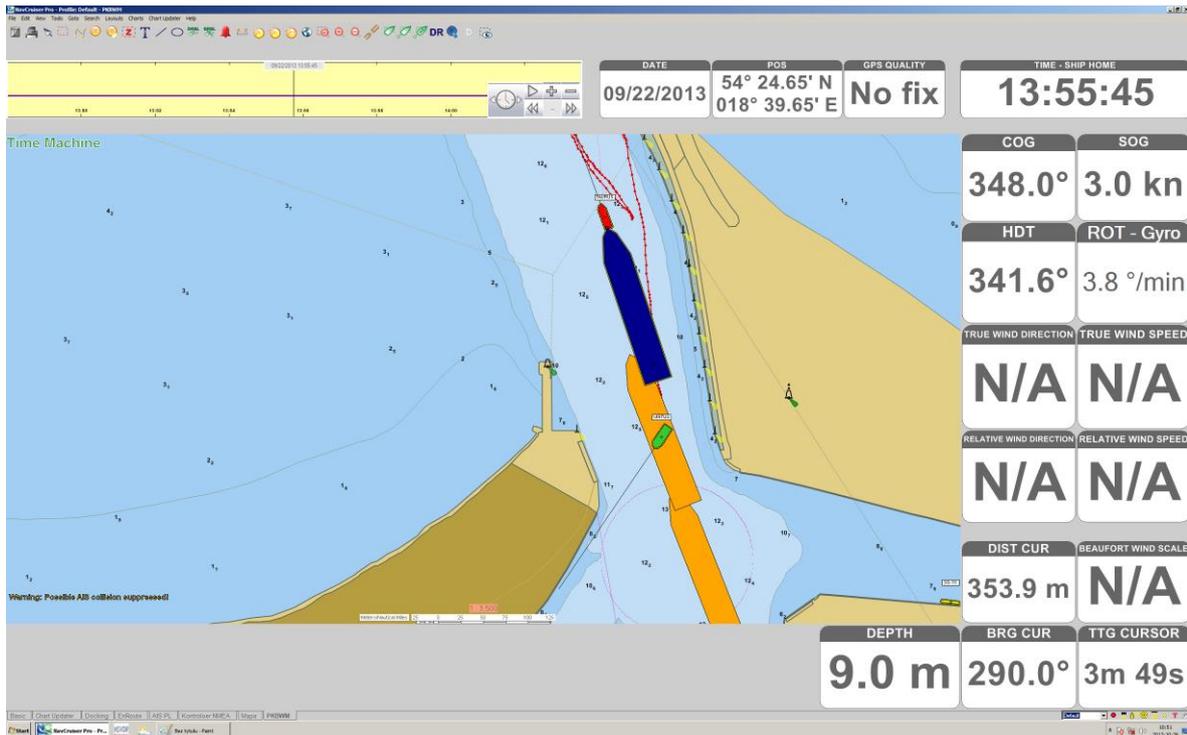
The pilot should have foreseen that at such a large windage area of an empty and not fully ballasted vessel, and with a strong wind blowing almost perpendicularly to the ship's side, the vessel would be exposed to its effect, especially after passing the quays and port buildings, which accounted for some protection from the wind. Using a tugboat at the bow after the vessel had passed the western breakwater, holding the vessel on the towline from the port or pushing the bow from the starboard, would prevent drifting and causing damages.

Figure 2. Position of the vessel at the time of passing the head of the western breakwater (15:55:45 LT)

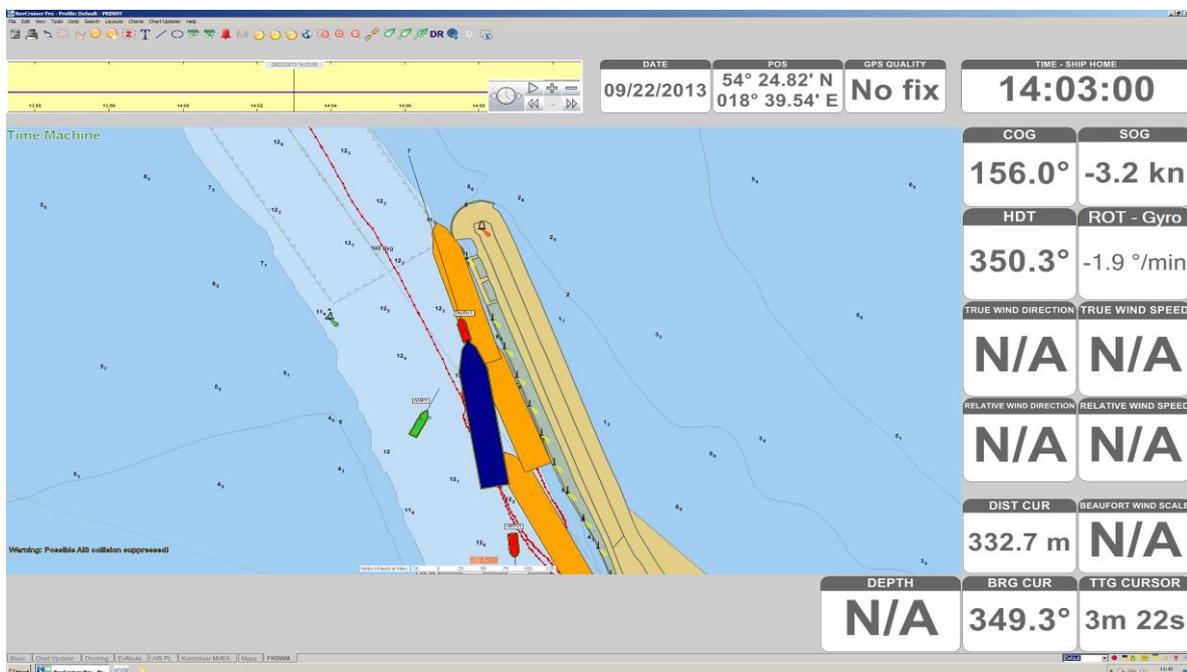
Figure 5. Position of the vessel after moving away from the fender frame (16:03:00 LT)

After the vessel moved away from the head and the fender frame of the breakwater due to a strong drift and prolonged time of giving the towline at the bow, there was another blow at the fender frame (with the bow). There passed almost 6 minutes from the time the pilot ordered to give the towline until it was fixed. The towline was fixed 10 seconds before the blow.

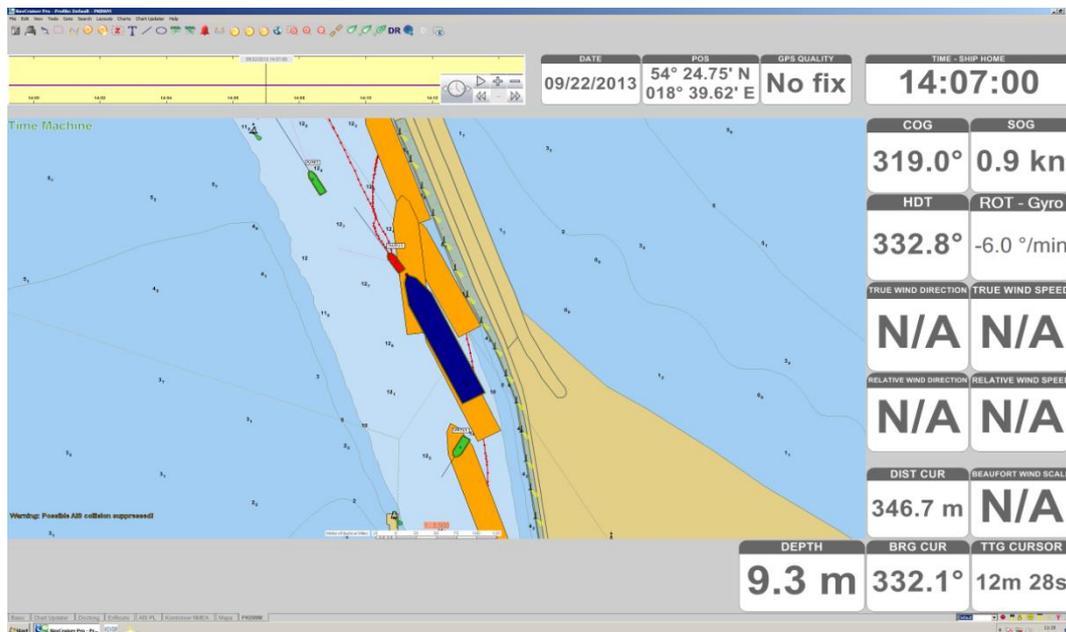
Figure 7. Position of the vessel after it was pulled away from the breakwater by tugboats (16:07:00 LT)
