STATE COMMISSION ON MARITIME ACCIDENT INVESTIGATION

FINAL REPORT 30/14

M/V LANGBALLIG

Contact of the stern with underwater part of the central breakwater embankment
on the fairway in Świnoujście on 9 August 2014

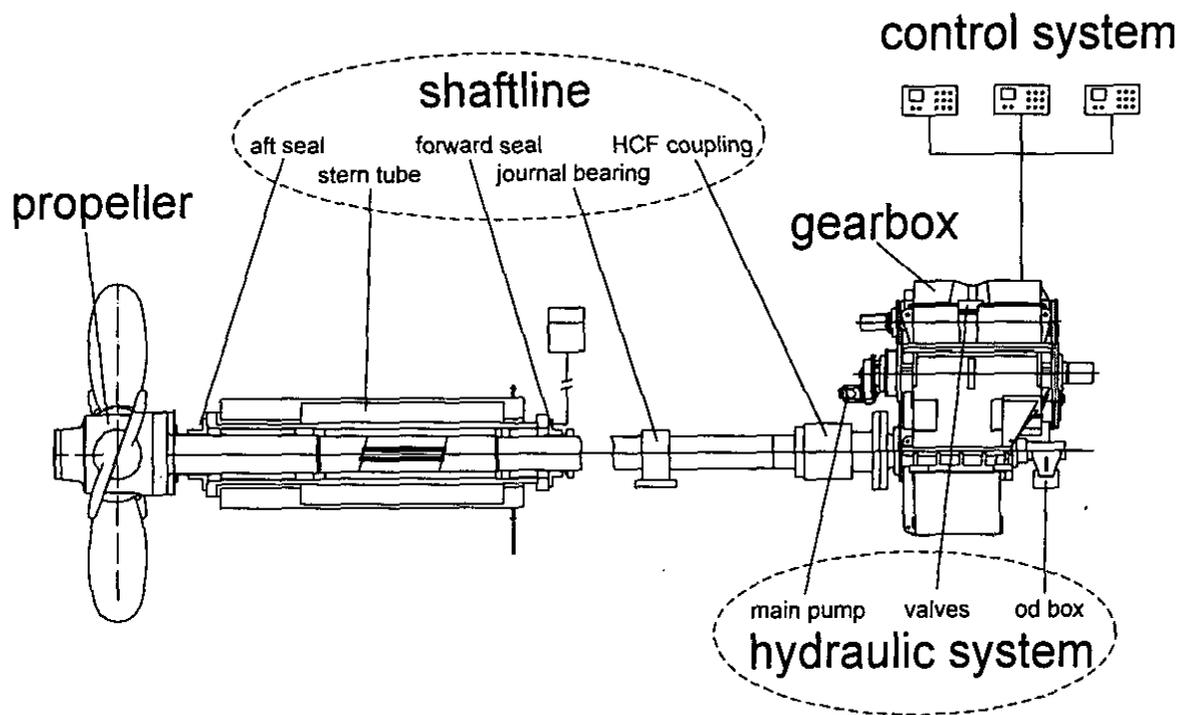
Figure 1: Integrated propulsion system of Langballig

“Langballig” is equipped in an integrated propulsion package (IPP) consisting of an adjustable propeller, a shaftline, a reduction gearing with a reduction gear with hydraulic gearbox and a hydraulic system - Fig. 1. Additionally, the integrated propulsion system is equipped with a control system.

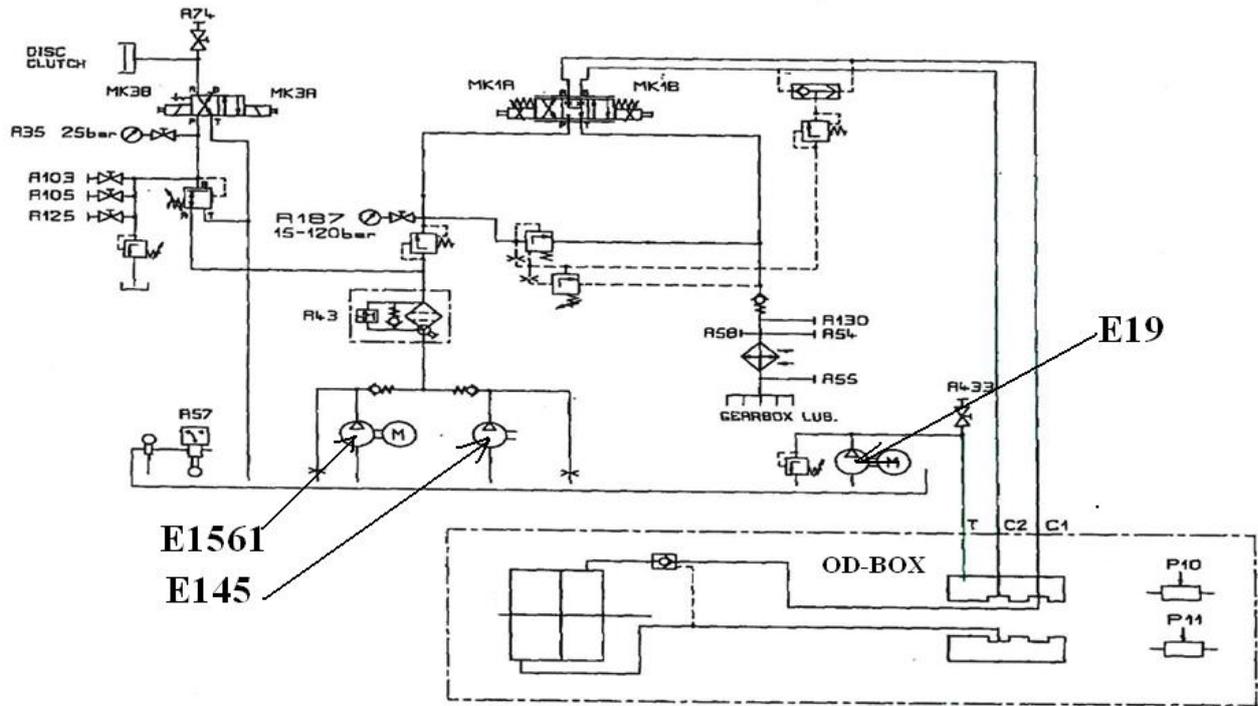
Figure 2: Hydraulic diagram of the integrated propulsion system of “Langballig”

The propulsion system presented in Fig. 2 in the propulsion system of the vessel generates pressure needed to alter the deflection of the adjustable propeller, to switch on and off the clutch

gear and to lubricate and cool the internal parts of the transmission gear. The pressure of the hydraulic oil is produced by the main oil pump (the so called suspended pump) - driven by the transmission, or an auxiliary pump – driven by the electric motor.

- E1561 - hydraulic oil pump of the IPP driven by the electric motor
- E145 – suspended main hydraulic oil pump of the IPP driven by the transmission gear
- E19 - oil pressure pump of the adjustable propeller hub driven by means of an electric motor
- DISC CLUTCH - clutch gearbox
- OD-BOX - distributor of hydraulic oil adjustable propeller
- GEARBOX LUB – lubricating of the transmission gear

The Commission found out that the failure which caused the main engine to stop was due to a very poor state of insulation of the damaged electric motor that drives the propulsion hub oil pressure pump. Poor insulation condition caused interference in the working of the electronic control system, which caused instability and fluctuations in the hydraulic oil pressure in the gearbox lubrication system. The hydraulic oil pressure drop below the 16 bars activated the security system against lack of lubrication of the gear that stopped the main engine.
