# **STATE MARINE ACCIDENT INVESTIGATION COMMISSION**

## **FINAL REPORT 13/15**

**M/V CORINA**

death of a seaman and carbon monoxide poisoning of four other persons  
during the port call in Hanstholm on 28 April 2015

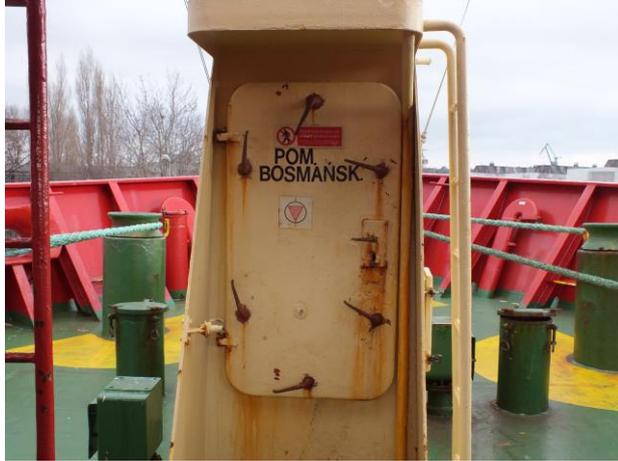
The entrance to the lashing equipment locker leads from the forecastle deck (Photograph 4), through the storage of mooring equipment (bosun store) and the adjacent small room housing the unit of hydraulic pumps of the cargo hold covers (Photograph 5).

*Photograph 3. Entry doors to rooms in the bow of the vessel*

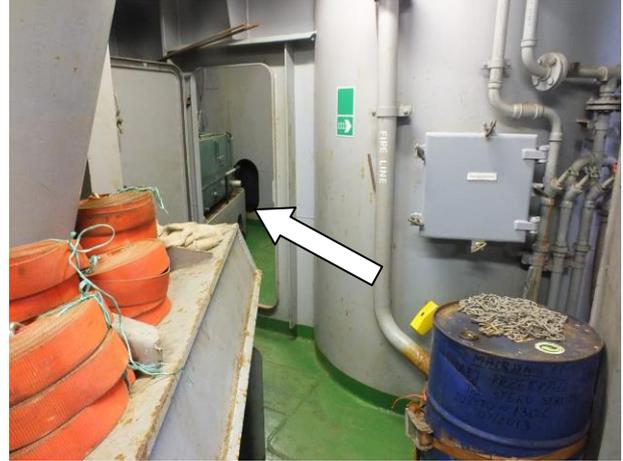
The paramedics arriving on board the ship went down to the hydraulic pumps room, located above the lashing equipment locker, assessed the situation and ordered the persons in the locker, who were still conscious, to immediately leave the room. The port officer and the seaman left on their own, supported by the rescuers standing at the hatch. The remaining unconscious persons were evacuated to the deck by the firemen, who came inside the room wearing breathing apparatus.

*Photograph 4. Cargo hold covers hydraulic pumps unit room*

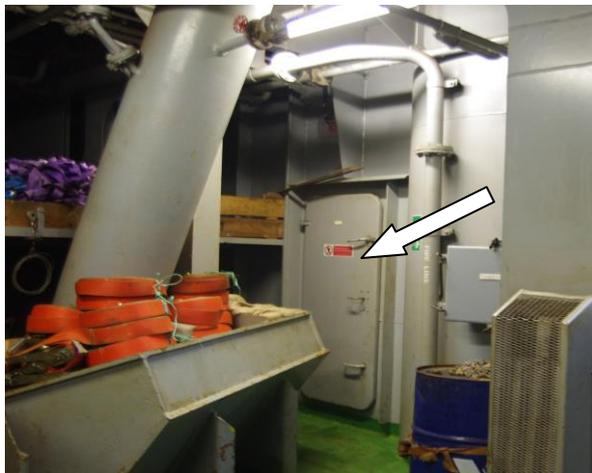
The entrance to the pump room is secured with steel bolted doors (Photograph 5), while the manhole to the lashing equipment locker located below is closed by a cover equipped with a rubber seal and wing nuts (Photograph 6).

*Photograph 5. Entrance door to the hydraulic pumps room*
