# **STATE MARINE ACCIDENT INVESTIGATION COMMISSION**

## **FINAL REPORT 15/15**

### **SAILING YACHT DOWN NORTH**

Capsize and sinking of the yacht with the loss of a crew member  
in the Pomeranian Bay on 30 May 2015

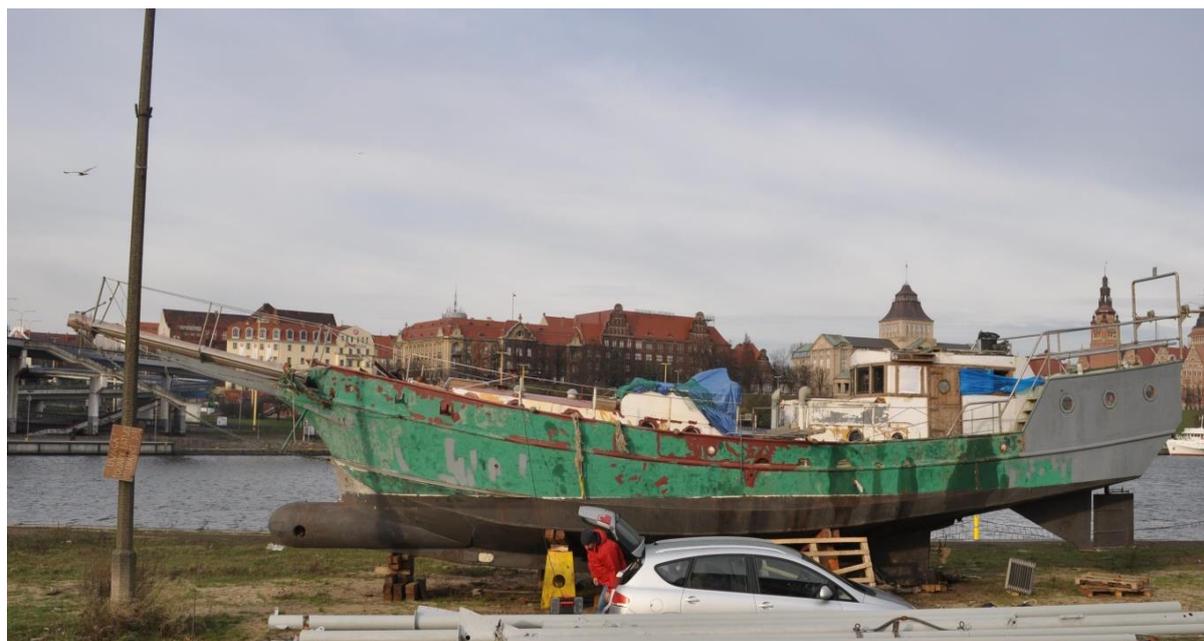
Photograph 1. Yacht *Down North* at Łasztownia Wharf in Szczecin. December 2015

Four months later, the wreck of the yacht *Down North* was lifted from the bottom of the Pomeranian Bay and towed to the port of Świnoujście, and then transported to Szczecin by land.

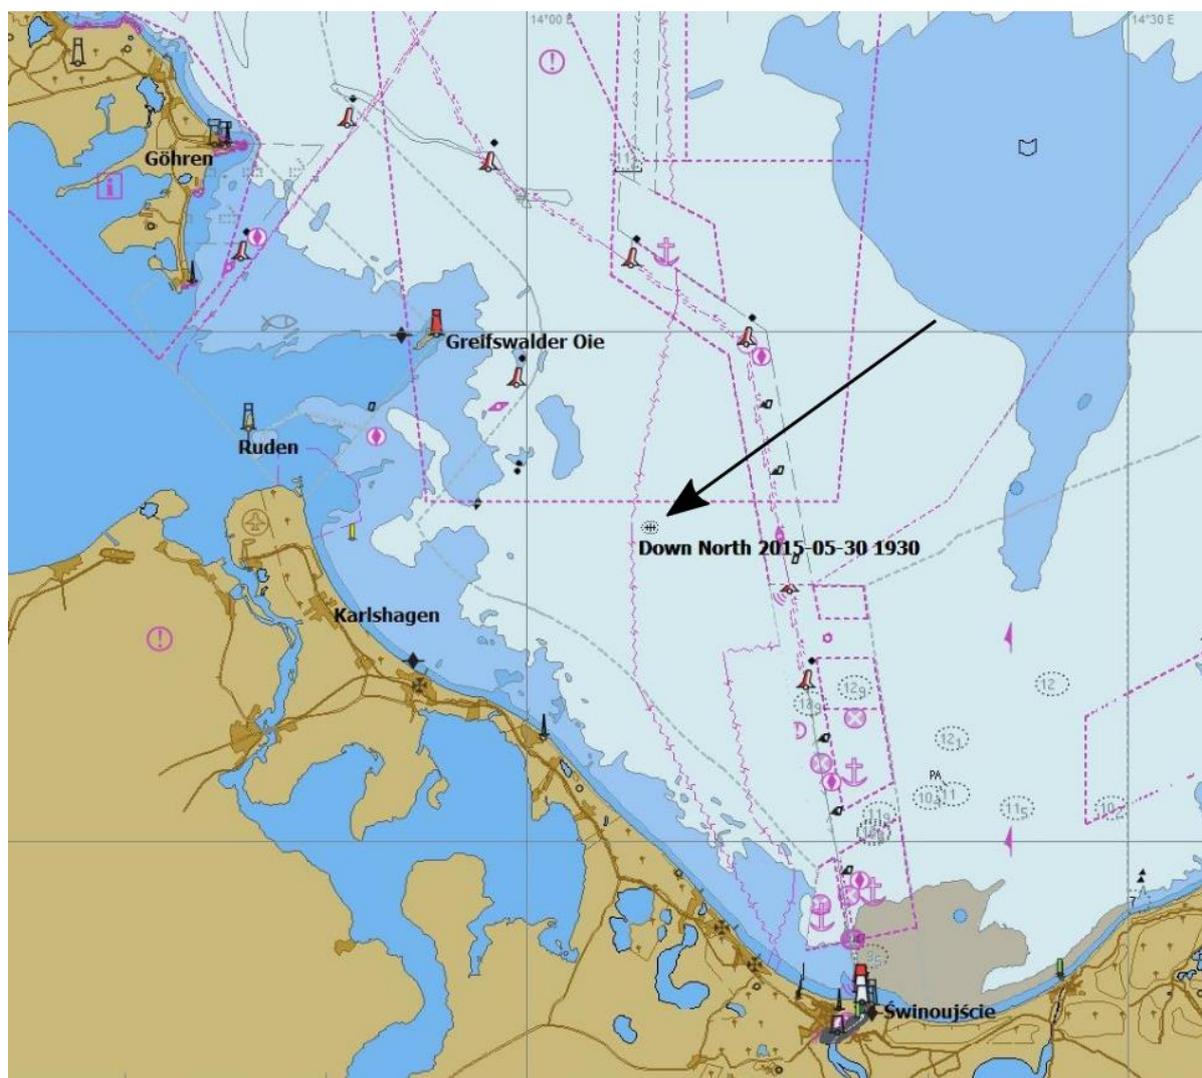
Figure 2. Position of sinking of the yacht Down North

After approximately 20 minutes, at 19:30 on 30 May 2015, the yacht sank and settled at the depth of 12 meters. The masts remained visible above the surface.

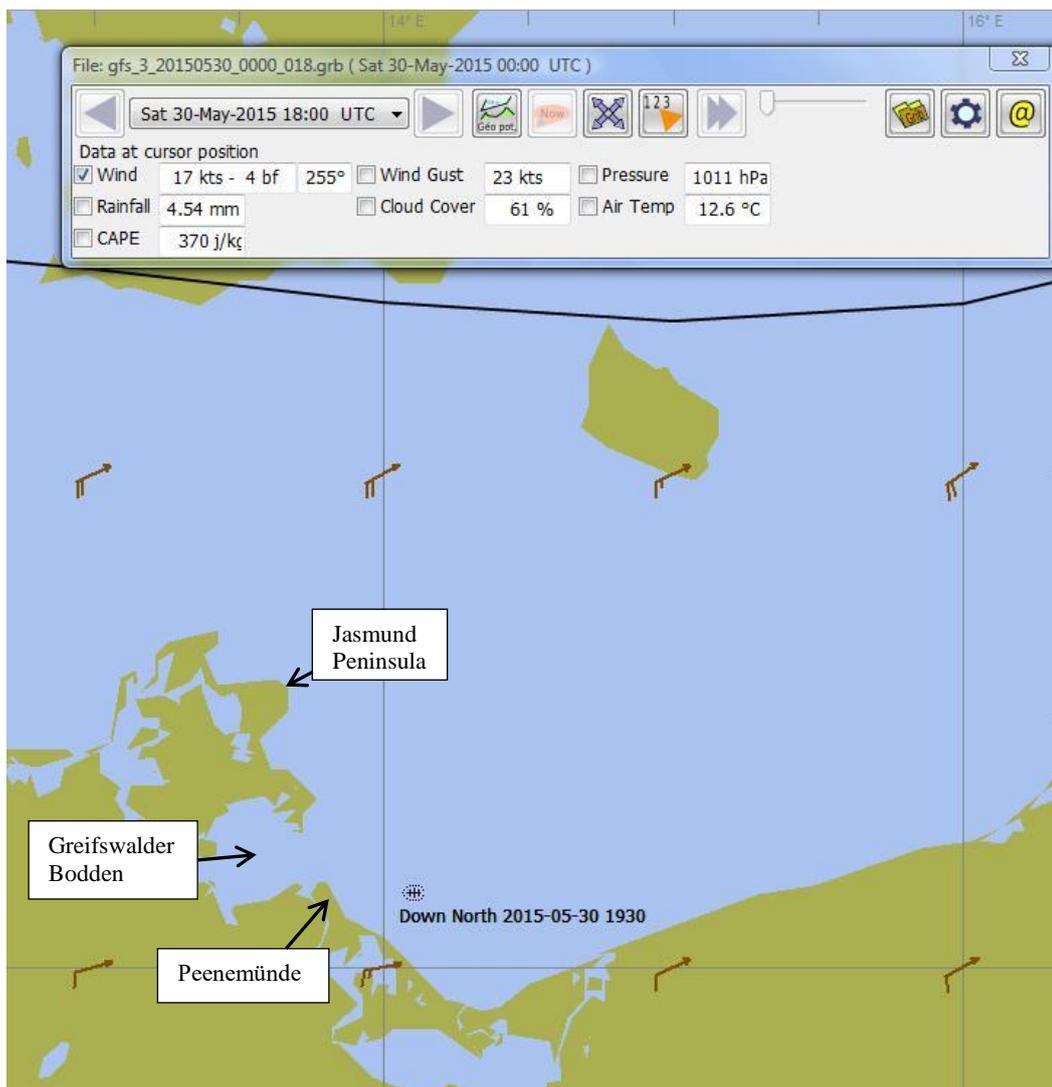
Figure 8. Morning GFS GRIB forecast for 20:00 LT

Both forecasts suggested the possibility of encountering strong gusts as the distance from Świnoujście increased on the route towards the Jasmund Peninsula, however both the DWD forecast and the later IMGW analyses connected strong gusts with storm cloud formations, which were not seen from the yacht *Down North*.

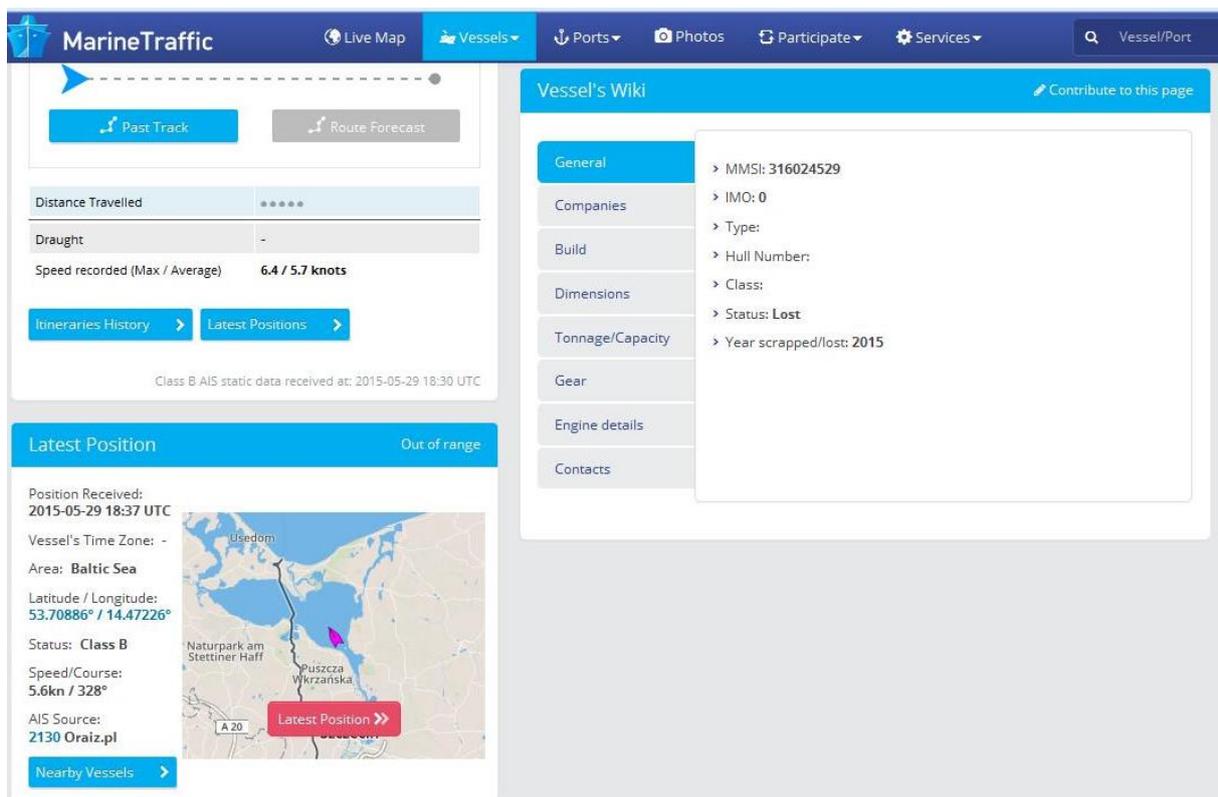
Figure 9. Last position of *Down North* according to *MarineTraffic*

2. JRCC Halifax checked the information and on the basis of the Canadian Beacon Registry identified the yacht *Down North* and its previous owner<sup>24</sup>. Phone contact with the previous owner gave information on the sale of the yacht and provided the contact data for the broker handling this transaction. The broker provided contact data for the current Polish owner. Registration data of the radio beacon were not available in global registration systems ITU MARS and COSPAS-SARSAT IBRD.
3. JRCC Halifax found the yacht *Down North* in the AIS MarineTraffic (Figure 9) system showing the position timestamped as being 22 hours old, near the Brama Torowa 3 beacon in Zalew Szczeciński (Szczecin Lagoon, position marked with a letter A at Figure 12).

4. This information was immediately relayed by JRCC Halifax by phone to MRCK Gdynia. It provided only the name of yacht, flag and the 22-hours-old AIS position. The message was not a typical one and the Canadian operator failed to ensure that he

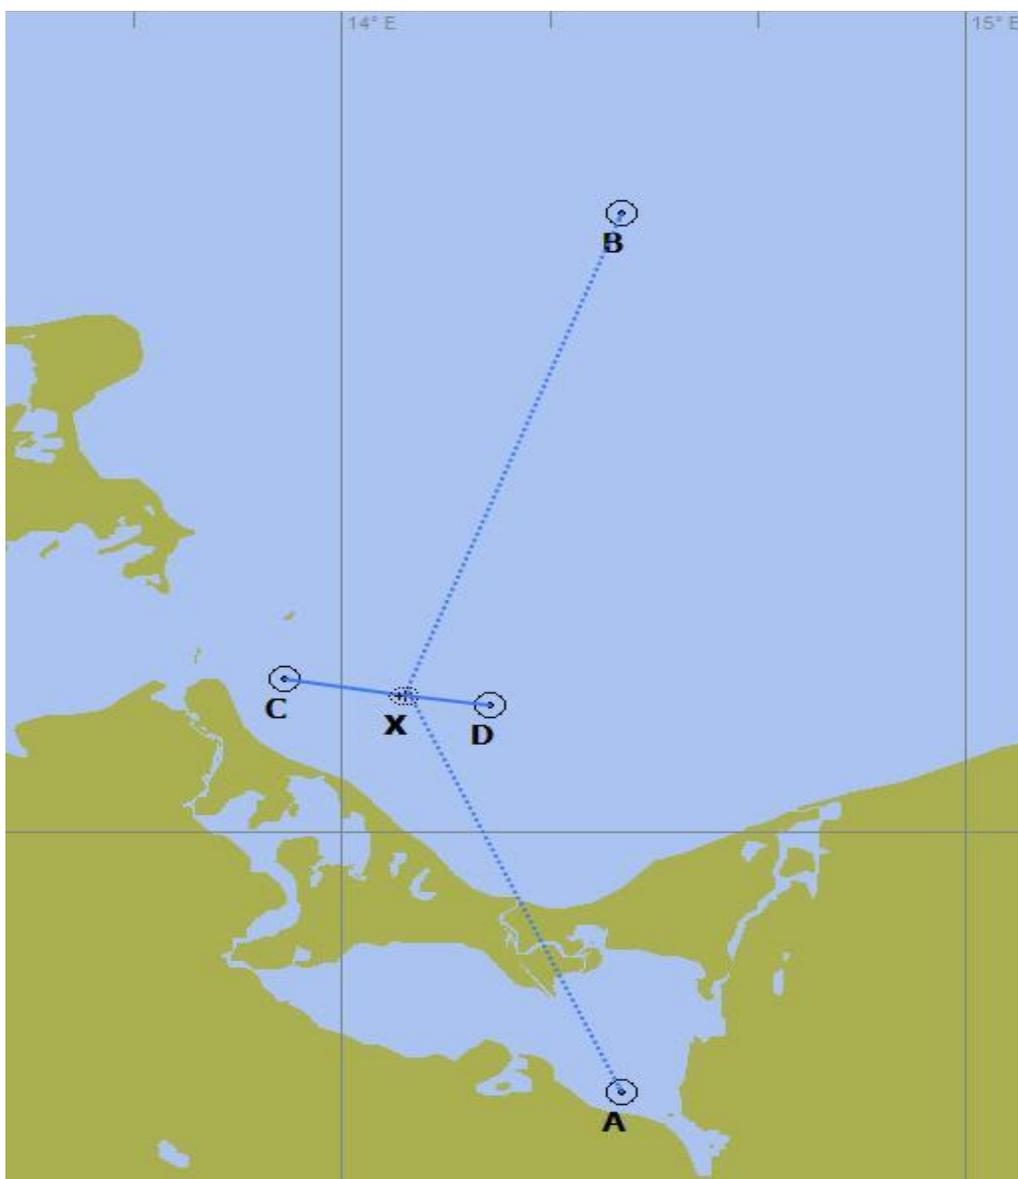
Figure 12. Map showing positions of the *Down North* indicated in subsequent messages

5. MRCK Gdynia duty inspector on receiving the first message failed to observe the procedure in force in the Centre and did not ask JRCC Halifax for sending information in written form, by fax or email. When jotting down the position provided by the Canadian operator, the duty inspector made a mistake in latitude, writing 54° N instead of 53° N (area of Adlergrund marked with letter B on Figure 12) and assumed mistakenly that the provided position concerns the signal from EPIRB rather than from the yacht AIS device. In further activities the operator assumed that the yacht was most probably heading from Adlergrund to Świnoujście.

14. After 53 minutes from detection of the *Down North*'s radio beacon signal by the first satellite of LEOSAR system, another radio beacon signal was detected and sent to LUT station in Moscow by another LEOSAR satellite SARSAT-13 (position marked with a letter D on Figure 12).

Figure 12 presents all the positions of the yacht considered in the second stage of SAR operation (initial actions, upon receiving a danger message). Letter X marks the place of sinking of the yacht *Down North*.
