**M.V. STENA SPIRIT**

**Report of the marine safety investigation into a  
fatality of a Passenger on a Passenger/Ro-Ro vessel on  
20 September 2018**

## M.V. Stena Spirit– Marine Safety Investigation Report

Date of Issue: 26 March 2019  
Bahamas Maritime Authority  
120 Old Broad Street  
LONDON  
EC2N 1AR  
United Kingdom

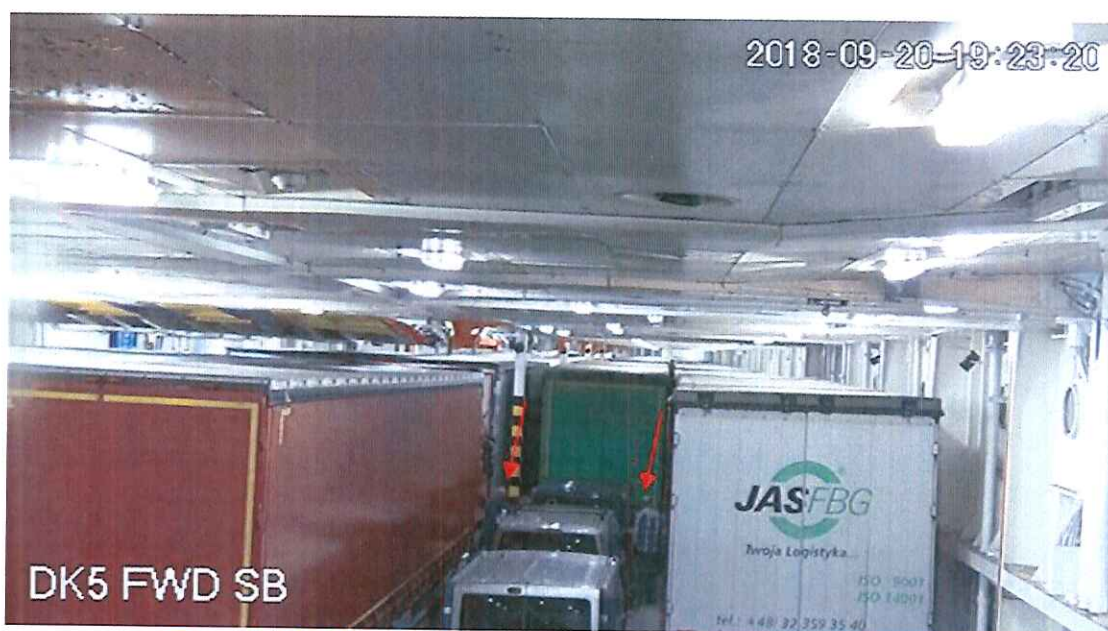
Figure 2: CCTV footage<sup>2</sup> screenshot of passengers arriving on deck 5

- 4.1 On 20 September 2018 at 1925 hours the vessel was approaching the port of Gdynia, Poland. The passengers were on the car deck to access their vehicles at this time.
