STATE MARINE ACCIDENT
INVESTIGATION COMMISSION

ANNUAL ANALYSIS

2023

**MARINE
CASUALTIES
AND INCIDENTS**

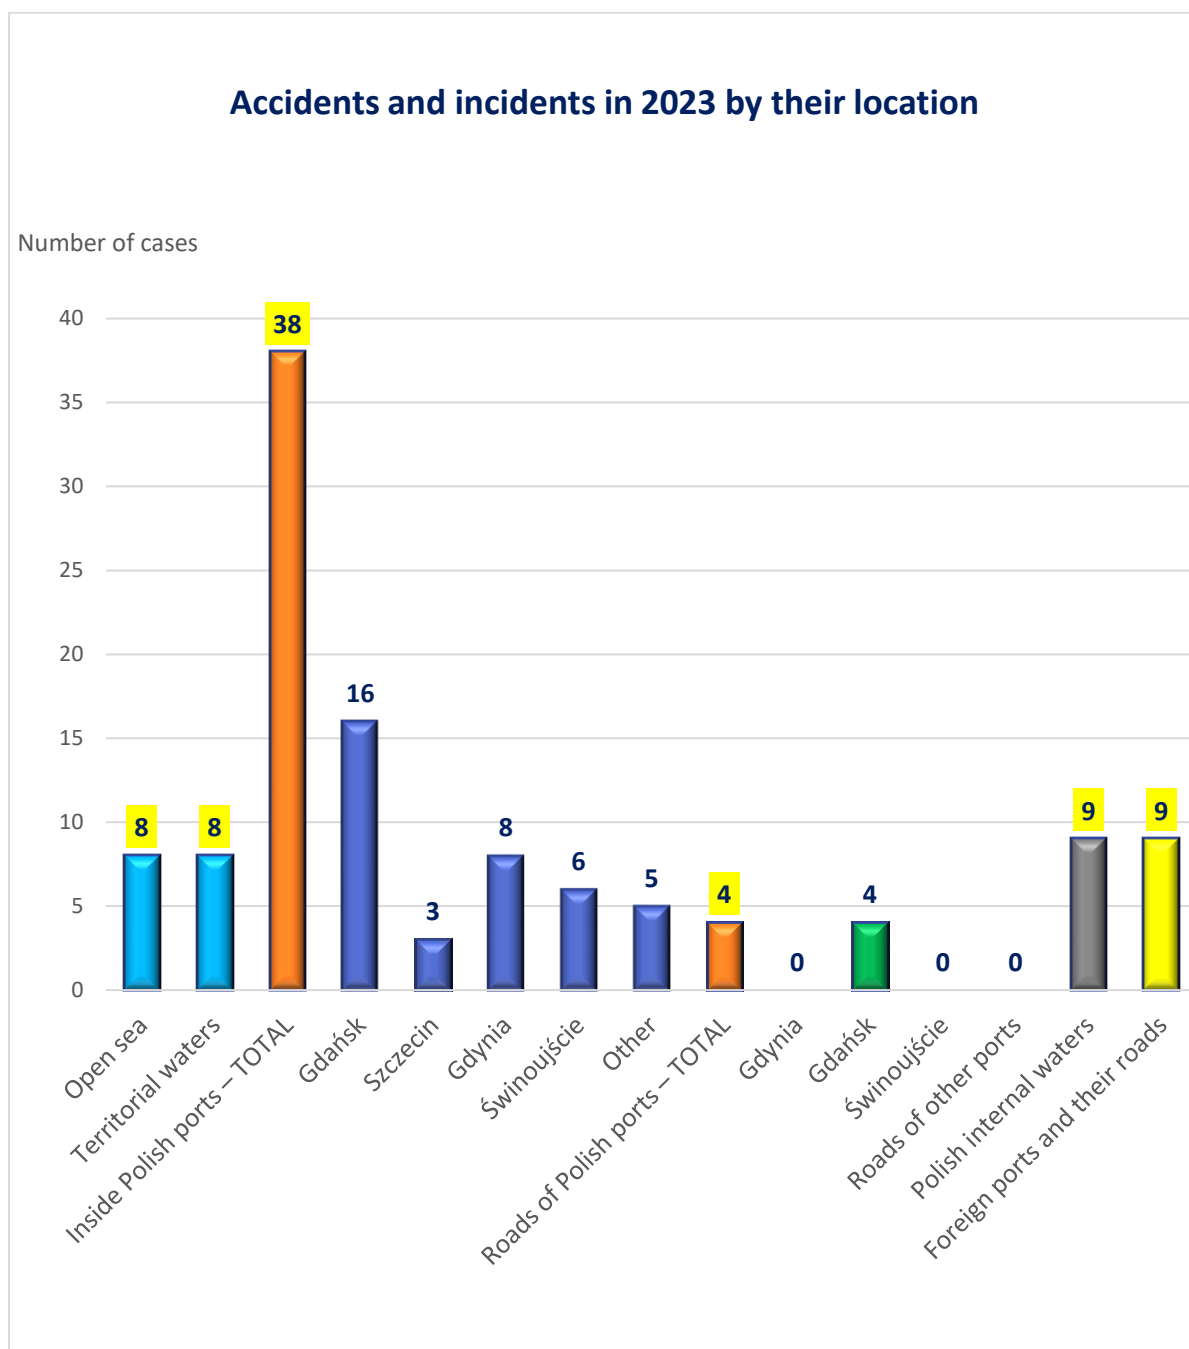
- 0 on Gdynia roads,
- 4 on Gdańsk roads,
- 0 on Świnoujście roads,
- 0 on other Polish ports' roads,
- 9 occurred on Polish internal water,
- 9 occurred on the roads to and in foreign ports.

Figure 5. Breakdown of marine casualties and incidents by their location

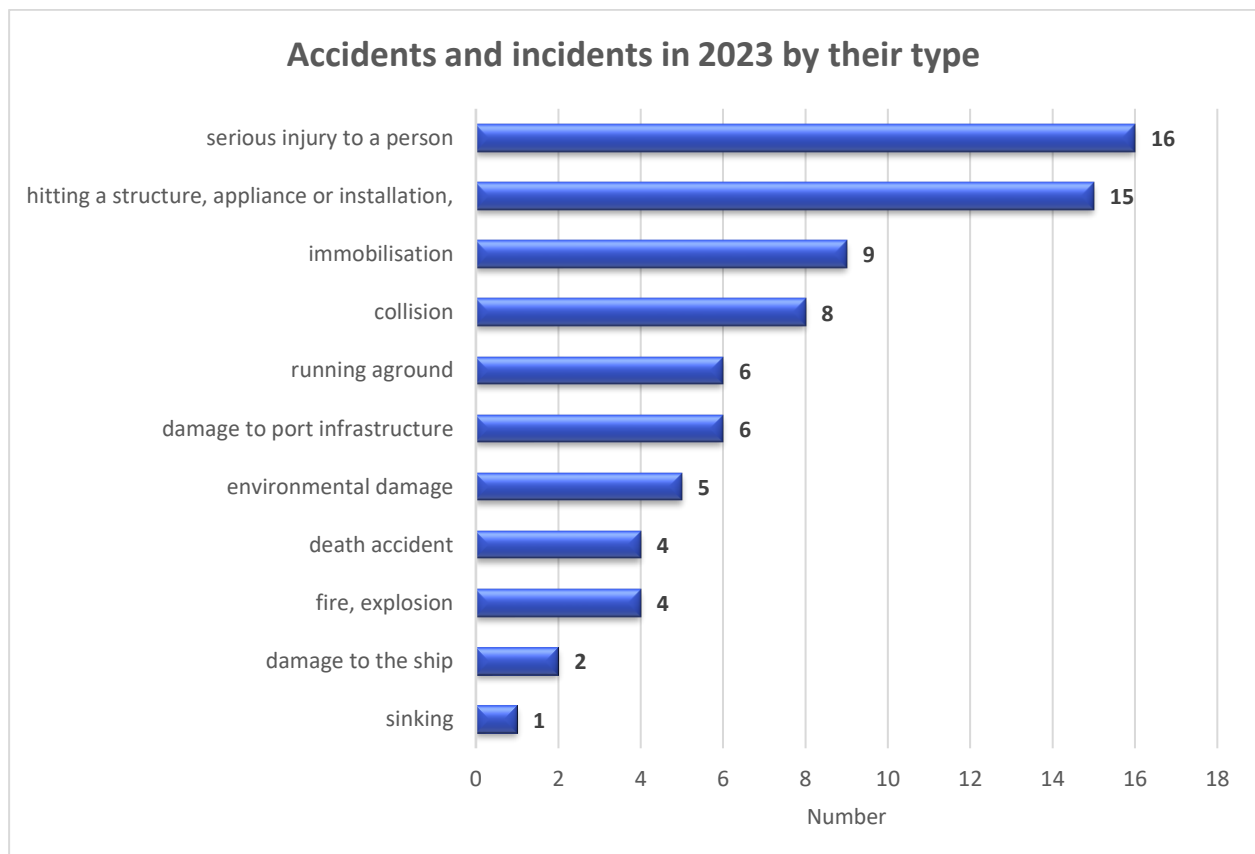
- **16** cases caused serious human injuries,
- **15** ships hit a structure, appliance or installation,
- **9** cases caused immobilisation of the vessels,
- **8** ships collided,
- **6** ships run aground, came into contact with the sea bottom or hit an underwater obstacle,
- **6** ships caused major damage to port infrastructure, to infrastructure providing access to ports or harbours, installations or structures at sea, resulting in a serious threat to the safety of the ship, other ships or persons,
- **5** cases of environmental damage or danger of such damage, manoeuvring or operation requiring major repairs,
- **4** death accidents,
- **4** ships were on fire, explosion,
- **2** damage to the ship appreciably affecting her structure, manoeuvrability or operation, requiring major repairs,
- **1** ship sunk, was missed or lost in other way

Figure 6. Breakdown of marine casualties and incidents by their type

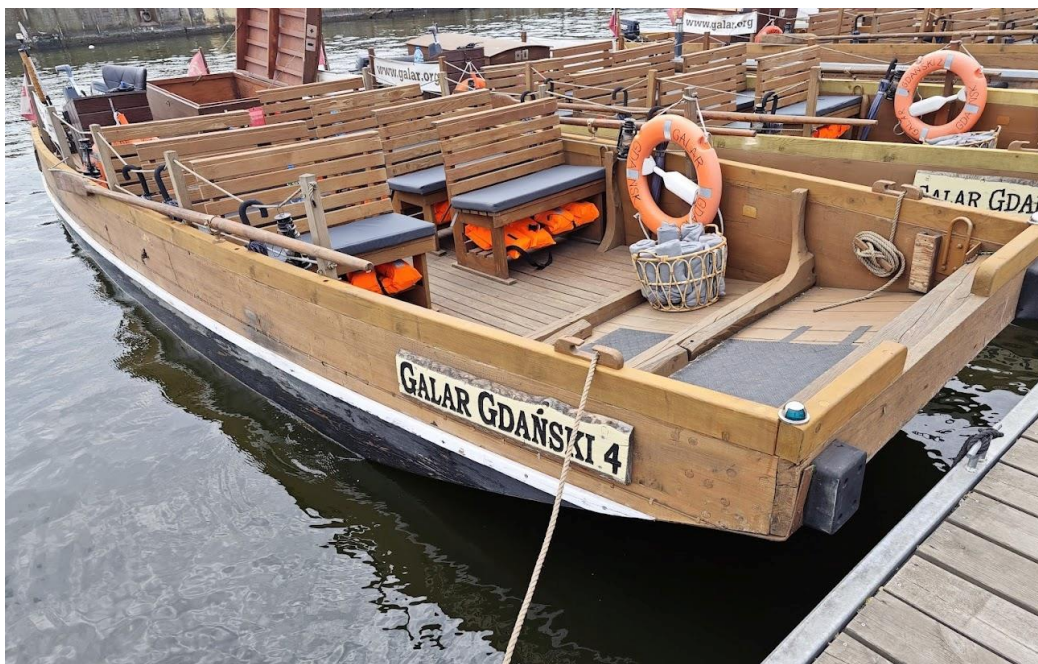
The Technical Supervision Inspector of the Polish Yachting Association recommended changes to the boats 'Galar Gdański 2', 'Galar Gdański 3', 'Galar Gdański 4', 'Galar Gdański 5', 'Galar Gdański 6' ('Galar Gdański 1' was not put into service) consisting in raising the side by 10 cm. The changes were made by the builder of the Galar yachts.

Gdańsk Galars 2-6 after the side was heightened by 10 cm.

The Commission requested the PYA to present results of the fulfilment of the PYA's technical regulations by Galar-type crafts, after their rebuilding. From the information received it appeared that criterion IV of the stability requirements (angle of flooding) had not been reviewed. Based on the limited review, a navigability licence (*Orzeczenie Zdolności Żeglugowej – OZZ*) was issued, without any remarks, and the inspection body – the Director of the Maritime Office in Gdynia issued new Safety Charters allowing Galar Gdański yachts No. 2-6 to be used as commercial motor yachts at a wind force up to 6°B and a wave height up to 0.3 m, with restrictions to the sailing area specified for design category C.

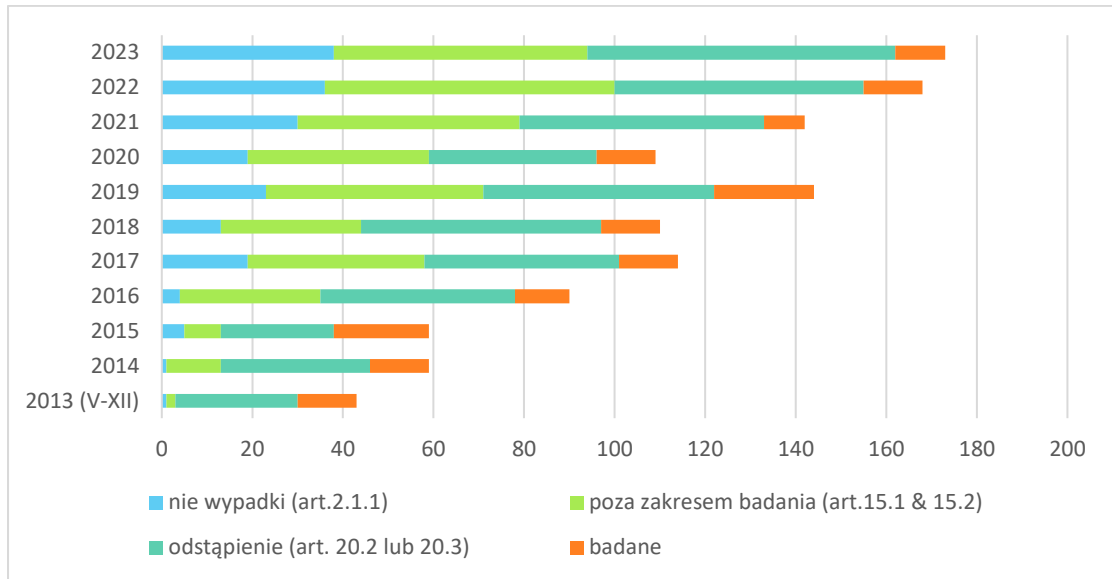
- incidents which, after analysis of the accident definition, were not considered as marine casualties,
- marine casualties which fall outside the Commission's legal jurisdiction,
- marine casualties or incidents which were not investigated taking into account the seriousness of the accident, the type of ship or cargo involved and whether the results of the investigation will contribute to the prevention of similar marine casualties or incidents in the future,
- marine casualties to be further investigated by the Commission.

Figure 1. Marine casualty and incident reports 2013 - 2023

nie wypadki (art.2.1.1)	no accident (Article 2.1.1)
poza zakresem badania (art.15.1 & 15.2)	outside the scope of the investigation (Articles 15.1 & 15.2)
odstąpienie (art. 20.2 lub 20.3)	abandoned (Articles 20.2 or 20.3)
badane	investigated

The chart below shows the categorisation of reported marine casualties and incidents shown on Figure 1, omitting reports/incidents that are not marine casualties or incidents and those that fall outside the statutory scope of Article 15. The sharp increase in very serious casualties in 2015 and the subsequent decrease to minimum values of 4 -7 during the next years should be noted.
